APPLICATION FOR RESOURCE CONSENT OR FAST-TRACK RESOURCE CONSENT

PBisset Road and 5, 6, 7, 8 and 10 Rimu Place and Taraire 1M, Kaikohe Proposed Residential Development

Geotechnical Investigation for Proposed Residential Development at

Bisset Road and 10 Rimu Place, Kaikohe

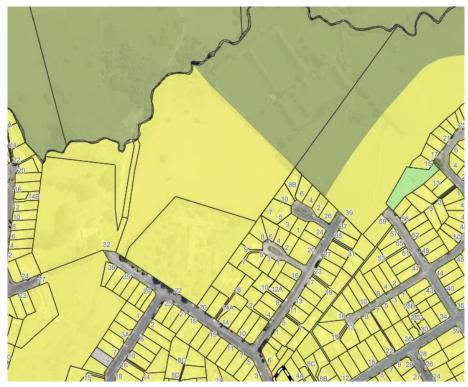
Figure 3: Proposed District Plan zoning. Source: FNDC GIS

The site is zoned as General Residential under the Proposed Far North District Plan, as shown in Figure 3 below.

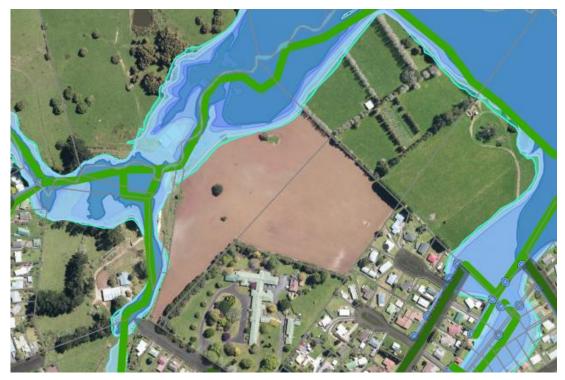
Figure 4: Flooding. Source: FNDC GIS

The subject site has areas at the northern end (as shown in Figure 4 below) that are identified as subject to flooding.

Under the Operative District Plan the site is zoned Residential, with River Flood Hazard Zone (100 Year ARI Event) and River Flood Hazard Zone (10 Year ARI Event), as shown in Figure 4 above.

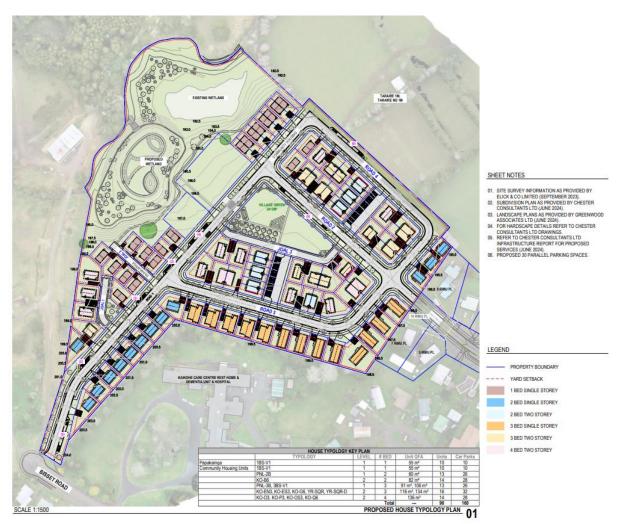
Figure 5: Site Layout (Source: Young and Richards)

The site plan and elevations are included as **Appendix 9** and **Figure 2**, below, shows the general layout of the site.

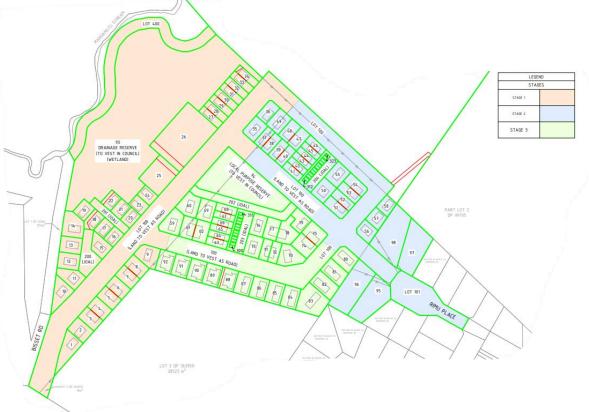
Figure 6: Development Staging Plan (Source: Chester Consultants)

It is anticipated that the development will be undertaken in stages with a total time of not more than 3 years to complete [per stage]. Figure 6, below, outlines the anticipated stages for the development. Of note is that Stage 1 (access off the Bisset Road and including the western portion of the stie) will include the stormwater pond and Road 1.

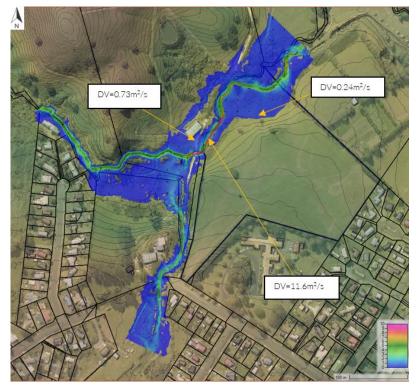
Figure 7: 1% AEP (MPD + CC) maximum flood depth x velocity from the pre-development model

To assess the flooding risk posed to the development site and determine effective measures to manage the risk, Chester Consultants completed flood modelling to estimate the flood levels and the extent of the overflow from the Mangamutu Stream during the 1% AEP rainfall event (MPD + CC) looking at both pre and post development scenarios.

Based on the post-development model, it is estimated that the OLFP will act in similar manner as the predevelopment scenario with the flood extent remaining unchanged except in the area adjacent to the proposed wetland, where the proposed wetland embankment acts as a barrier to allow flood waters into the development site along its length.

There is a minor difference between the maximum flood depth and maximum velocity between the preand post-development scenario model. Overall, there is less than minor change to the flood hazard onsite or in the neighbouring properties.

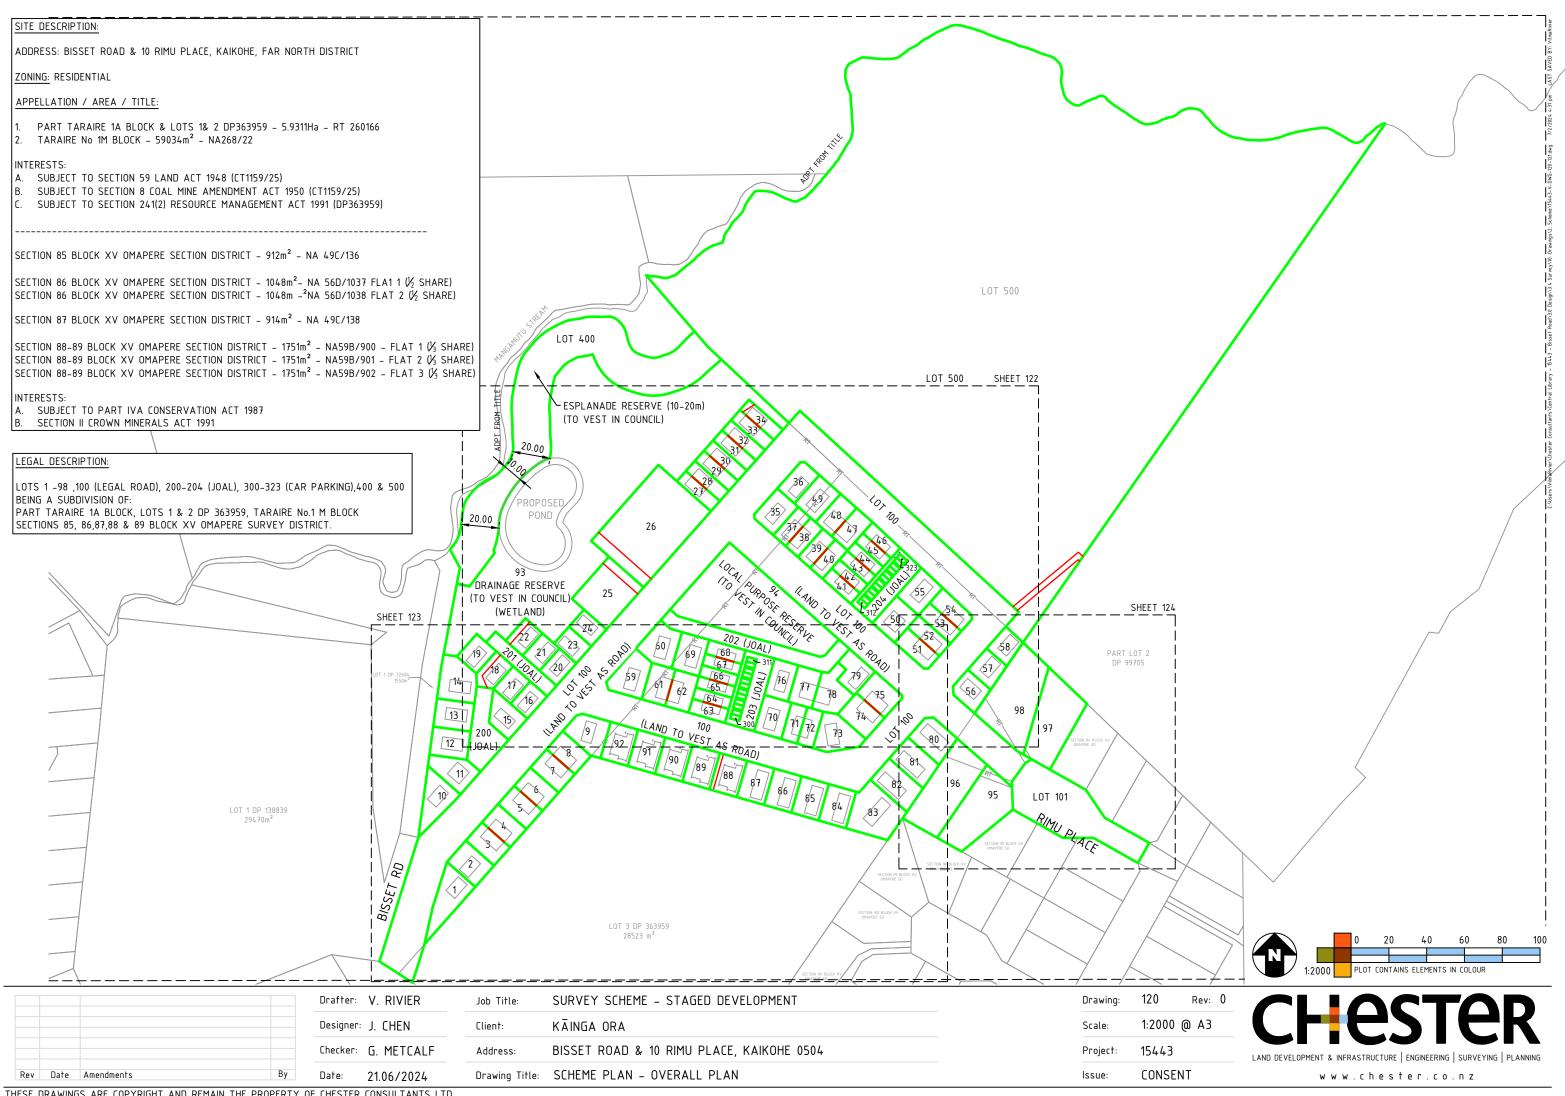
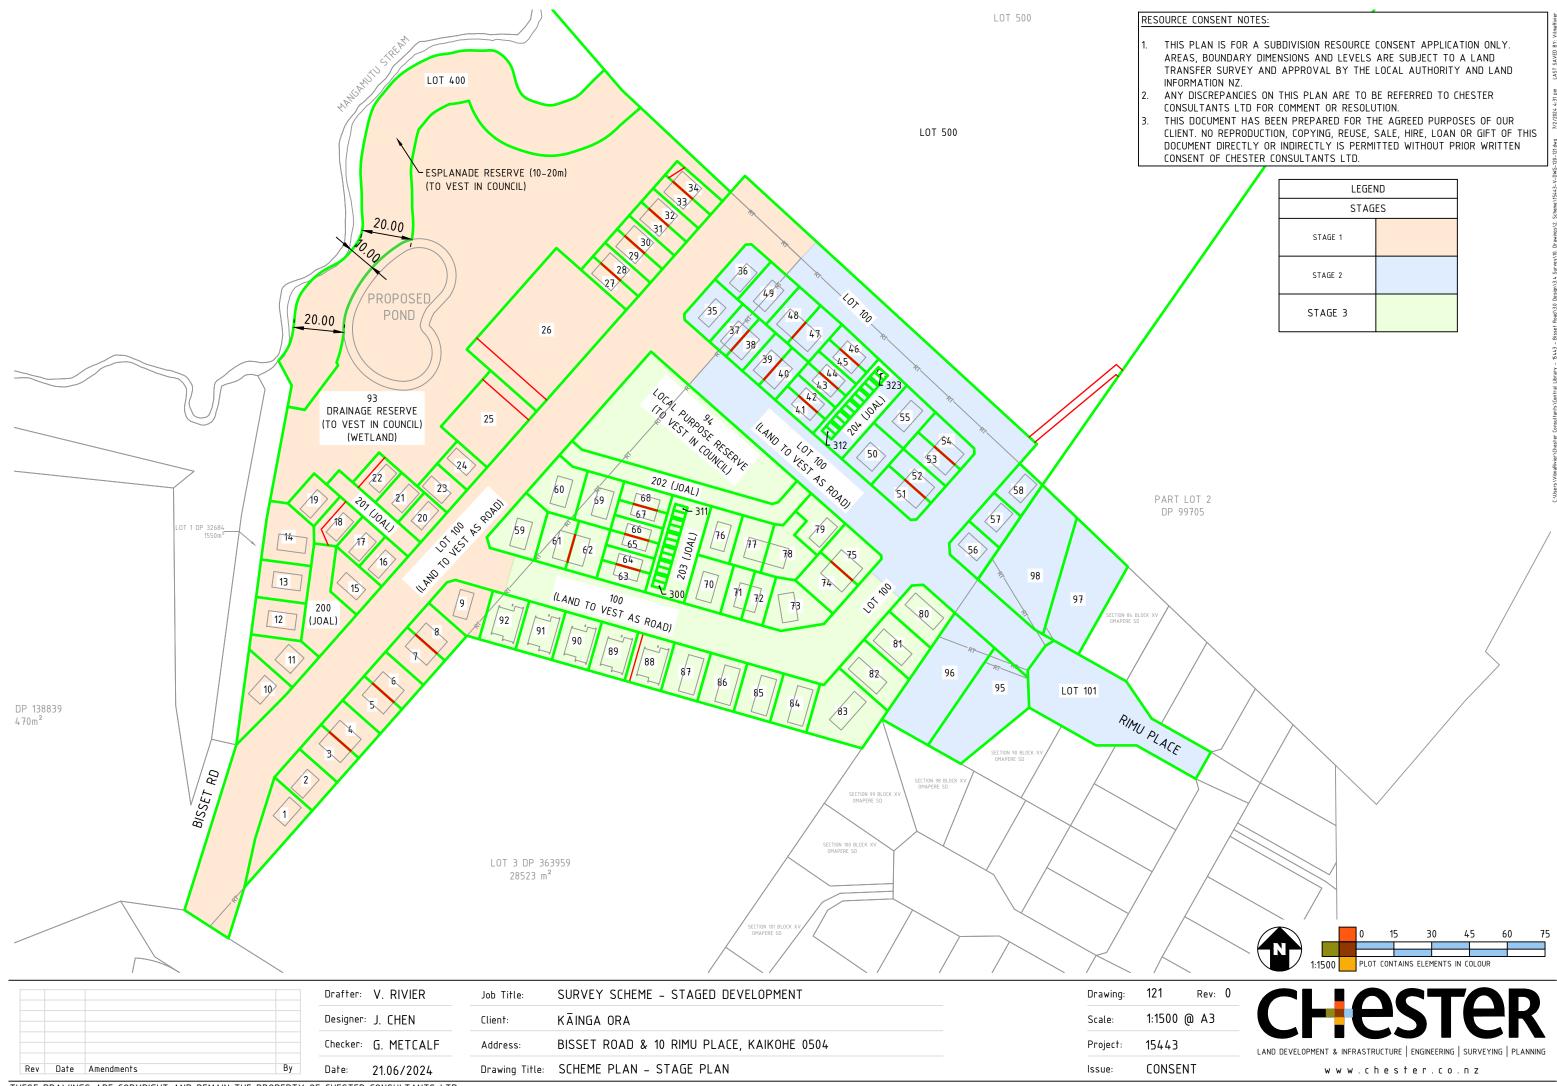
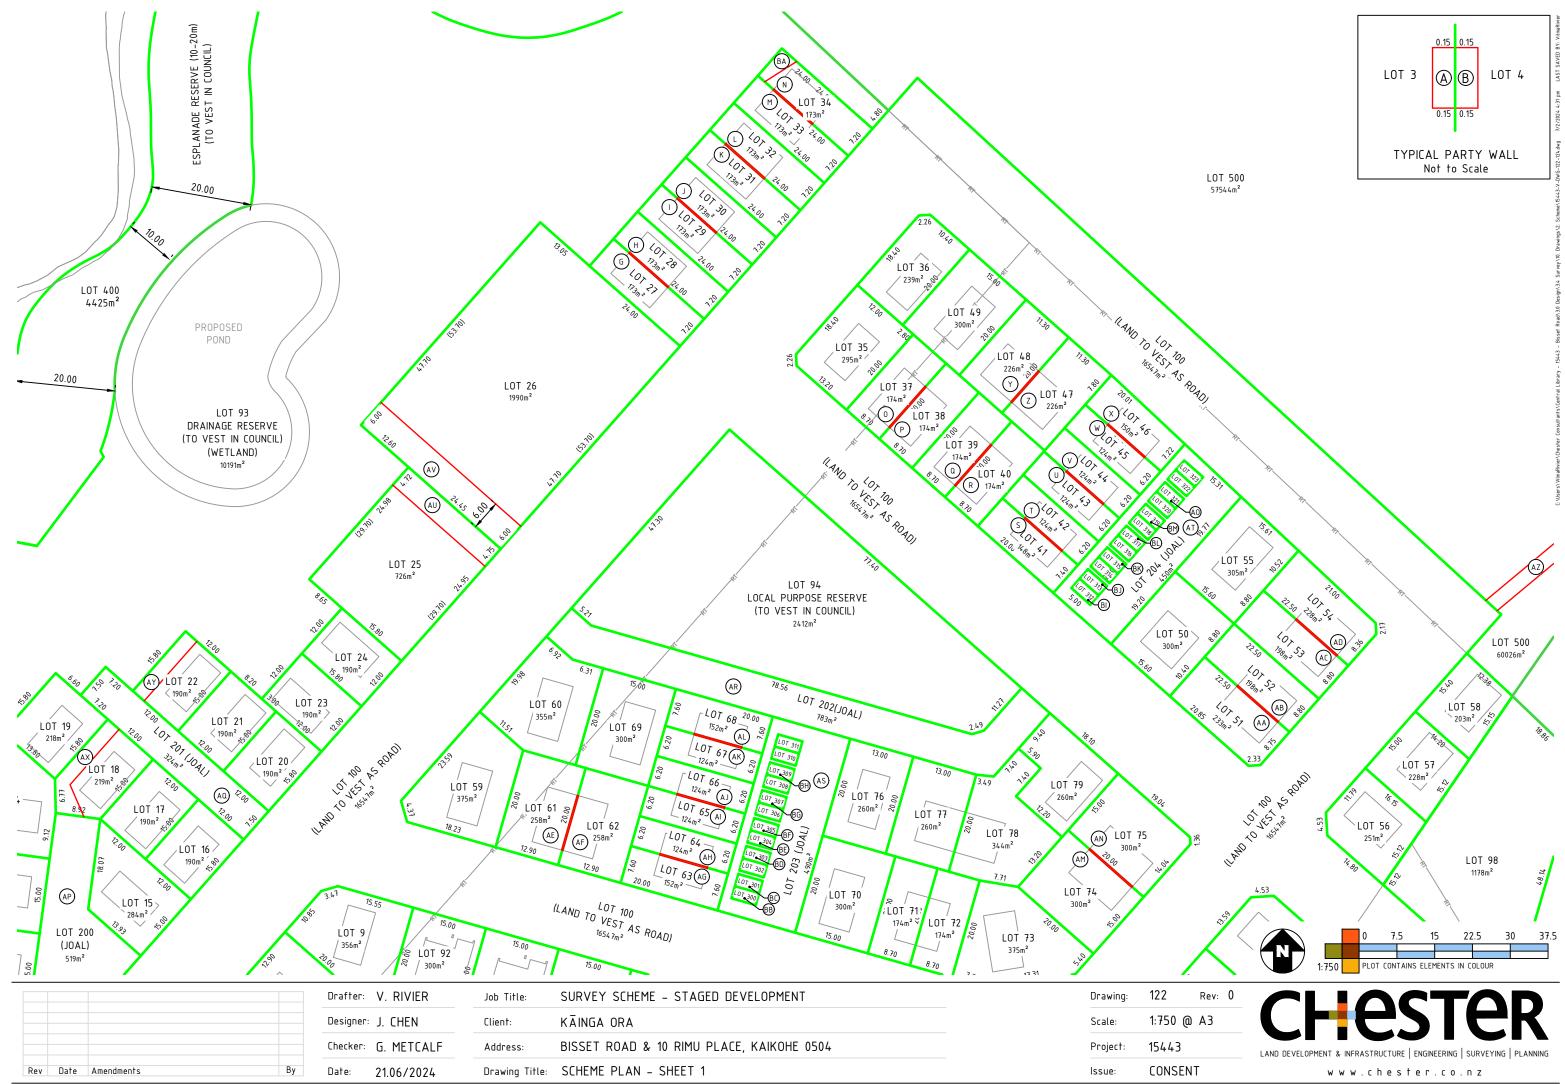
Appendix 2: Scheme Plan

LEGEND STAGES			
STAGE 1			
STAGE 2			
STAGE 3

LOT 1 DP 32684 1550m ² 20.00 LOT 13 300m ² 20.00 LOT 12 300m ² 20.00 LOT 12 300m ² 20.00 LOT 12 300m ² 20.00 LOT 12 300m ² 20.00	LOT 19 218m ² & AX LOT 18 218m ² & AX LOT 18 219m ² & AX LOT 18 219m ² & AX LOT 18 LOT 15 284m ² 200 LOT 15 284m ² 284m ² 284	$\begin{array}{c} \begin{array}{c} LOT 21 \\ 190m^{2} \\ 20 \\ 32 \\ 32 \\ 190m^{2} \\ 20 \\ 32 \\ 190m^{2} \\ 20 \\ 32 \\ 190m^{2} \\ 32 \\ 20 \\ 32 \\ 190m^{2} \\ 38 \\ 20 \\ 32 \\ 32 \\ 190m^{2} \\ 38 \\ 38 \\ 190m^{2} \\ 38 \\ 190m^{2} \\ 38 \\ 38 \\ 100m^{2} \\ 100m^{2} \\ 38 \\ 100m^{2} \\$	101 109 15 100 10 101 105 10 10 101 105 10 10 101 105 10 101 1	LOT 59 375m ² 18.23 LOT 61 8 12.90 13.00 14.00 15.00 10.	15,00 15	Lor 300 Lor 88 300m ² Lor 88 Jon Lor 87 Lor 86 Jon Lor 80 Lor 8
368m ²		LOT 5	ME	MORANDUM OF EASEMENTS IN GRO	OSS	300m ²
113	N	258m ²	PURPOSE	SHOWN BURDENED LAND (SERVIENT TENEMENT)	GRANTEE	
	B LOT 4 258m ²	\mathbf{Y}	RIGHT OF WAY	AV LOT 26 HEREON	-

N 500 258m		PEDESTRIAN RIGHT OF WAY	AQ LOT 201 HEREON	-	
55 55 55 55 55 55 55 55 55 55 55 55 55	LOT 3 258m ² LOT 2 300m ²		RIGHT TO DRAIN WATER	AVLOT 20 HEREONA0LOT 321 HEREONAPLOT 200 HEREONAQLOT 201 HEREONARLOT 202 HEREONASLOT 203 HEREONATLOT 204 HEREONAULOT 25 HEREONAWLOT 88 HEREONAXLOT 18 HEREONAYLOT 22 HEREONBALOT 301 HEREONBCLOT 303 HEREONBFLOT 305 HEREONBGLOT 307 HEREONBHLOT 309 HEREONBJLOT 315 HEREONBLLOT 317 HEREONBMLOT 319 HEREON	FAR NORTH DISTRICT COUNCIL	SECTION
	Drafter: V. RI	VIER Job Title:	SURVEY SCHEME -	STAGED DEVELOPMENT		Drawing: 123
	Designer: J. CH	IEN Client:	KĀINGA ORA			Scale: 1:750 @
	Checker: G. ME	ETCALF Address:	BISSET ROAD & 10	RIMU PLACE, KAIKOHE 0504		Project: 15443
Rev Date Amendments THESE DRAWINGS ARE COPYRIGHT AND REMAIN THE			SCHEME PLAN – SH	EET 2		Issue: CONSENT

Following the completion of the development, the applicant will undertake a fee simple subdivision to create individual lots for all units (refer to **Appendix 2** for the scheme plan) on a staged basis. In addition to the above, access will also be created from Rimu Place [at Stage 2]. To provide for that access, several of the sections on Rimu Place will undergo a boundary adjustment to create legal road width. Note that those sites will continue to have legal access to Rimu Road and will continue to meet the bulk and location standards of the Far North District Plan. All properties subject to the boundary adjustment are owned by Kainga Ora.

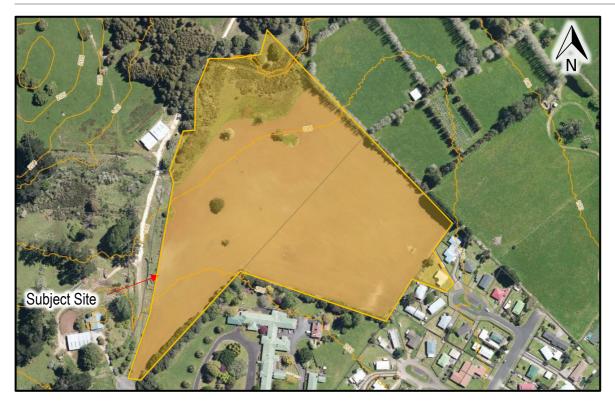
Figure 1: Aerial Image (Source: Northland Regional Council Map)

The site subject to development, legally described as Pt Taraire No 1A Block, Lot 1-2 DP 363959 and Section 87 Block XV Omapere, is irregular in shape and covers an area of 6.0ha (see Figure 1).

The site is currently undeveloped and serves as farmland with sparse tree and scrub vegetation. There is a single dwelling located at the southwest end of the site, at 10 Rimu Place, Kaikohe. The site is currently accessed from Bisset Road.

The ground surface is predominately near level to gently sloping, in the main gradually descending to the north and northwest at inclinations of less than 5°. Slopes become moderately steep toward the northwest end of the site, where a wetland and a pond are present.

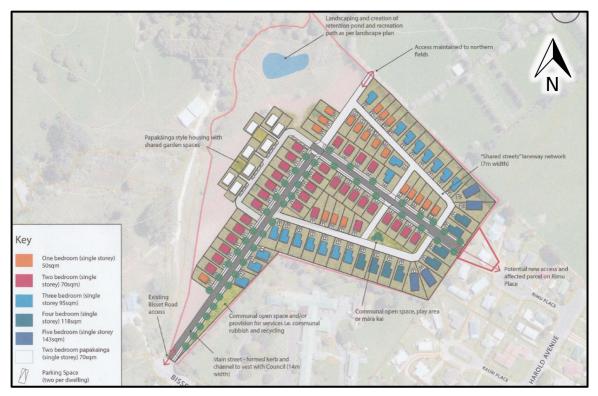
Figure 2: Proposed Development (Source: Site Plan by Kainga Ora)

A draft scheme plan supplied by Kainga Ora shows the proposed development will comprise construction of 87 dwellings with associated access and vehicle parking areas. These are indicated in Figure 2 below.

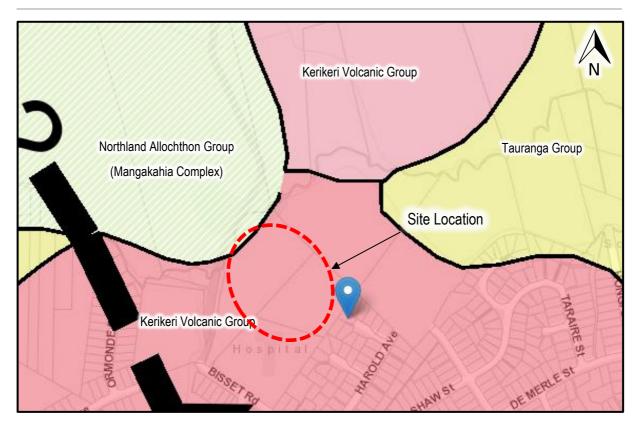
Figure 3: Geological Map (Source: GNS WebMaps Website)

It is not uncommon for Alluvium and Volcanic soils to overlie each other as both are placed as discrete geological episodes. Further, alluvium is usually found in low-lying areas and it is in the nature of lava flows that they flow downslope to cover the in-situ soils. Our augerhole data and Cross Section drawings indicate that this has been the case at the subject site.
