Application for resource consent or fast-track resource consent

This application seeks discretionary resource consent for the development of a library on the corner of State Highway 12 (Broadway) and Raihara Street within the Commercial Zone. The proposal replaces the current library approximately 100 metres away. The building has been designed in consultation with the local community, hapu and iwi and creates an iconic building on Kaikohe's main street. Overall, any potential adverse effects are considered to be less than minor.

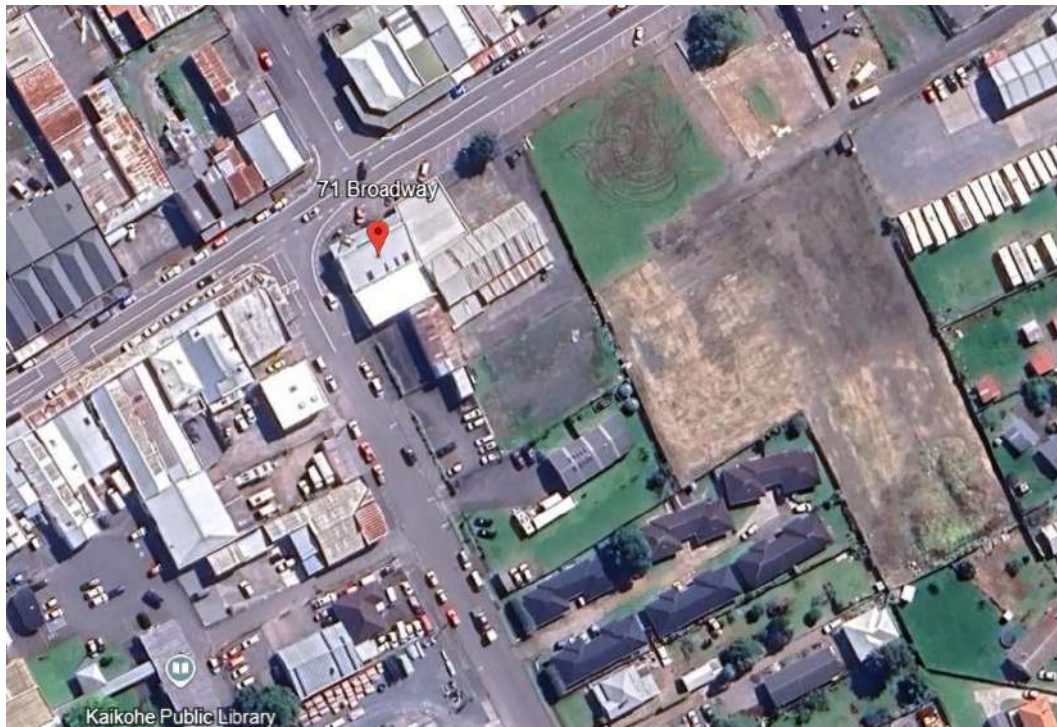
Figure 2 – Site aerial (Source Google Earth)

Despite the aerial showing a number of buildings over the site, these has recently been removed and the site is vacant. The adjacent site to the east on State Highway 12 (Broadway) is also vacant and is currently used for the Kaikohe markets. The building on the corner of State Highway 12 (Broadway) and Reihara Street opposite the site is currently untenanted.

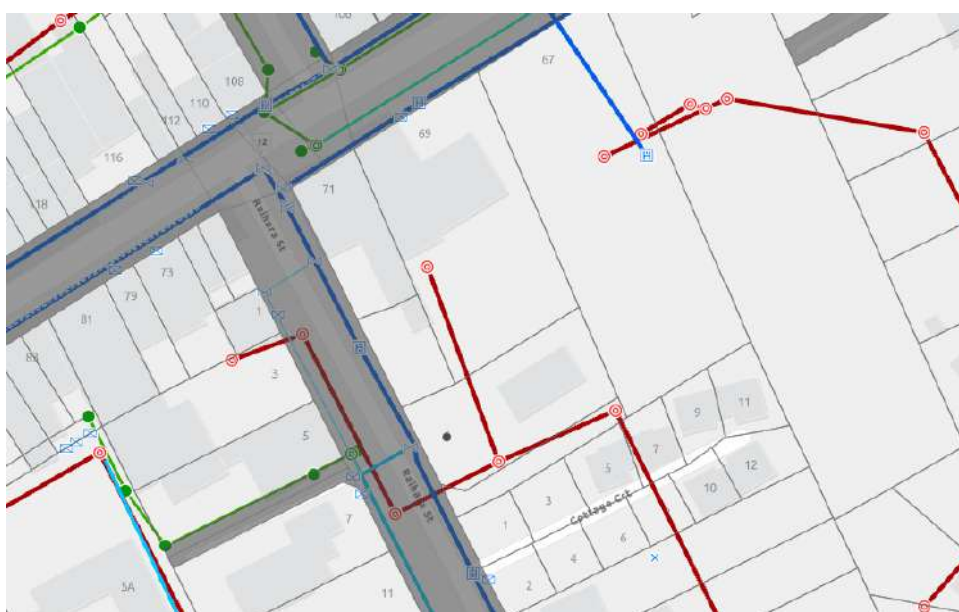
Figure 3 – Site services (Source Far North Maps)

The property has connection to all reticulated services.

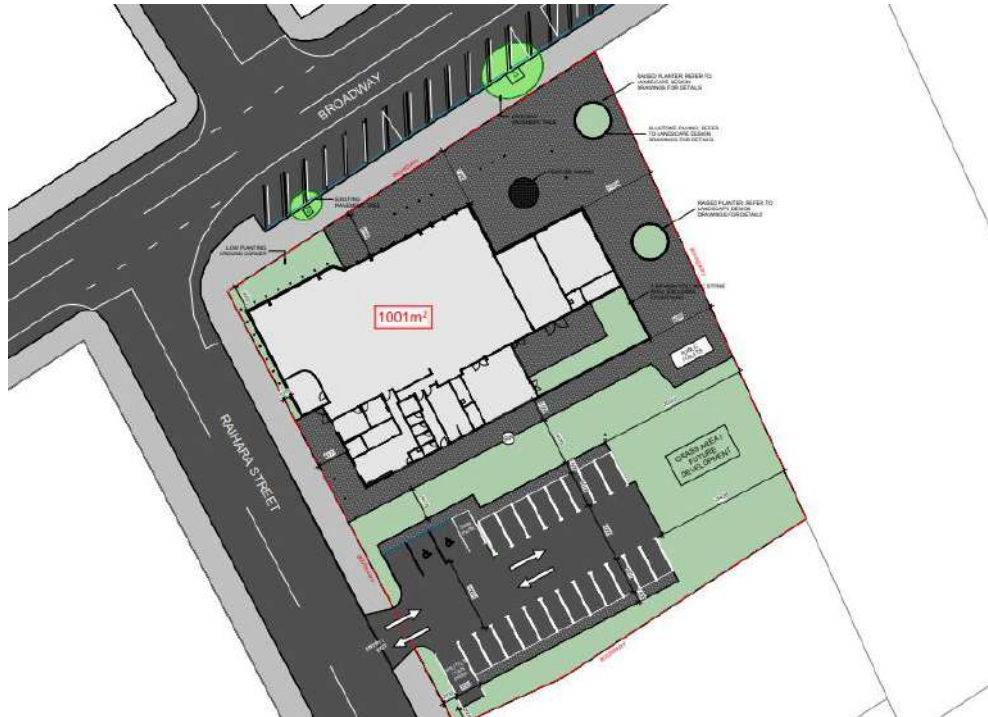
Figure 6 – Carparking (Source Ākau)

Carparking will be provided at the rear of the site with ingress and egress being accommodated from Raihara Street.

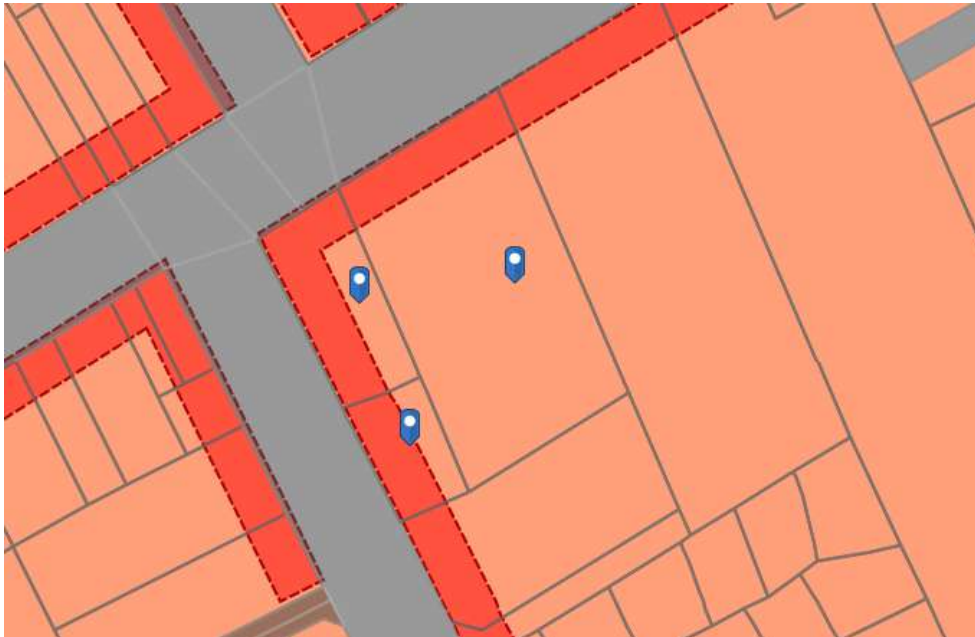
Figure 7 – ODP zone Commercial (Source Far North Maps)

Under the ODP, the site is zoned ‘**Commercial**’. The site is also subject to Pedestrian Frontage controls.

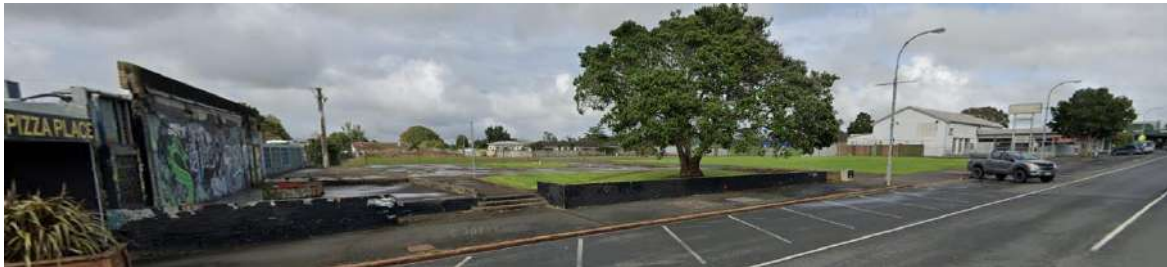
Figure 13 – Sites at 65 and 67 State Highway 12 (Broadway) looking west towards the library site (Source Google Maps)

The library is not proposing to provide a pedestrian frontage in accordance with the permitted activity standard. Pedestrian frontage along the southern side of State Highway 12 (Broadway), east of the proposed library, is sporadic. The neighbouring properties adjacent to the library site to the east (67 and 65 State Highway 12 (Broadway)) are free of development. These sites are large open spaces, currently utilised for the Kaikohe markets (see Figure 13).

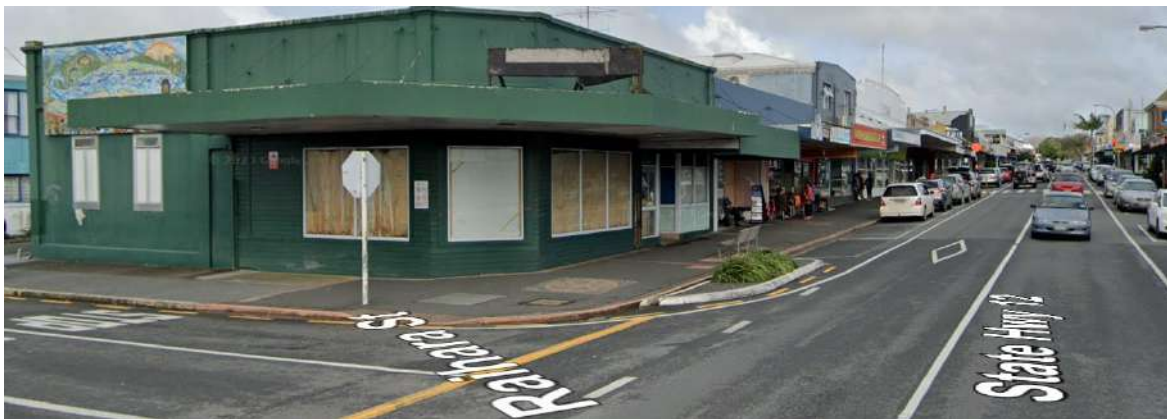
Figure 14 – Broadway looking west on the opposite side of Raihara Street (Source Google Maps)

To the west on the opposite side of Raihara Street, the pedestrian frontage along State highway 12 (Broadway) is more consistent and in keeping with the pedestrian frontage controls in the ODP (see Figure 14).

The character of the Commercial zone along the southern side of State Highway 12 (Broadway) east of Raihara Street is distinctively different to the character west of Raihara Street.

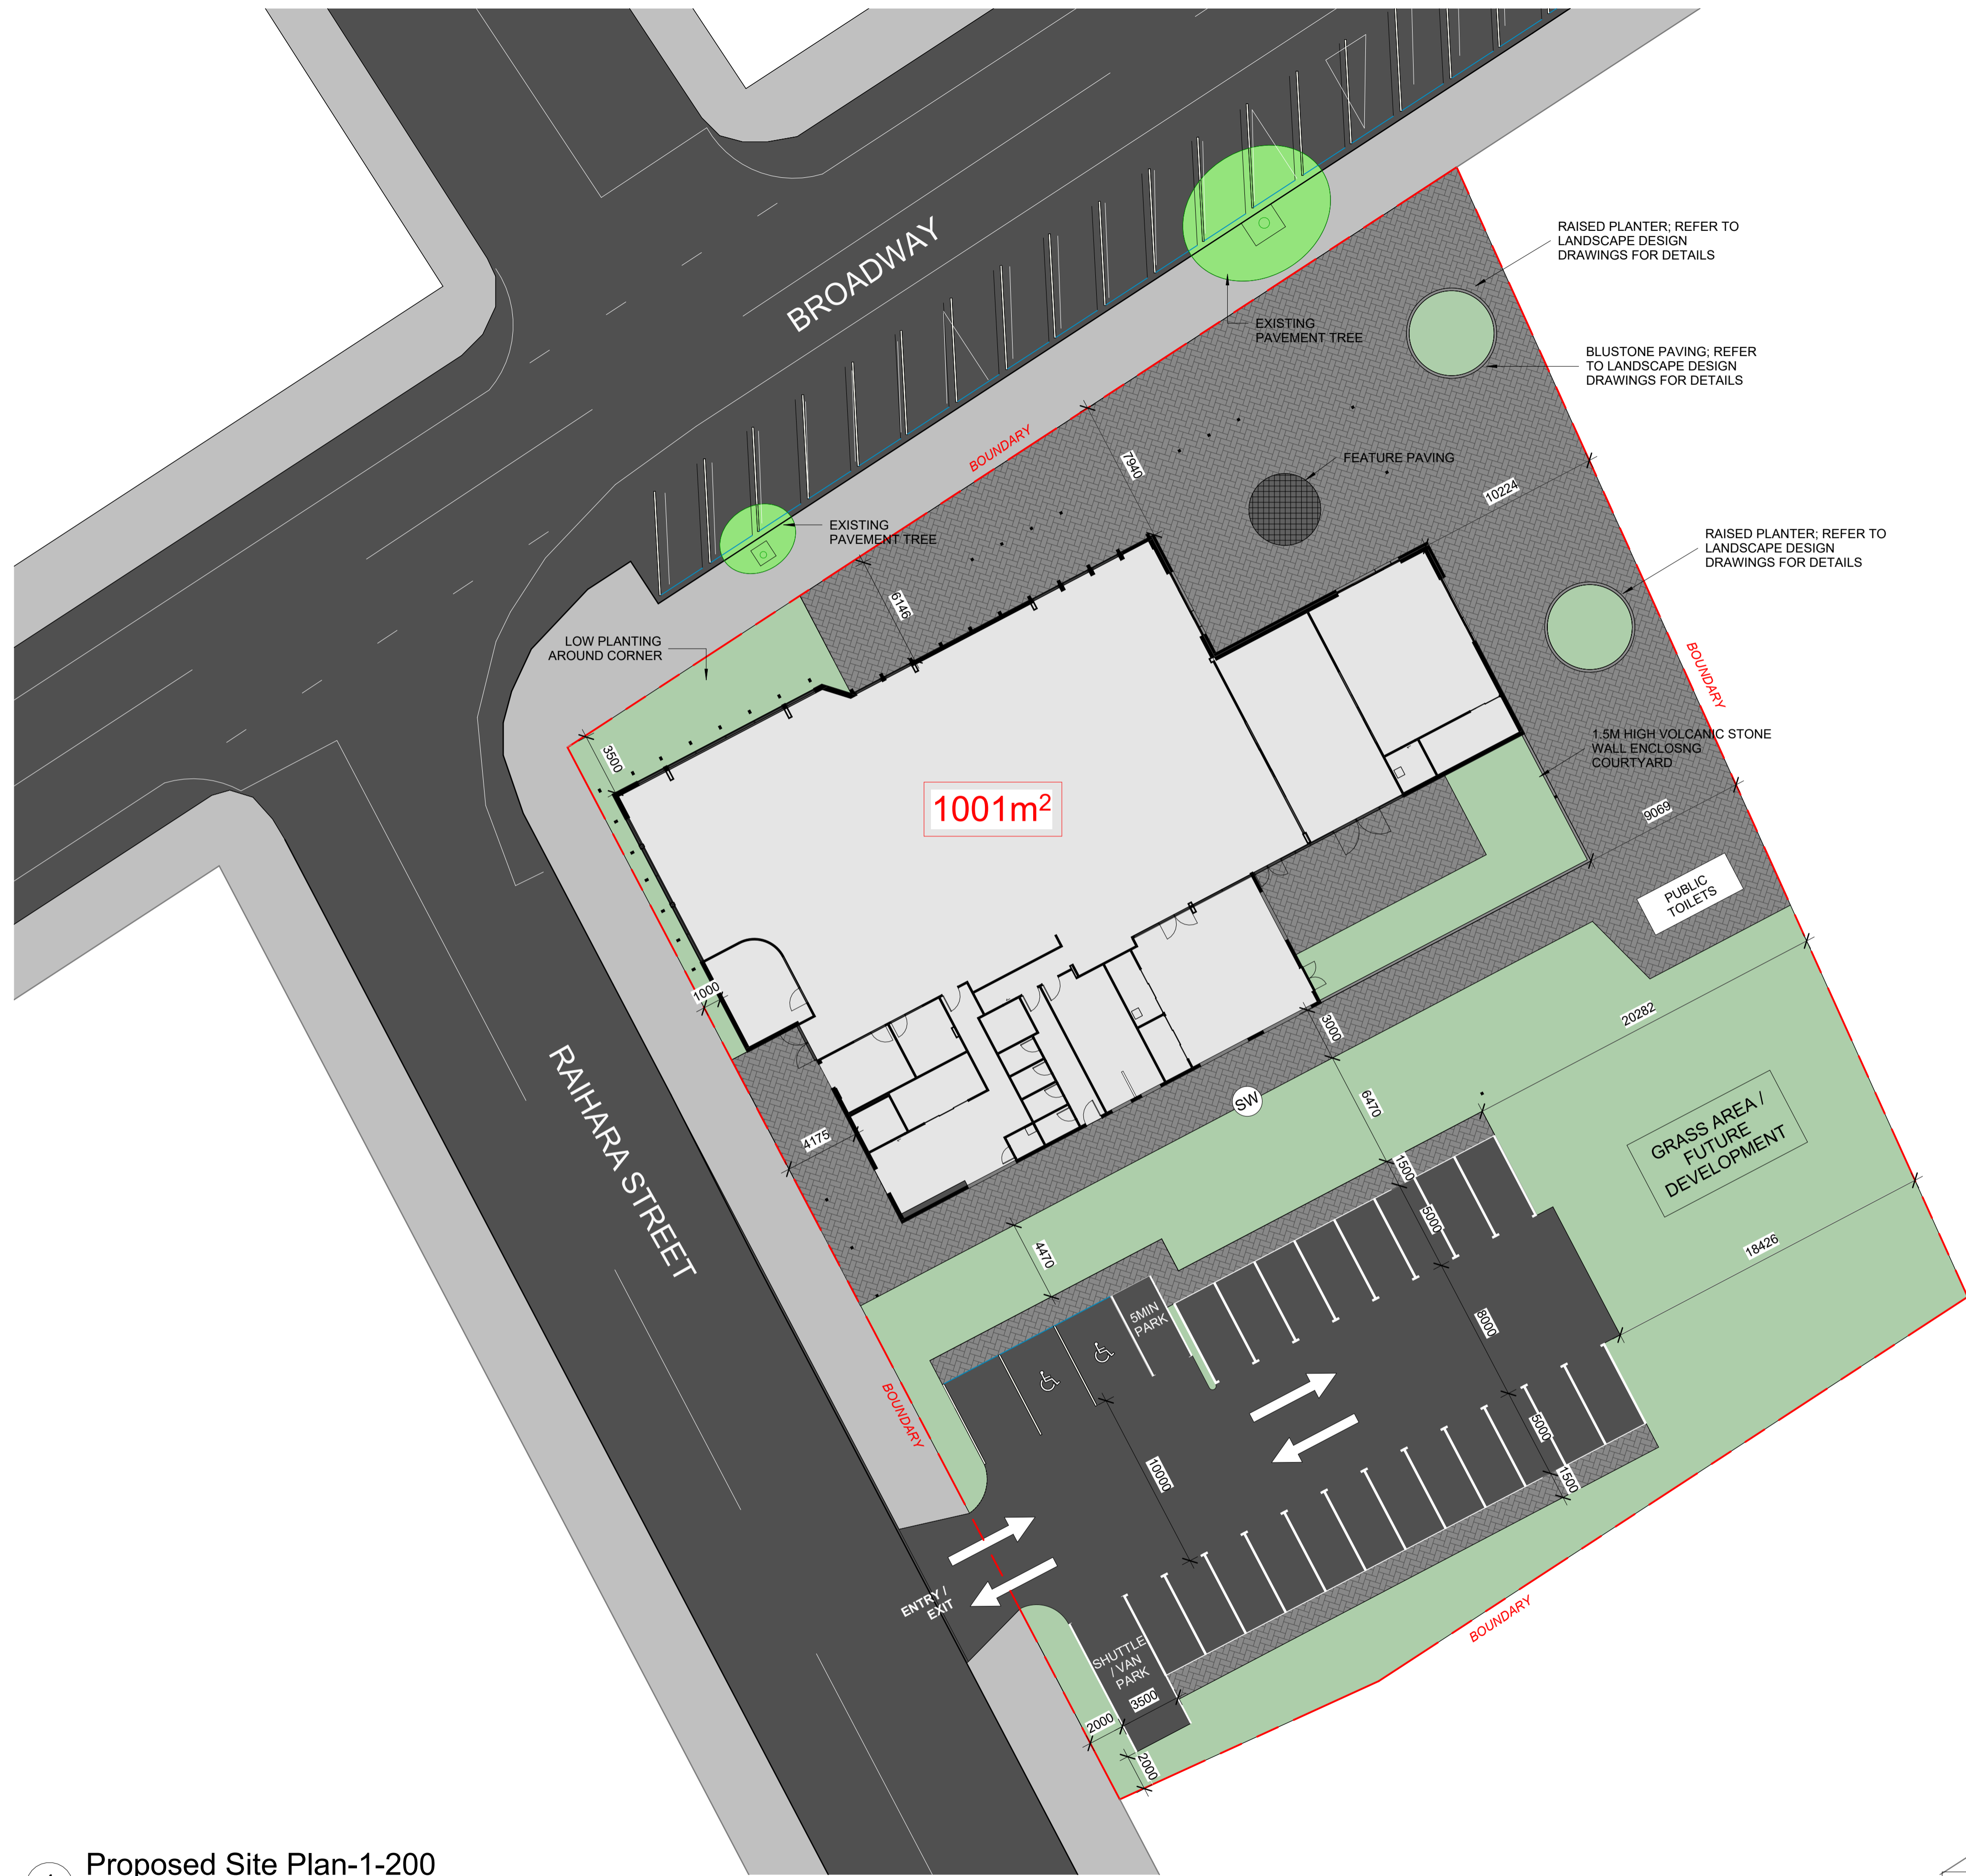
SITE AREAS	
SITE AREA	3830m ²
BUILDING AREA	1001m ²
PAVING AREA	1017m ²
LANDSCAPING AREA	455m ²
CARPARKS	31

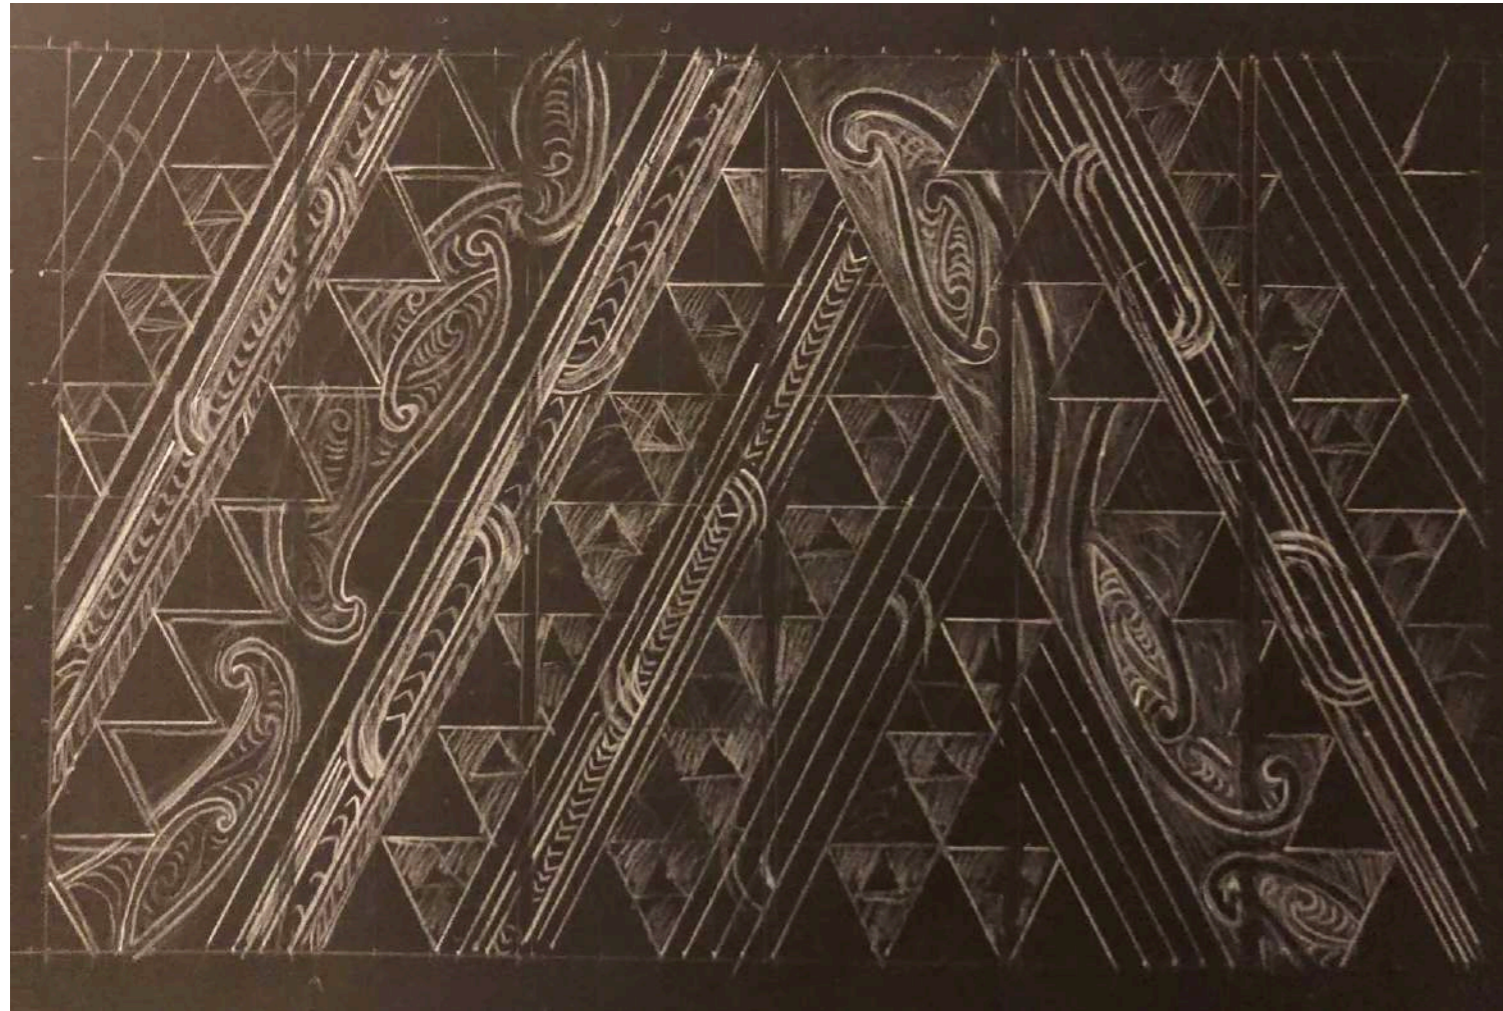
Facade Design
Concept Drawings by Allen Wihongi

This image will be created on the elevation of Broadway and Raihara St through imagery applied directly to the window elements and be reinforced by mesh sunscreening sitting in front of the windows. The mesh will take on elements of the image so that the final outcome will be a layered element visible from both the interior and exterior of the whare.

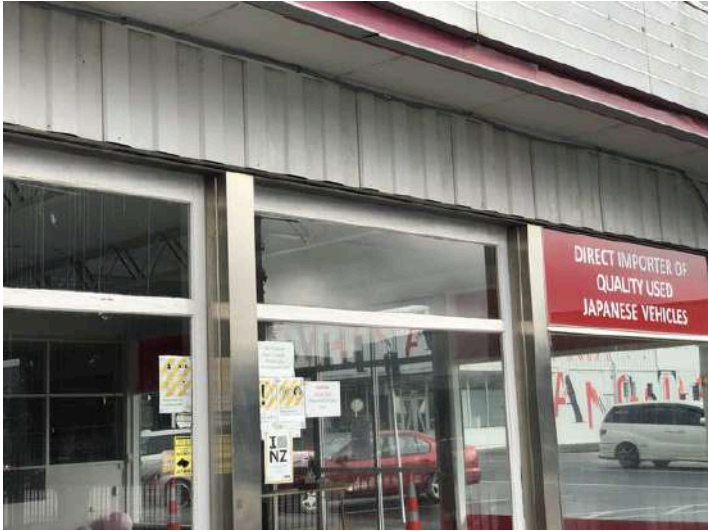
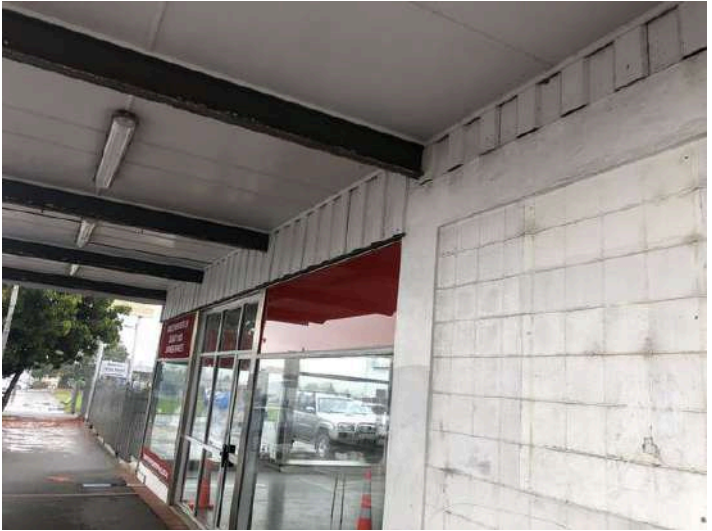
Building	Main Building	Level	0
Location	001 - Showroom exterior	Item	Cladding above windows
Material	Cement Sheet	Extent	Approx 19 sq m

Strategy / Sample Id	Sample / 02	Fibre Type	Grunerite (Amosite), Chrysotile
Recommendation	Remove prior to demolition		
General Comments	Must be removed by a suitably licensed and experienced asbestos removal contractor under Class B asbestos controls.

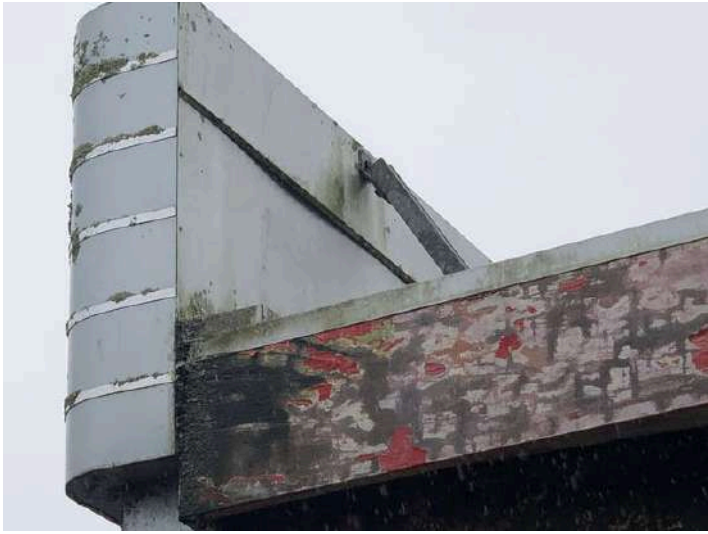
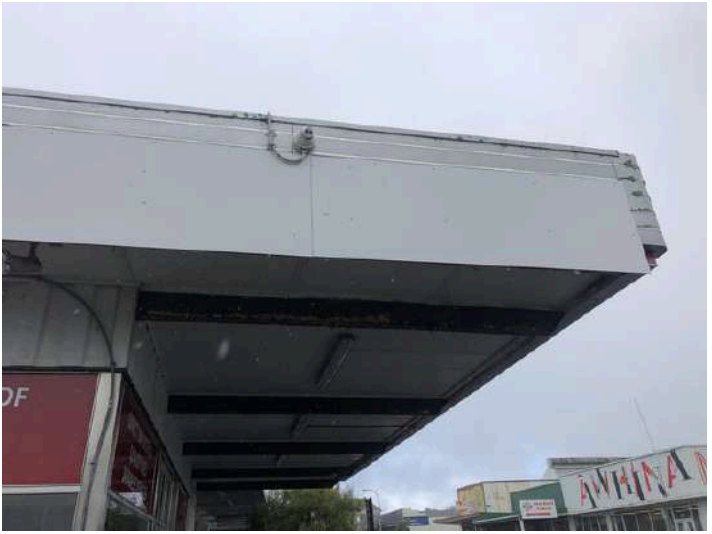
Building	Main Building	Level	0
Location	001 - Showroom exterior	Item	Lining on parapet
Material	Cement Sheet	Extent	Approx 15sq m

Access / Notes	No Access / Due to height and wet roof making it too dangerous to access.		
Strategy / Sample Id	Strongly Presume	Presumed Fibre Type	Crocidolite
Recommendation	Remove prior to demolition		
General Comments	<p>Is visible on the inside face. It is likely that it is on the 'roadside' or outer face under the signage too.</p> <p>Must be removed by a suitably licensed and experienced asbestos removal contractor under Class B asbestos controls.</p>

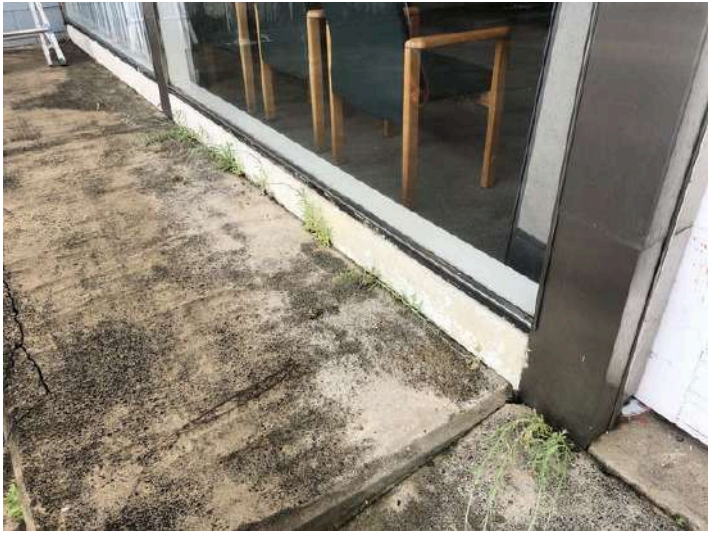
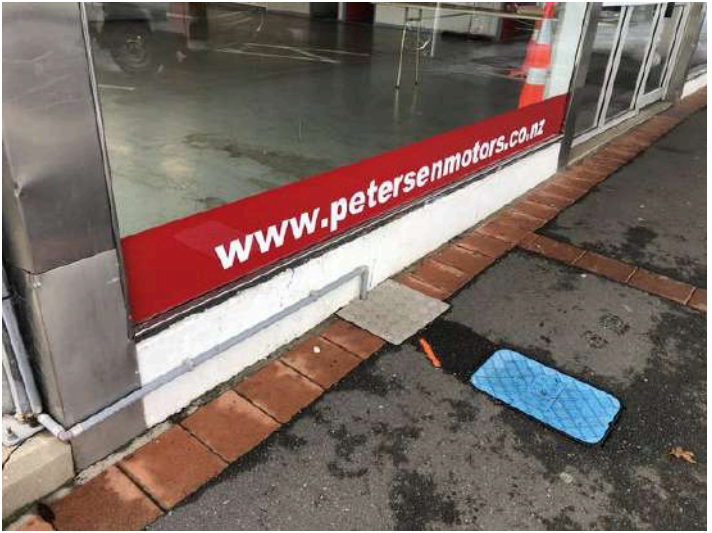
Building	Main Building	Level	0
Location	001 - Showroom exterior	Item	Rendered plaster below windows
Material	Cement Rendered Plaster	Extent	Approx 5 sq m

Strategy / Sample Id	Sample / 03	Fibre Type	NADIS
General Comments	No asbestos detected.

No Asbestos Detected in Sample

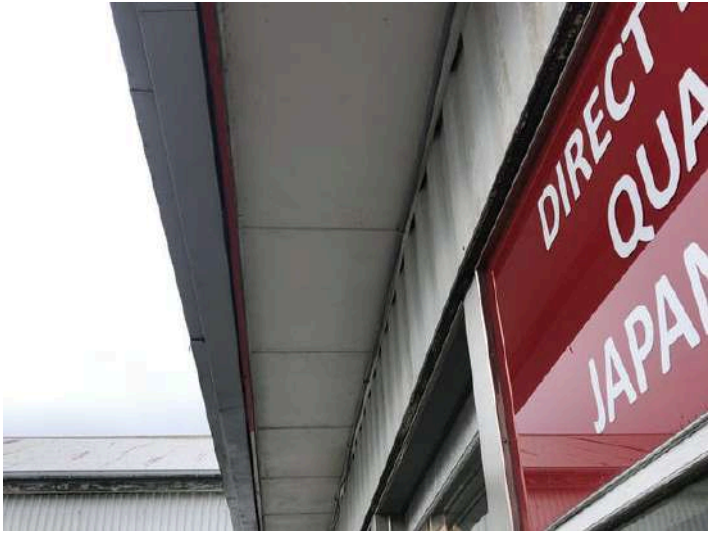
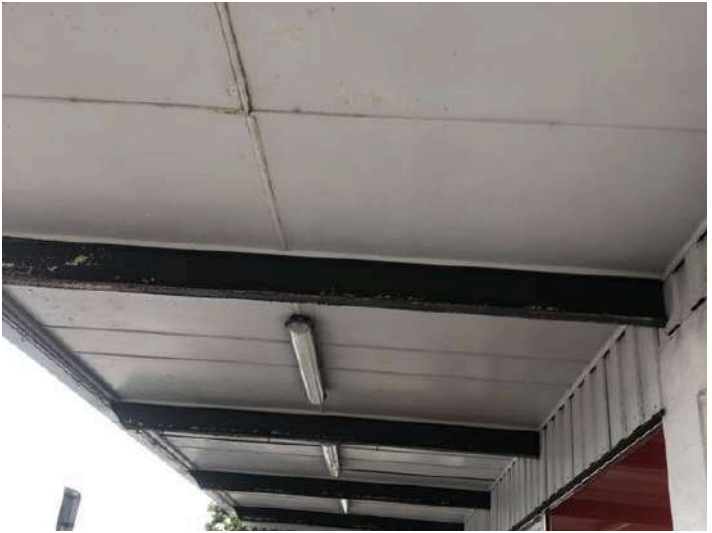
Building	Main Building	Level	0
Location	001 - Showroom exterior	Item	Soffit
Material	Cement Sheet	Extent	Approx 60 sq m including canopy over footpath

Strategy / Sample Id	Sample / 01	Fibre Type	Grunerite (Amosite), Chrysotile
Recommendation	Remove prior to demolition		
General Comments	Must be removed by a suitably licensed and experienced asbestos removal contractor under Class B asbestos controls.

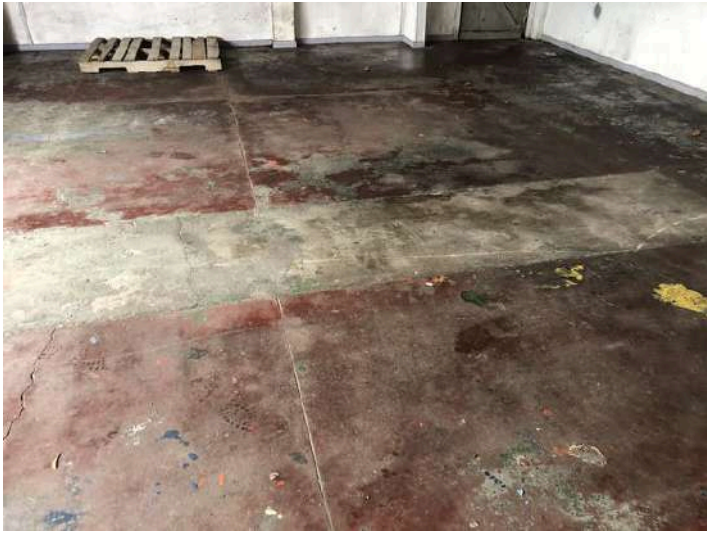
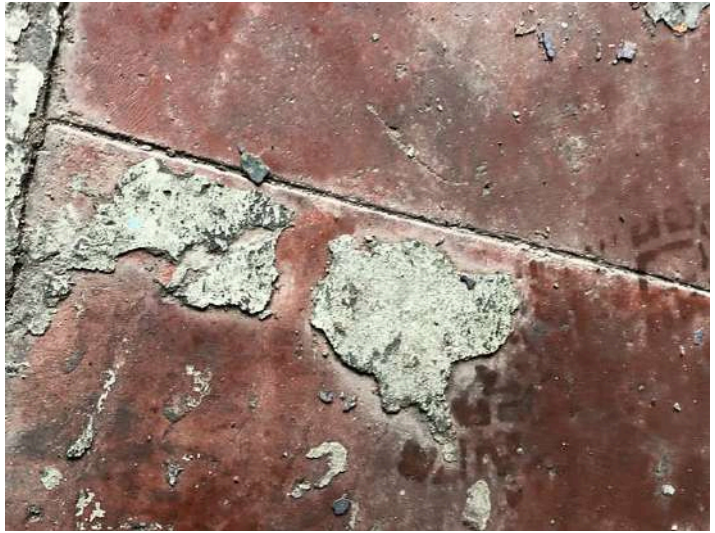
Building	Main Building	Level	0
Location	006 - Grooming Bay interior	Item	Floor Covering
Material	Paint/Vinyl Remnants	Extent	Approx 42 sq m

Strategy / Sample Id	Sample / 04	Fibre Type	NADIS
General Comments	No asbestos detected

No Asbestos Detected in Sample

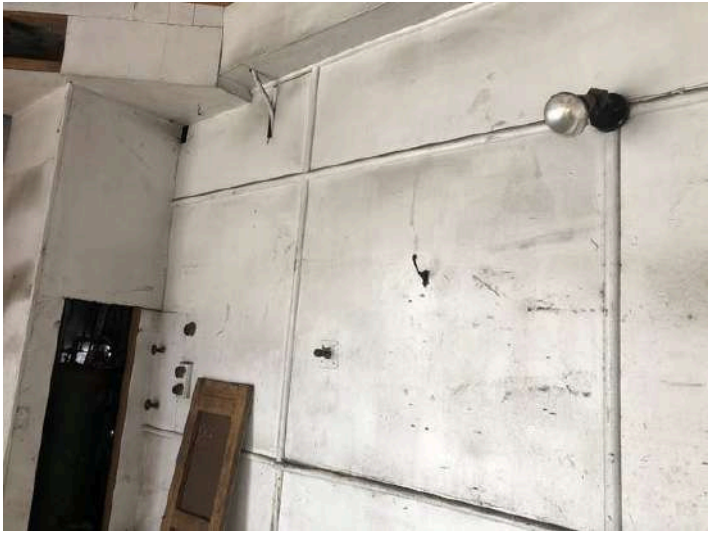
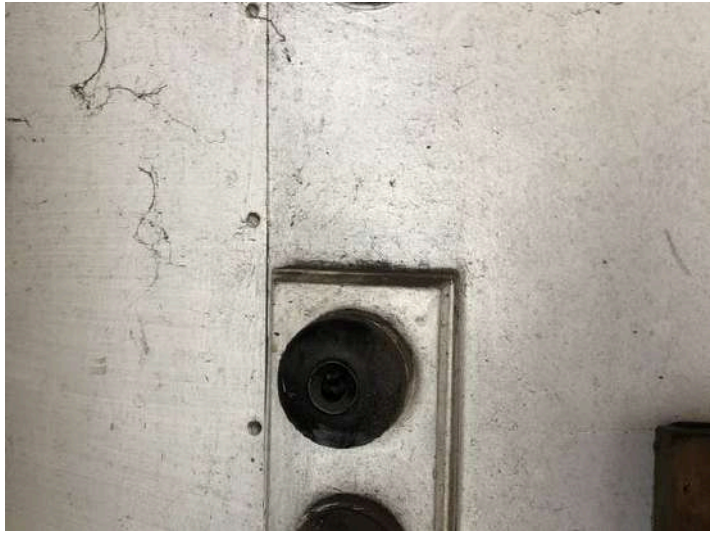
Building	Main Building	Level	0
Location	006 - Grooming Bay interior	Item	Switches & light fittings
Material	Bakerlite Composite	Extent	Unquantified at the time of inspection

Strategy / Sample Id	Strongly Presume	Presumed Fibre Type	Crocidolite
Recommendation	Remove prior to demolition		
General Comments	<p>The exact number of switches was not accurately quantified.</p> <p>They must all be located and removed by a suitably licensed and experienced asbestos removal contractor under Class B asbestos controls.</p>

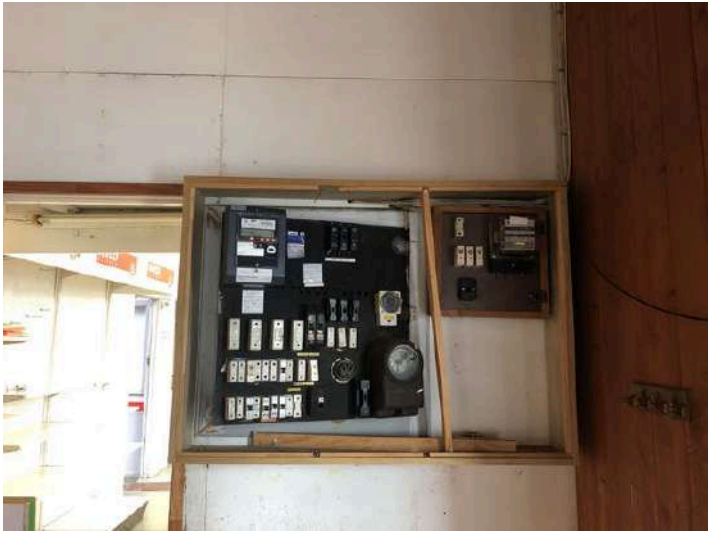
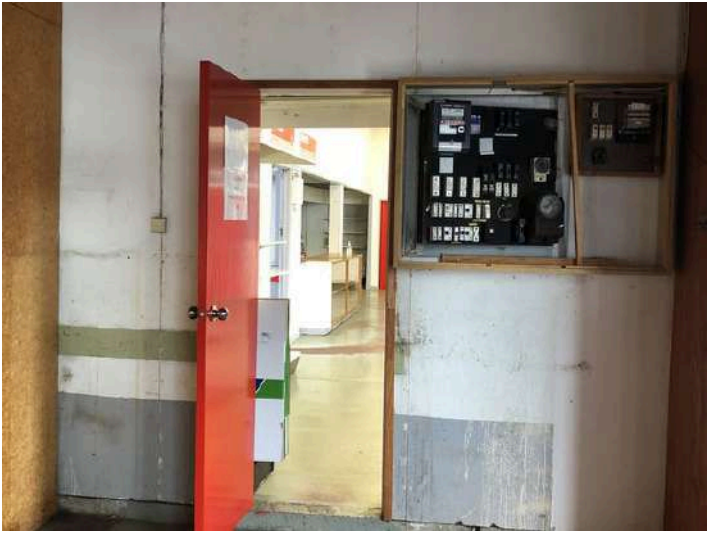
Building	Main Building	Level	0
Location	007 - Electrical Board Room Interior	Item	Fuse board
Material	Bakerlite	Extent	Approx 0.25sq m

Strategy / Sample Id	Strongly Presume	Presumed Fibre Type	Crocidolite
Recommendation	Remove prior to demolition		
General Comments	Must be removed by a suitably licensed and experienced asbestos removal contractor under Class B asbestos controls.

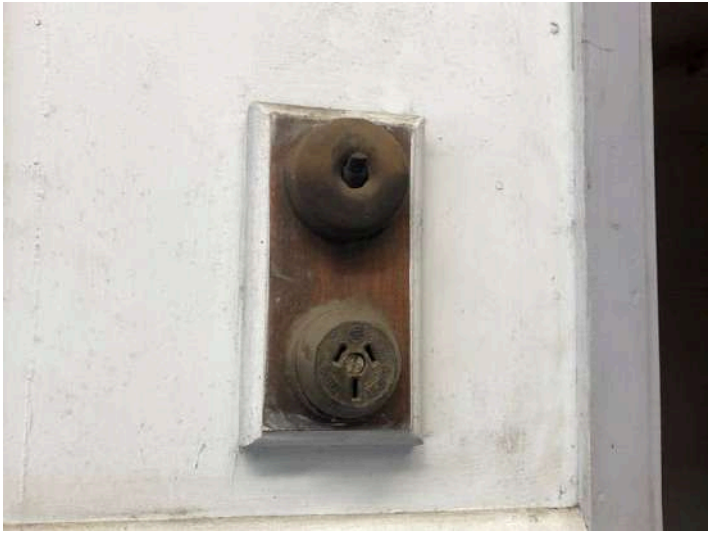
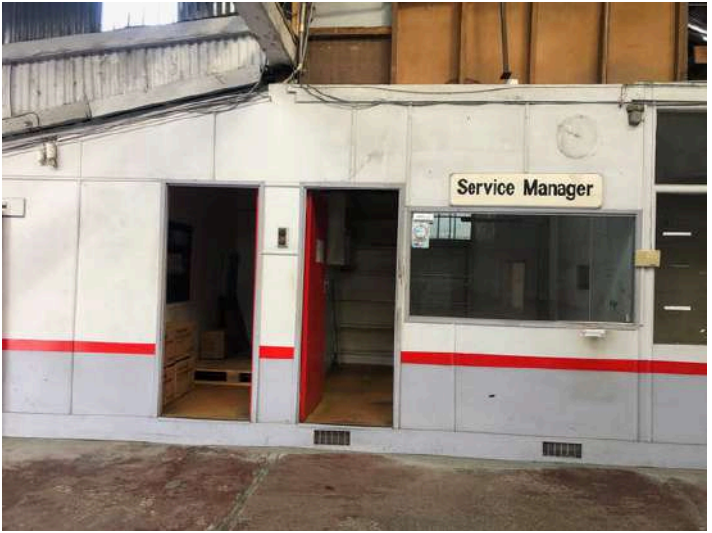
Building	Main Building	Level	0
Location	008 - Workshop Interior	Item	Electrical Switches
Material	Bakerlite Composite	Extent	Unquantifiable at the time of inspection

Strategy / Sample Id	Strongly Presume	Presumed Fibre Type	Crocidolite
Recommendation	Remove prior to demolition		
General Comments	<p>The exact number was not determined at the time of inspection, but it is not expected to be a high number.</p> <p>They must all be located and removed by a suitably licensed and experienced asbestos removal contractor under Class B asbestos controls prior to demolition.</p>

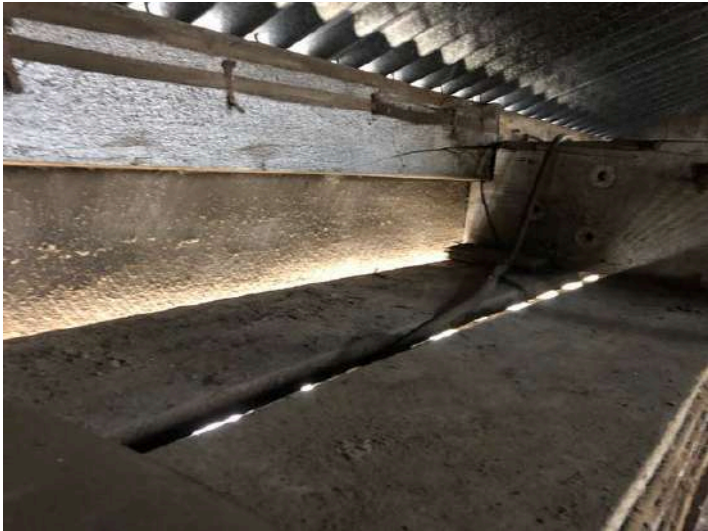
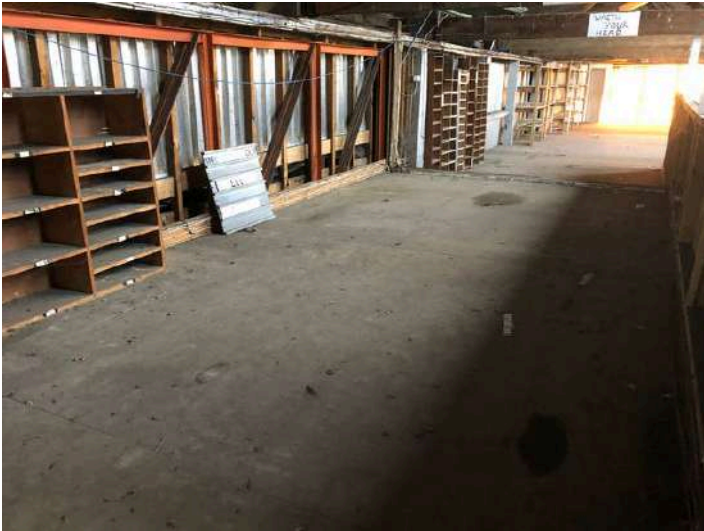
Building	Main Building	Level	0
Location	009 - Workshop Mezzanine Interior	Item	Horizontal Surfaces
Material	Loose Dust	Extent	Entire high level surfaces

Strategy / Sample Id	Sample / 06	Fibre Type	NADIS
General Comments	<p>A very thick coating of dust was on horizontal framing members and soffit interior.</p> <p>Due to the potential of asbestos dust in old car parts, and unknown original roof material, the dust was tested by composite sample (from numerous different locations but submitted as one sample).</p> <p>No asbestos was detected.</p>

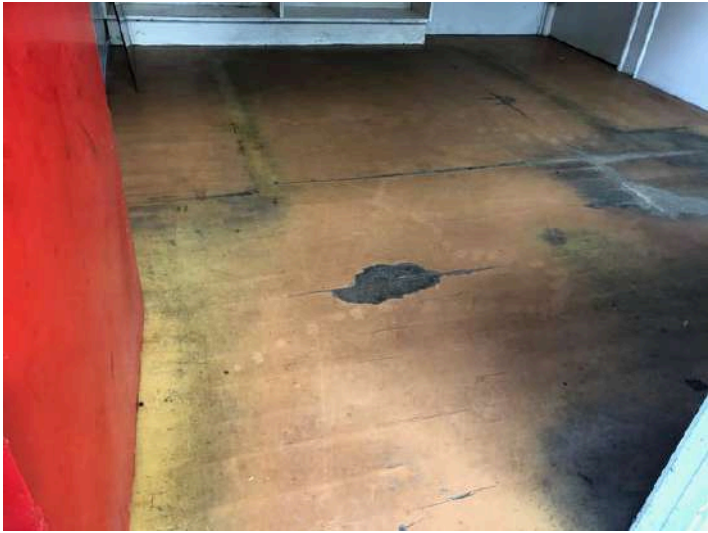
Building	Main Building	Level	0
Location	010 - Service Managers Office Interior	Item	Floor & Covering
Material	Vinyl on timber floor	Extent	Approx 15sq m

Strategy / Sample Id	Sample / 05	Fibre Type	NADIS
General Comments	No asbestos detected.

No Asbestos Detected in Sample

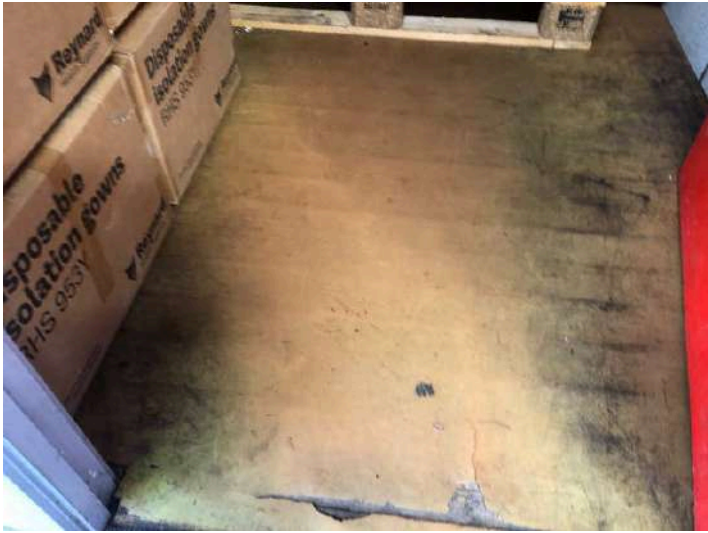
Building	Main Building	Level	0
Location	011 - Workshop Store Room Interior	Item	Floor & Covering
Material	Vinyl on timber floor	Extent	Approx 8sq m

Strategy / Sample Id	Cross Reference / 05	Fibre Type	NADIS
General Comments	<p>Identical to the vinyl in the managers office.</p> <p>No asbestos detected.</p>

No Asbestos Detected in Sample

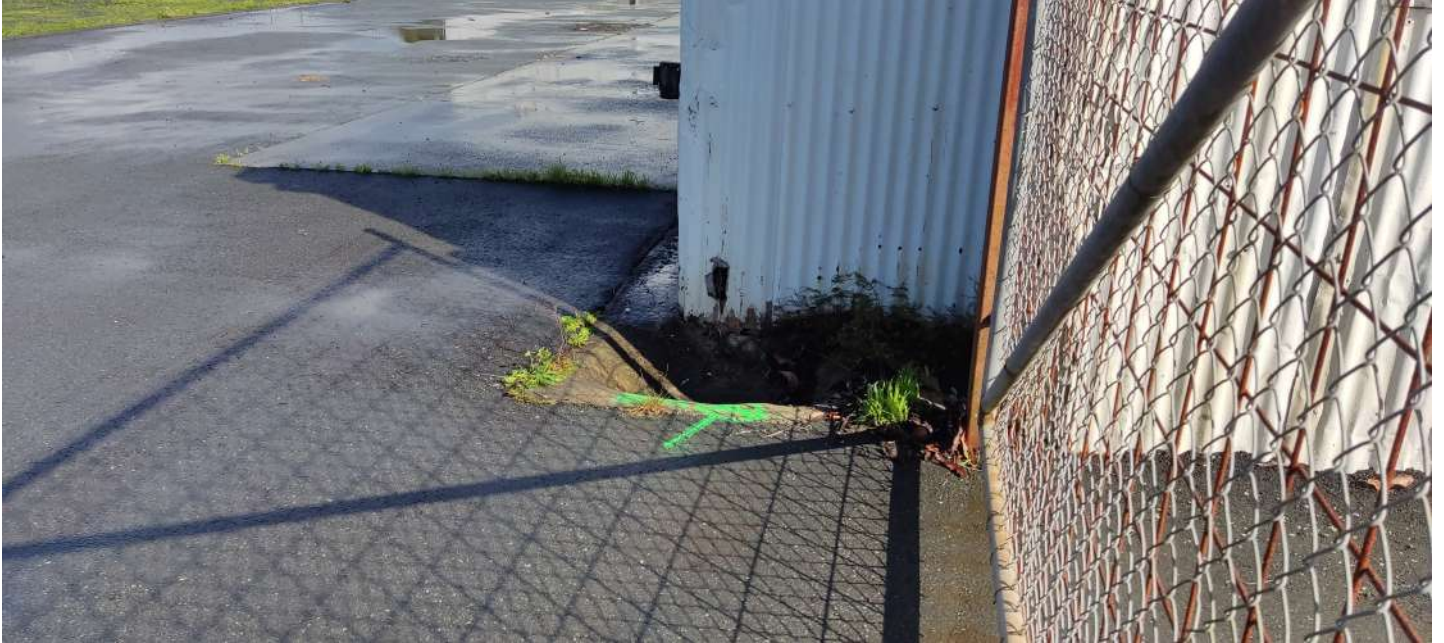
Photo 9. Drain at southeast corner of building inspected with no evidence of hydrocarbons.

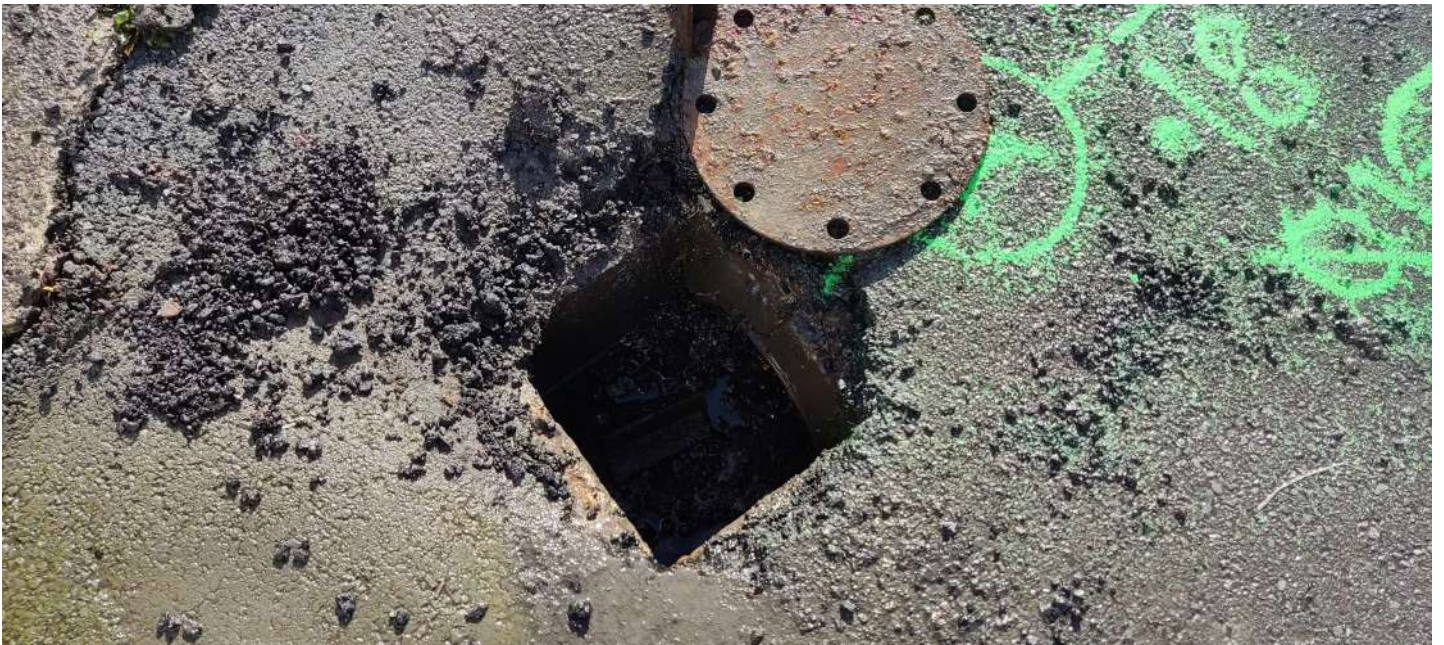
Photo 10. Drain at northeast corner of building inspected with no evidence of hydrocarbons.

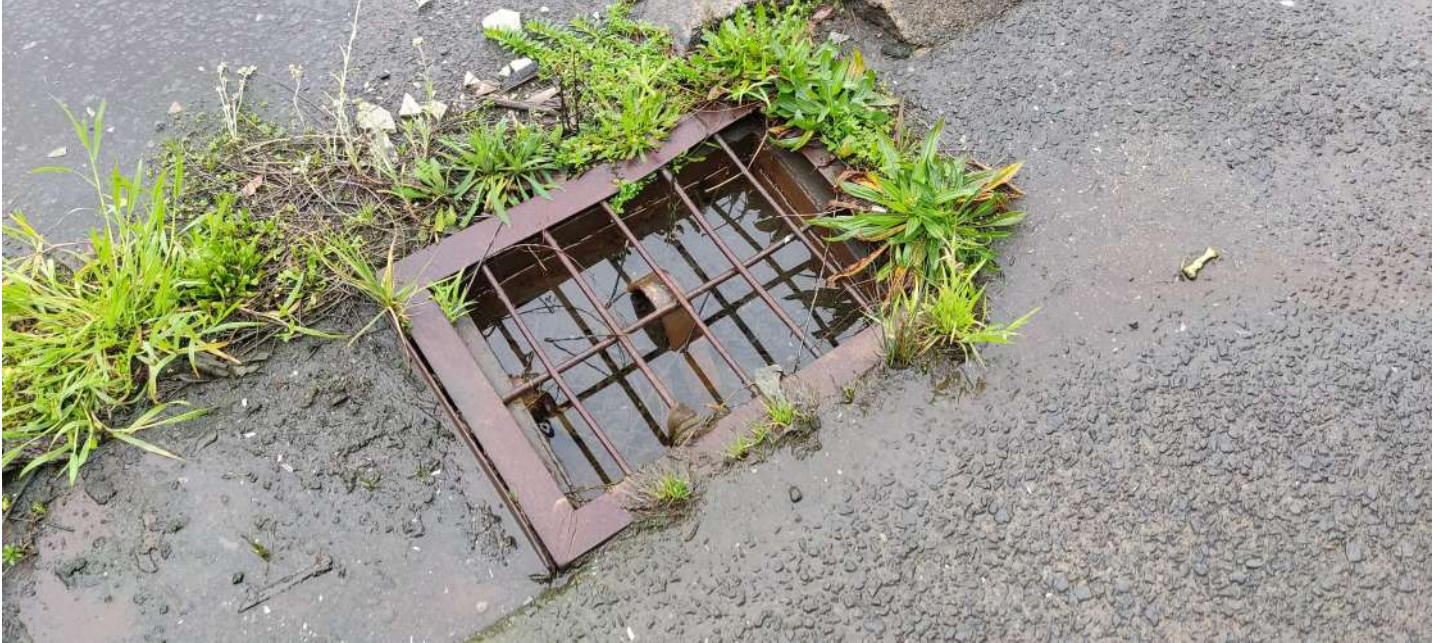
Photo 11. Drain adjacent to suspected washdown bay. Inspected with no evidence of hydrocarbons.

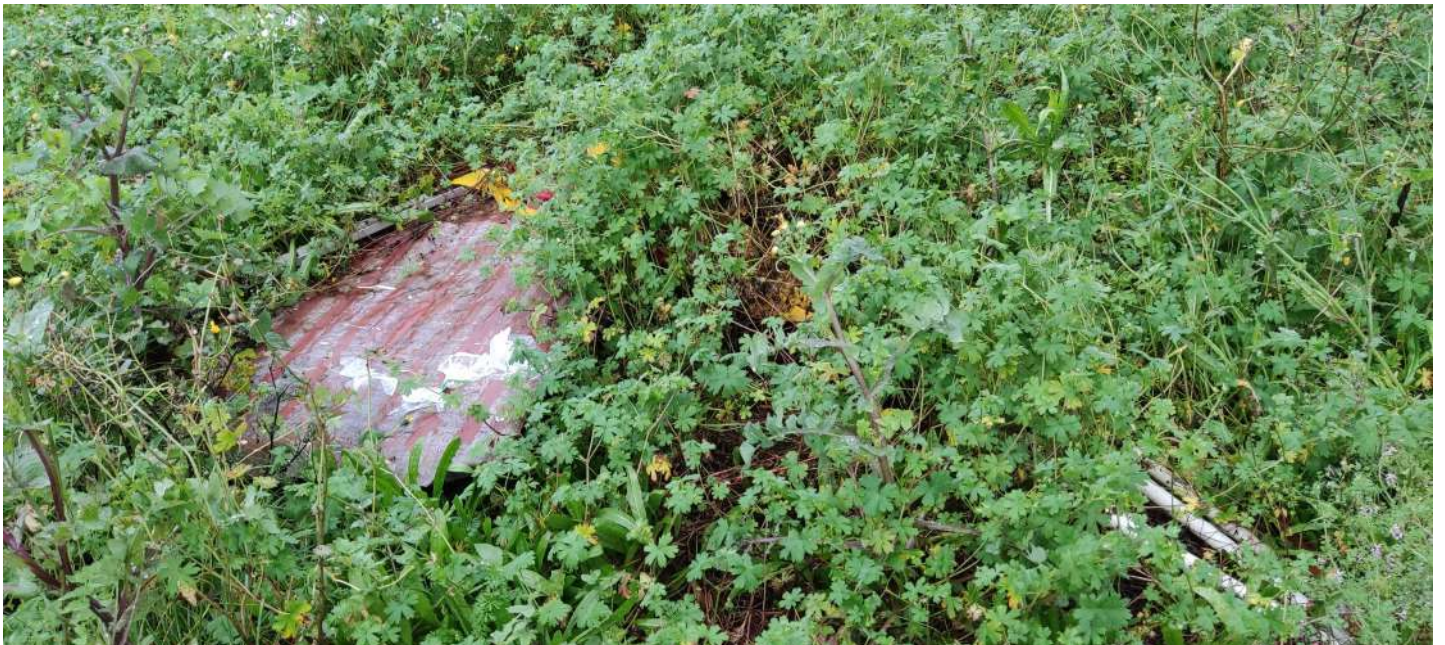
Photo 12. Corrugated iron and pipe on ground at rear of building.

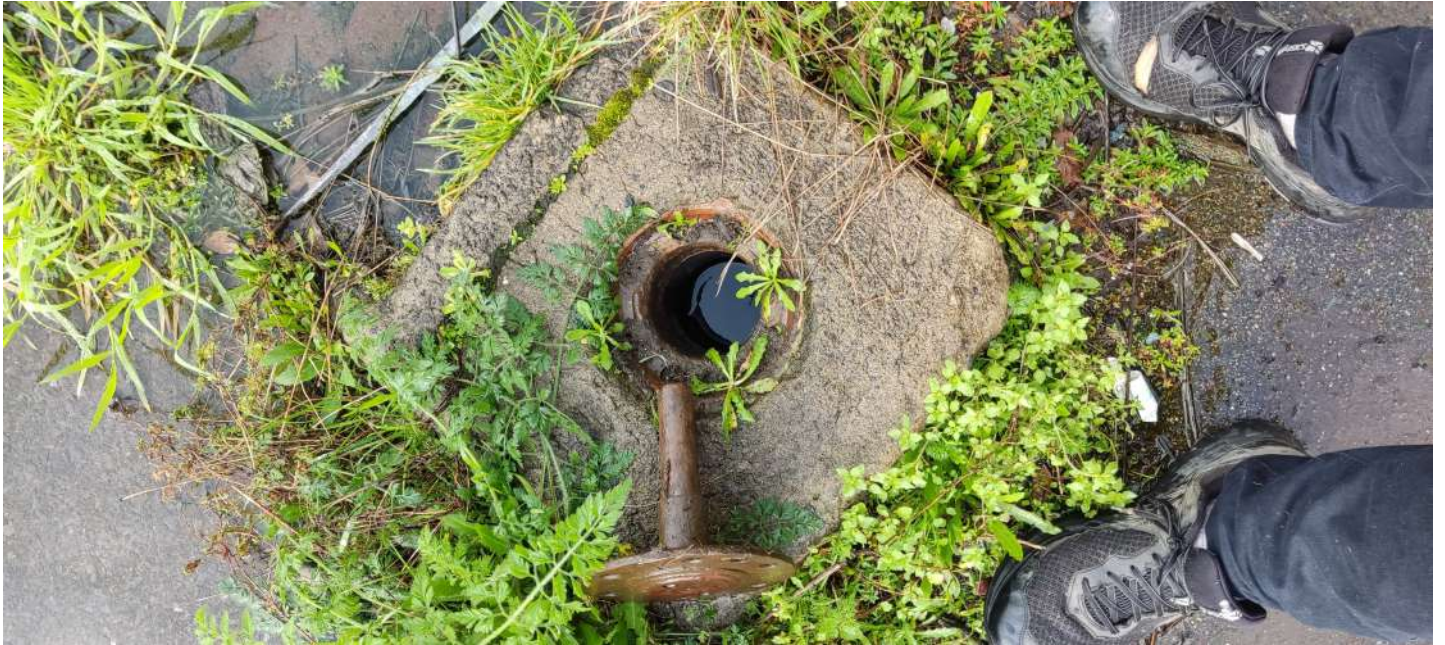
Photo 13. Sump adjacent to washdown area inspected, with no evidence of hydrocarbons.
