Application for resource consent or fast-track resource consent

This application seeks discretionary resource consent for the development of a library on the corner of State Highway 12 (Broadway) and Raihara Street within the Commercial Zone. The proposal replaces the current library approximately 100 metres away. The building has been designed in consultation with the local community, hapu and iwi and creates an iconic building on Kaikohe's main street. Overall, any potential adverse effects are considered to be less than minor.

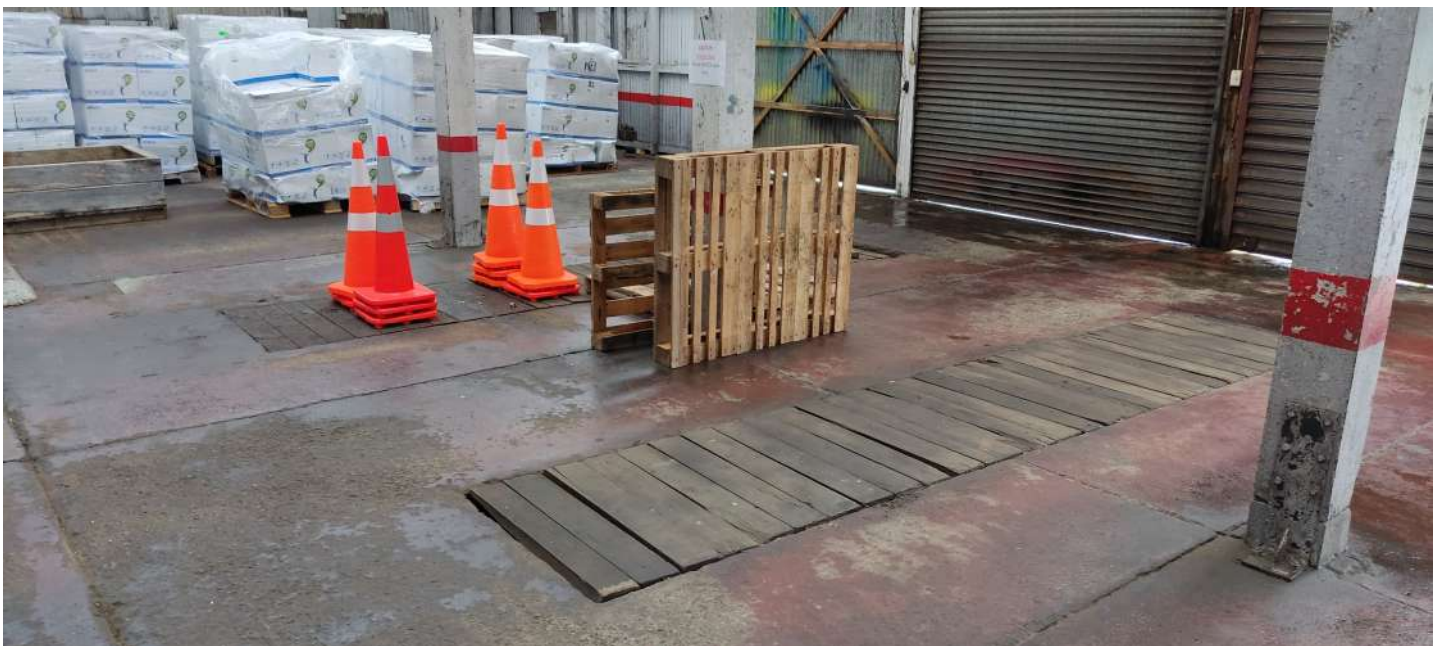
Photo 14. Inspection pits inside garage.

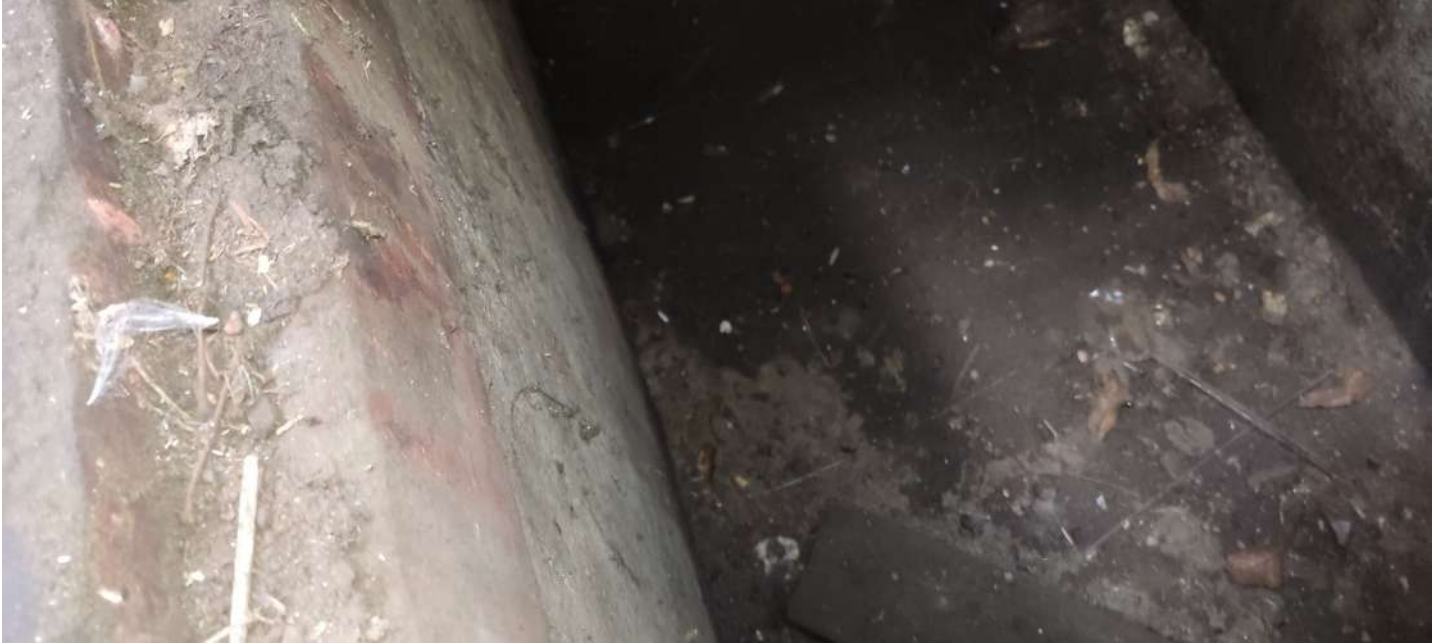
Photo 15. Inside of inspection pit 1.

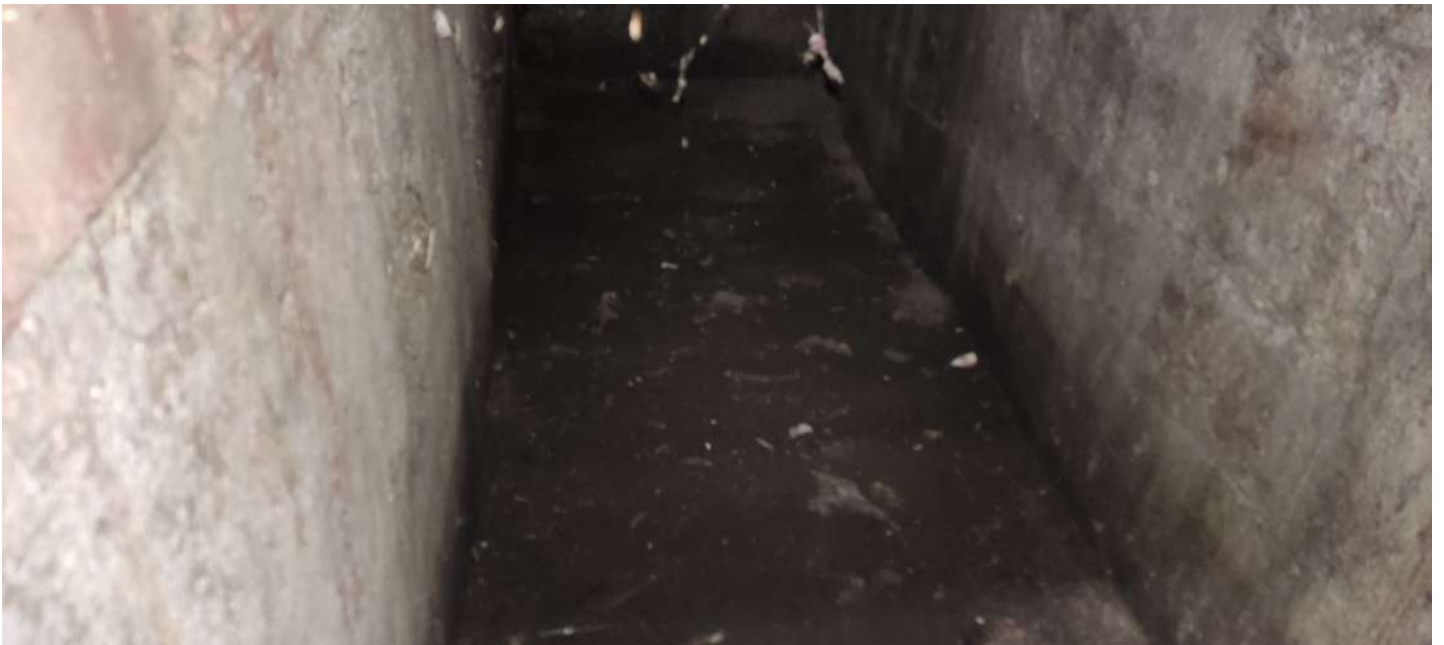
Photo 16. Inside of inspection pit 2.

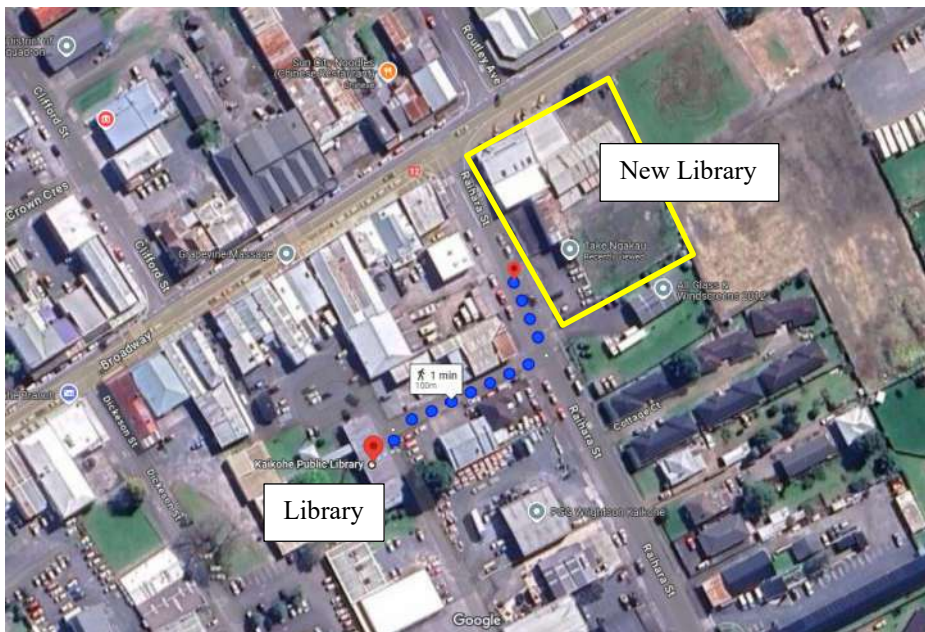
Figure 1 Location of new library, Kaikohe

The library is to replace the existing library located at a central block location between the Kaikohe New World on Memorial Ave, Reclaim Fitness on Raihara Street, Tony's Butcher on Broadway, and the central public ablution block. The physical distance between the old library and the proposed location is approximately 100m by foot.

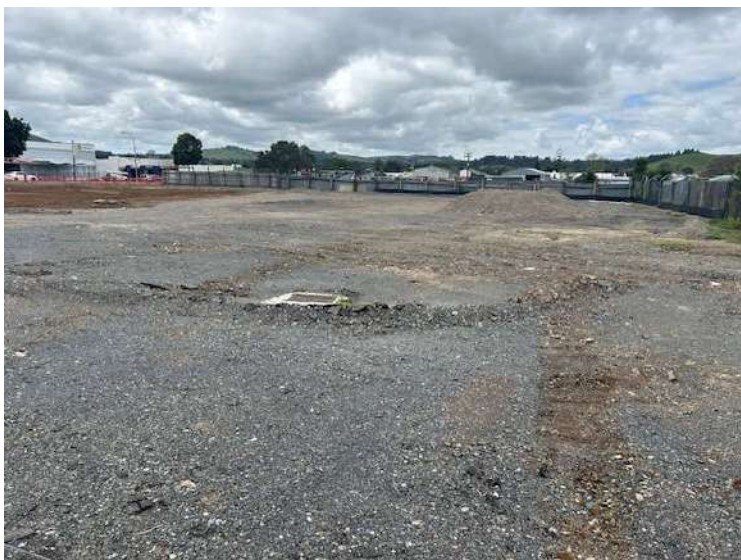
Figure 5 Subject site – cleared and brownfields

The site is situated on the eastern corner of Raihara Street and Broadway (SH 12). The subject site has an area of 3,864 m² and having recently been cleared, is brownfields undeveloped.

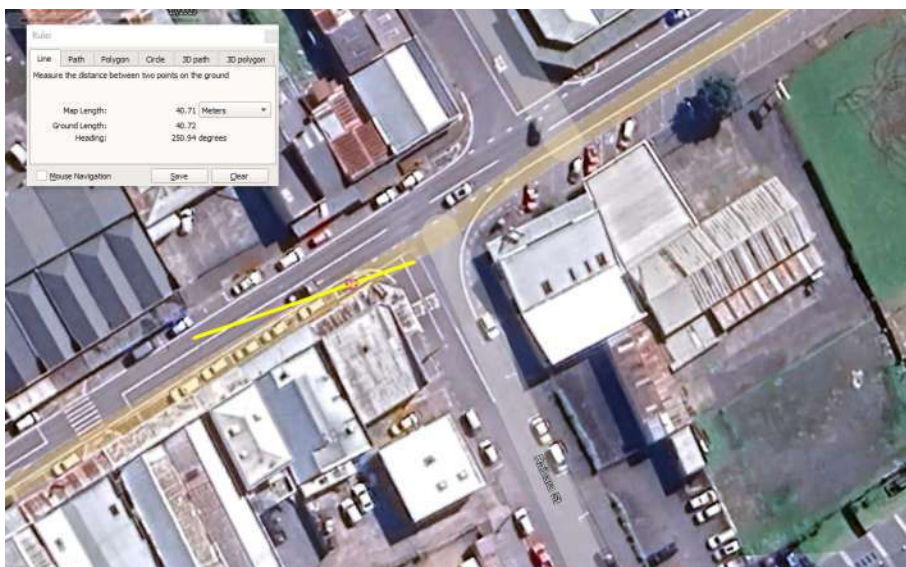
Figure 9 Sight distance of approximately 40m to the west

Visibility to the west is often impeded by parked vehicles along Broadway that restricts visibility to around 40m. Removal of parking to improve sight distance is not expected to be received well by local business, so is not recommended.

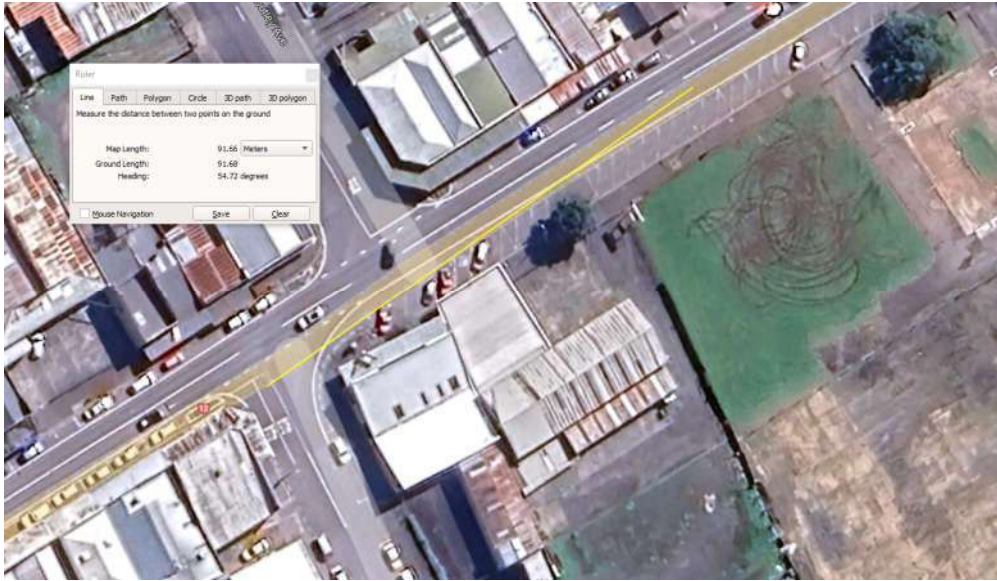
Figure 11 Sight distance of around 90m to the east.

Safe intersection sight distance of 90m that corresponds to 50km/hr with 1.5s reaction time, can be achieved to the east.

The intersection achieves approach sight distance of 34m that corresponds to a 40km/hr design speed with a 1.5 second reaction time (Austrroads Guide to Road Design – Part 4A: Unsignalised and Signalised Intersections, Table 3.1). For the reasons above, no changes are recommended for visibility towards the east. To summarise the reasoning for recommending no change, these are:

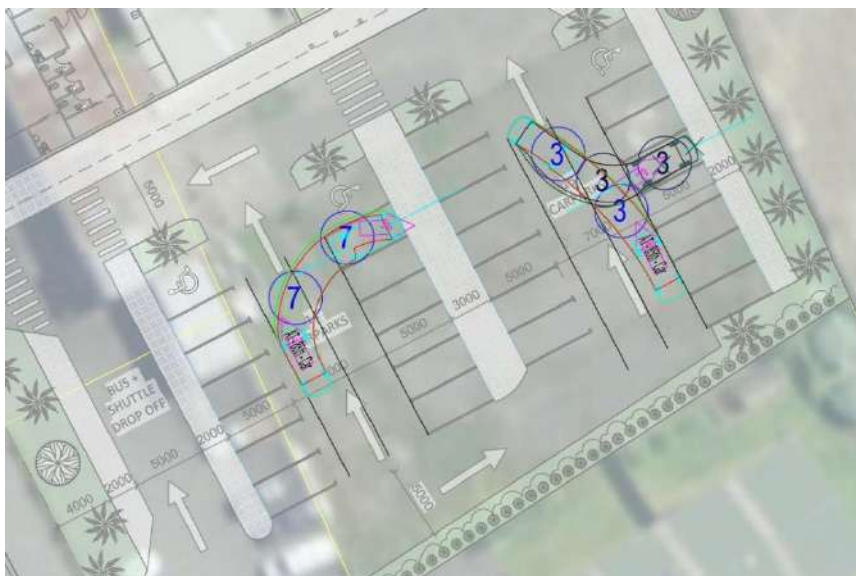
Figure 14 Snip of vehicle tracking for the car park using the 85th percentile vehicle.

For vehicle sweep paths and vehicle tracking curves, a 9.3m minibus was checked the tracking worked. Car parks were checked using the 85th percentile car. Some changes are recommended during the design phase to optimise the carpark and vehicle tracking.

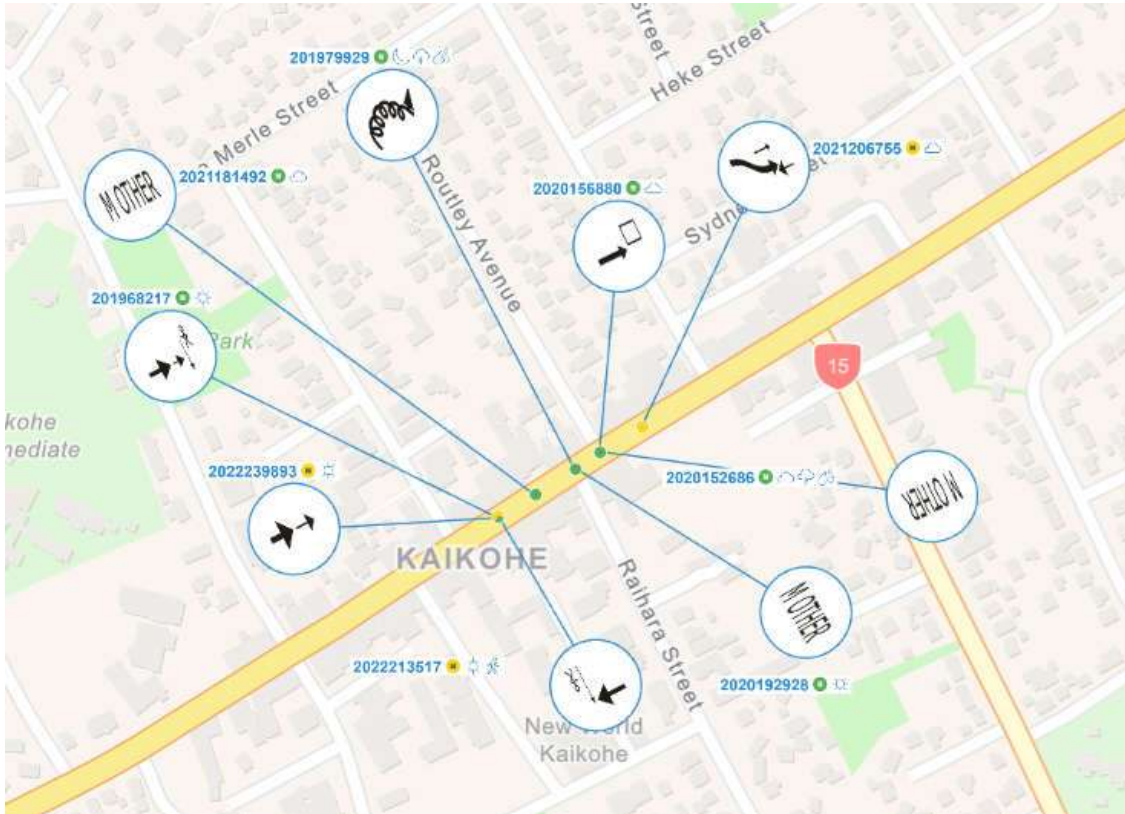
Figure 18 Collision diagram 2019 - 2023 inclusive

Five of the crashes involved a motor vehicle striking an unmanned parked vehicle and/or a stationary object. One crash involved the driver falling asleep. One crash involved reversing into the vehicle behind while queued at Raihara Intersection. One of the crashes involved an overtaking vehicle.

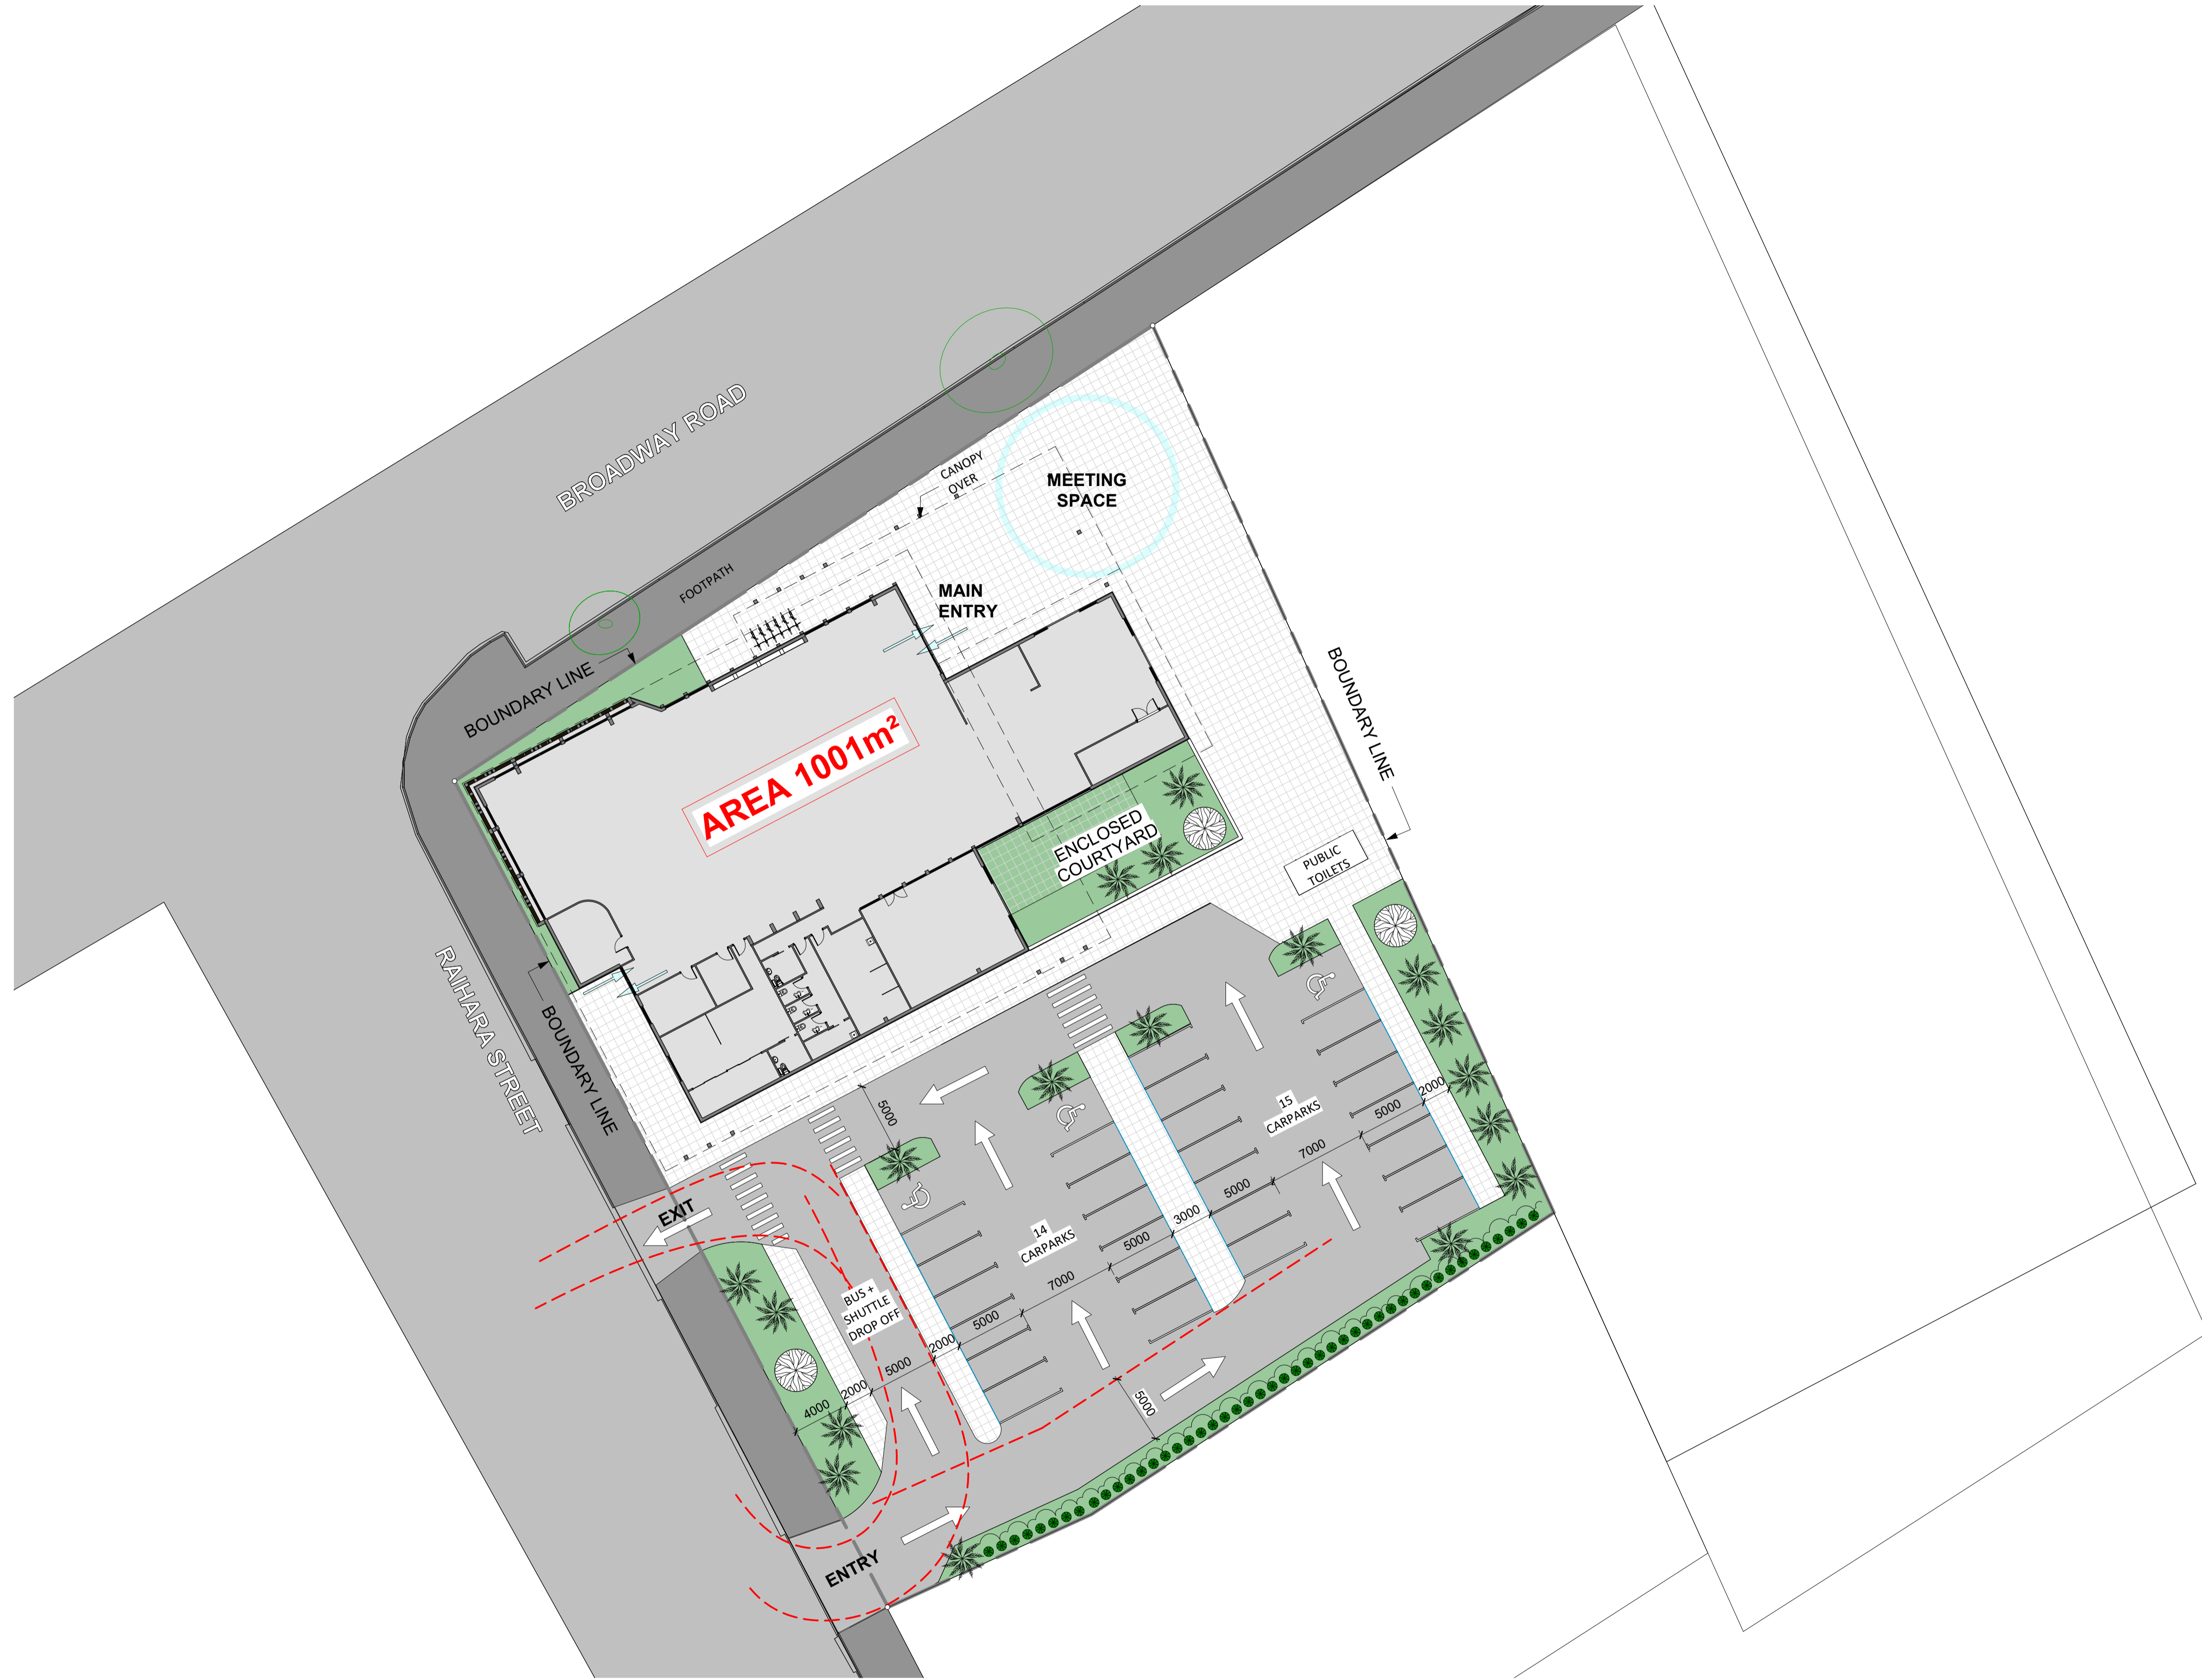
Appendix A – Concept Plan

A total of 29 car parks including 3 accessible carparks are shown on the concept plan. An additional 2 accessible car parks are recommended on Broadway Road (SH12) subject to NZTA approval.

It is considered that that the concept plan meets those objectives. The central 3.0m footpath is approximate. The minimum with of 1.5m should be provided for secondary footpaths. The width of 2.0m is shown on the concept plan that meets that recommendation.

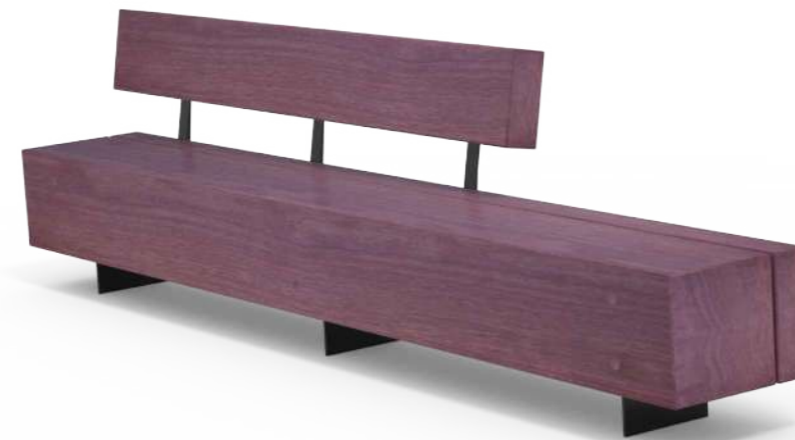
Kaitā Seat
3000L

MATERIALS	FINISHES	FINISH OPTIONS
Timber (Hardwood) <ul style="list-style-type: none"> Purple Heart as standard Other species available on request 	<ul style="list-style-type: none"> Un-sealed (Natural) as standard 	<ul style="list-style-type: none"> Penetrating oil / Graffiti guard / Clear sealant
Steelwork <ul style="list-style-type: none"> Mild steel as standard 	<ul style="list-style-type: none"> Hot dip galvanised powdercoated 	<ul style="list-style-type: none"> Custom paint options
Hardware / Fasteners <ul style="list-style-type: none"> Stainless steel 		
OPTIONS	DIMENSIONS	WEIGHT
<ul style="list-style-type: none"> Plant mounted Skate deterrents 	<ul style="list-style-type: none"> 3000L x 786H x 488D as standard 	<ul style="list-style-type: none"> 496Kg

• Made to order and can be customised to suit clients requirements.
 • Furniture is not supplied with installation instructions, install fastenings or footing details. These are to be specified and determined by the installing contractor for the specific requirements of each site.

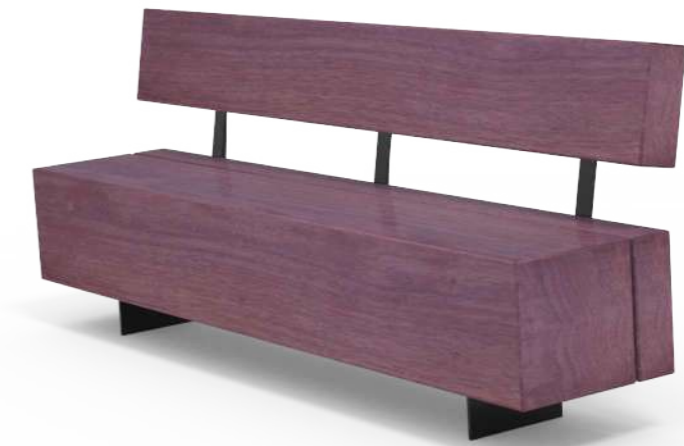
Kaitā Seat
2000L

MATERIALS	FINISHES	FINISH OPTIONS
Timber (Hardwood) <ul style="list-style-type: none"> Purple Heart as standard Other species available on request 	<ul style="list-style-type: none"> Un-sealed (Natural) as standard 	<ul style="list-style-type: none"> Penetrating oil / Graffiti guard / Clear sealant
Steelwork <ul style="list-style-type: none"> Mild steel as standard 	<ul style="list-style-type: none"> Hot dip galvanised powdercoated 	<ul style="list-style-type: none"> Custom paint options
Hardware / Fasteners <ul style="list-style-type: none"> Stainless steel 		
OPTIONS	DIMENSIONS	WEIGHT
<ul style="list-style-type: none"> Plant mounted Skate deterrents 	<ul style="list-style-type: none"> 2000L x 786H x 488D as standard 	<ul style="list-style-type: none"> 354Kg

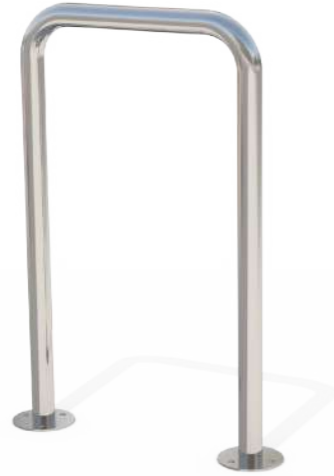
5no. Type D Cycle
Stand, inground
mounted

Steelwork	MATERIALS	FINISHES	FINISH OPTIONS
	<ul style="list-style-type: none"> Mild steel 304 Stainless steel 316 Stainless steel 	<ul style="list-style-type: none"> Hot dip galvanised only or Hot dip galvanised and powdercoated Electropolished as standard Electropolished or Bead blasted 	<ul style="list-style-type: none"> Custom paint options
	OPTIONS	DIMENSIONS	WEIGHT
	<ul style="list-style-type: none"> Plant or Surface Mounted 	<ul style="list-style-type: none"> 475L x 1000H x Ø50.8 600L x 1000H x Ø50.8 800L x 1000H x Ø50.8 1000L x 1000H x Ø50.8 	<ul style="list-style-type: none"> 7Kg 7.5Kg 8Kg 8.5Kg

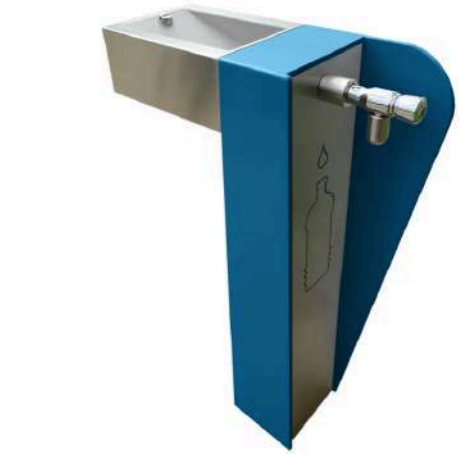
Apollo 280 Drinking Fountain

Colourful architectural style drinking fountain

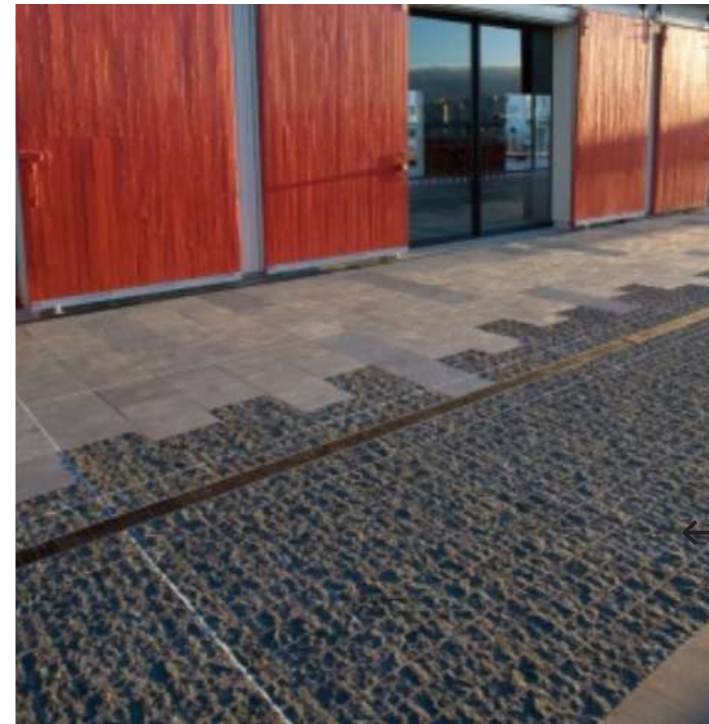
Textured granite setts

Paving under canopy opening: 18m² textured granite setts.

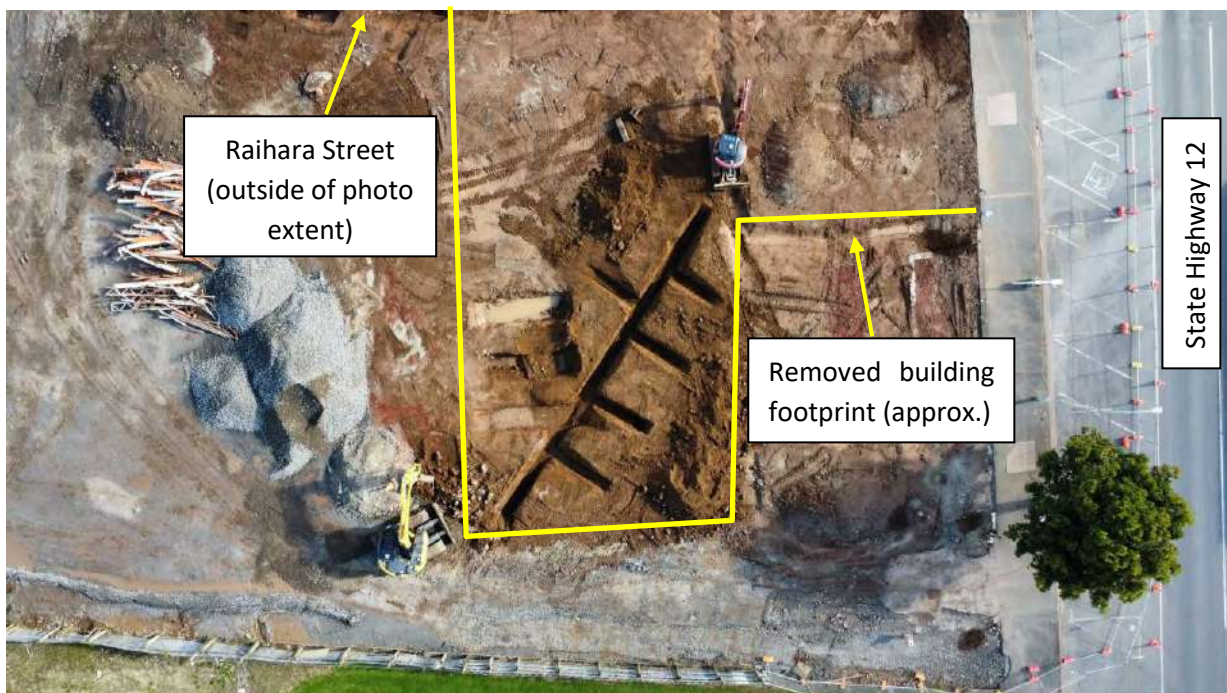
Figure 1 - Drone Photograph Prior to Backfilling

Haigh Workman undertook geotechnical monitoring works throughout the demolition process of the buildings. The area beneath the buildings were found to contain some deep pits and subsoil drains / trench network which had been backfilled at some point and were determined unsuitable for supporting building loads. These areas were typically excavated to expose natural ground, however they were backfilled with site-sourced non-engineered material due to the extent of the excavations. High-quality drone photographs were captured of the site prior to backfilling – refer Figure 1 below. See also Appendix E for Haigh Workman's site records.

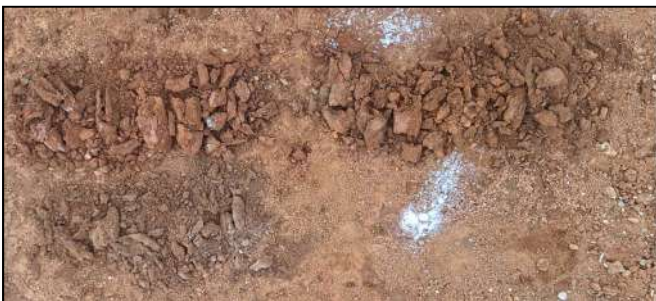
BH07 - Core Photo

Soil Description Based on NZGS Logging Guidelines 2005	Depth (m)	Geology	Graphic Log	Water Level	Sensitivity	Vane Shear and Remoulded Vane Shear Strengths (kPa)	Scala Penetrometer (blows/100mm)
Clayey SILT ; brown. Very stiff, dry, low plasticity. Trace coarse subangular gravel. [Kerikeri Volcanic Group]	0.0	Kerikeri Volcanic Group		Groundwater Not Encountered		229	0 5 10 15 20 25 30
	0.5						
SILT ; dark brownish-grey. Hard, dry - moist. Low plasticity. - inclusions of bluish grey silt (completely weathered rock).	1.0						
End of hole at 1.15m (Unable to Penetrate - Obstruction)	1.5						
	2.0						
	2.5						
	3.0						
	3.5						
	4.0						
	4.5

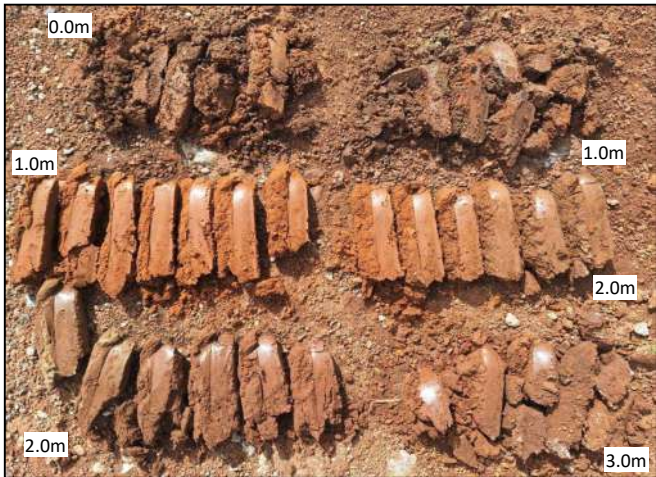
End of Hole at 3.0m (Target Depth) BH08 - Core Photo	3.0					UTP

Soil Description Based on NZGS Logging Guidelines 2005	Depth (m)	Geology	Graphic Log	Water Level	Sensitivity	Vane Shear and Remoulded Vane Shear Strengths (kPa)	Scala Penetrometer (blows/100mm)
SILT , minor clay; brown to orangish brown. Very stiff, dry to moist, low to medium plasticity. [Kerikeri Volcanic Group] From 0.4m: Becomes brown and light greyish brown. Moist.	0.0 0.5	KERIKERI VOLCANIC GROUP	[X-pattern]	Groundwater Not Encountered	Sensitivity	46 - 169	0 5 10 15 20
SILT , minor clay, trace fine gravel; brownish grey to greyish brown, mottled orange. Very stiff, moist, low plasticity. From 1.3m: Becomes orangish brown to brownish orange, speckled black. No gravel.	1.0					UTP	
From 1.8m: Becomes brownish grey to orange, speckled black. Trace fine gravel.	1.5					UTP	
SILT , minor clay, trace fine gravel; brownish grey, mottled orange. Very stiff, moist, low plasticity.	2.0					UTP	
SILT , some fine gravel; brownish orange and orange, mottled dark grey. Very stiff, wet, no plasticity. From 2.7m: Becomes dark brownish grey, mottled orange. Wet.	2.5					UTP	20 - 138

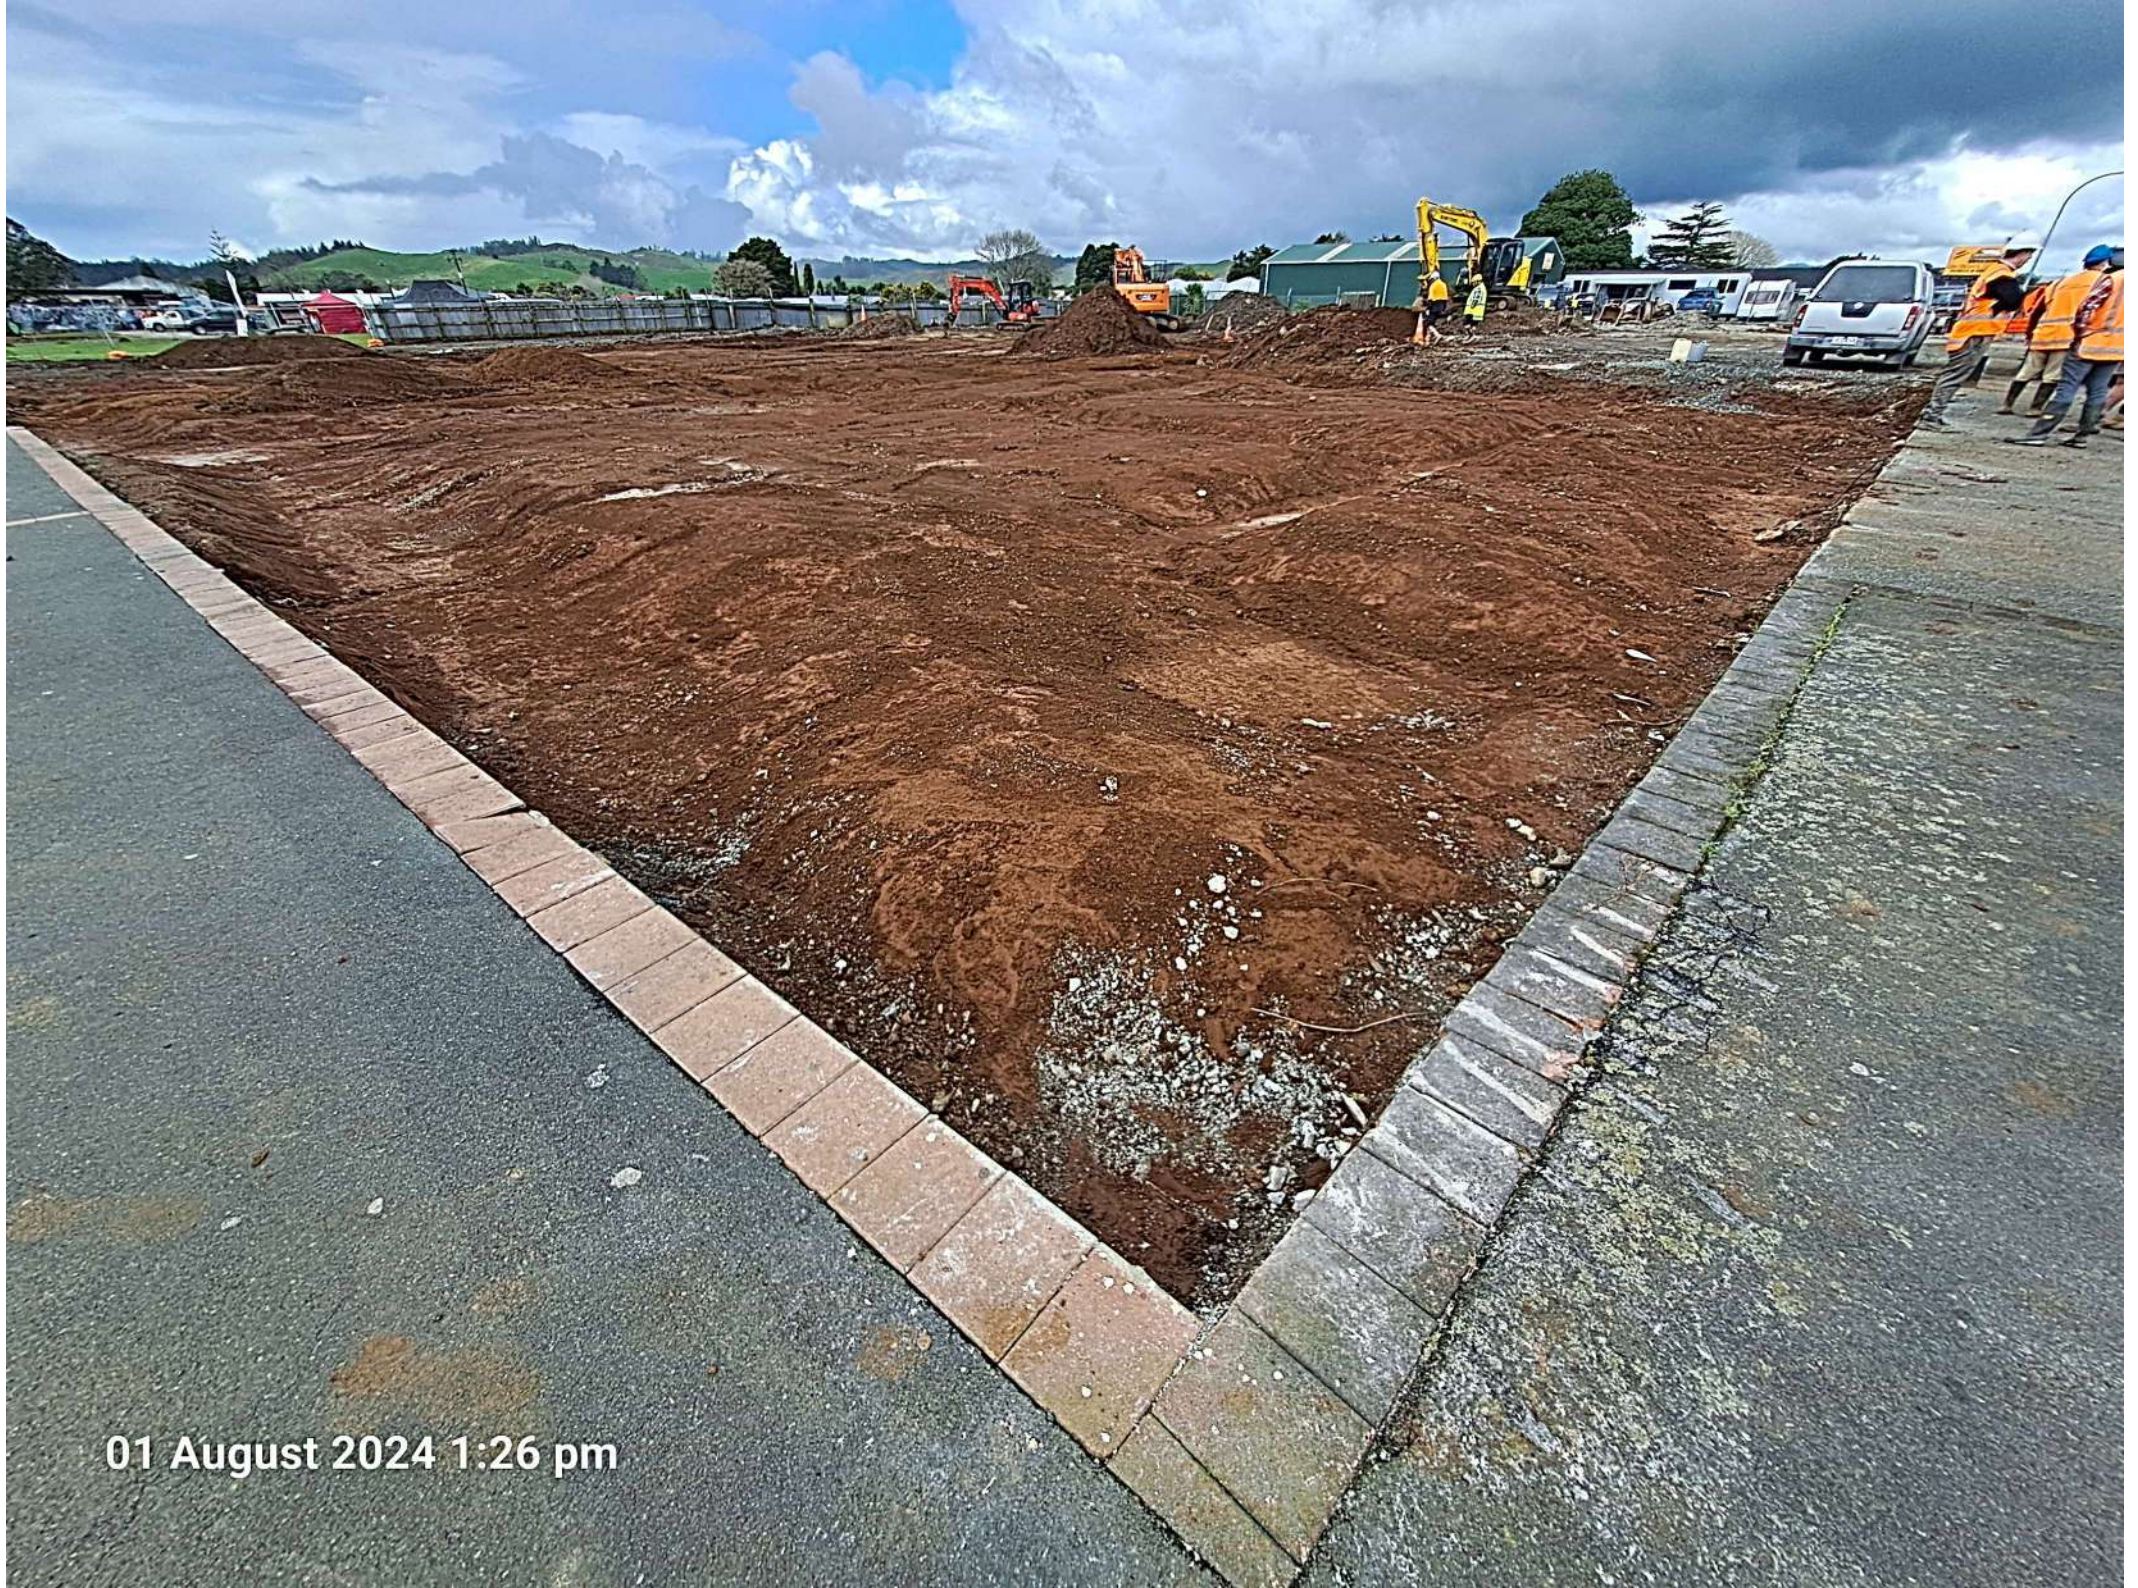
DWG No.	G02
Sheet No.	2 of 3

Project	Geotechnical Investigation 69 Broadway, Kaikohe	
Client	FNDC	
Project No.	22 277	RC no. N/A
