Application for resource consent or fast-track resource consent

This application seeks discretionary resource consent for the development of a library on the corner of State Highway 12 (Broadway) and Raihara Street within the Commercial Zone. The proposal replaces the current library approximately 100 metres away. The building has been designed in consultation with the local community, hapu and iwi and creates an iconic building on Kaikohe's main street. Overall, any potential adverse effects are considered to be less than minor.

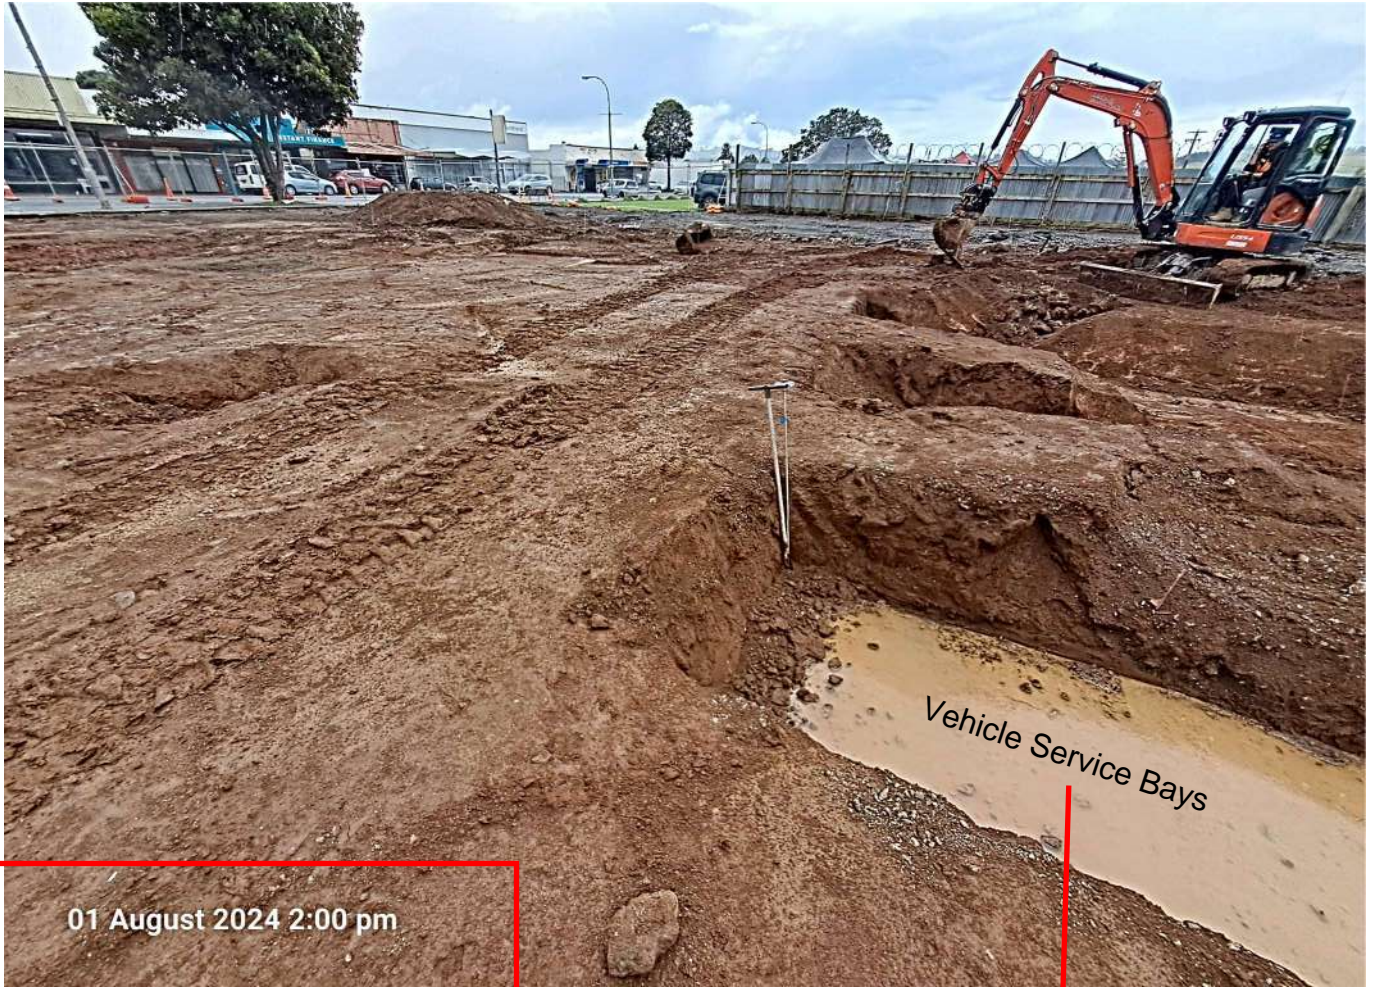
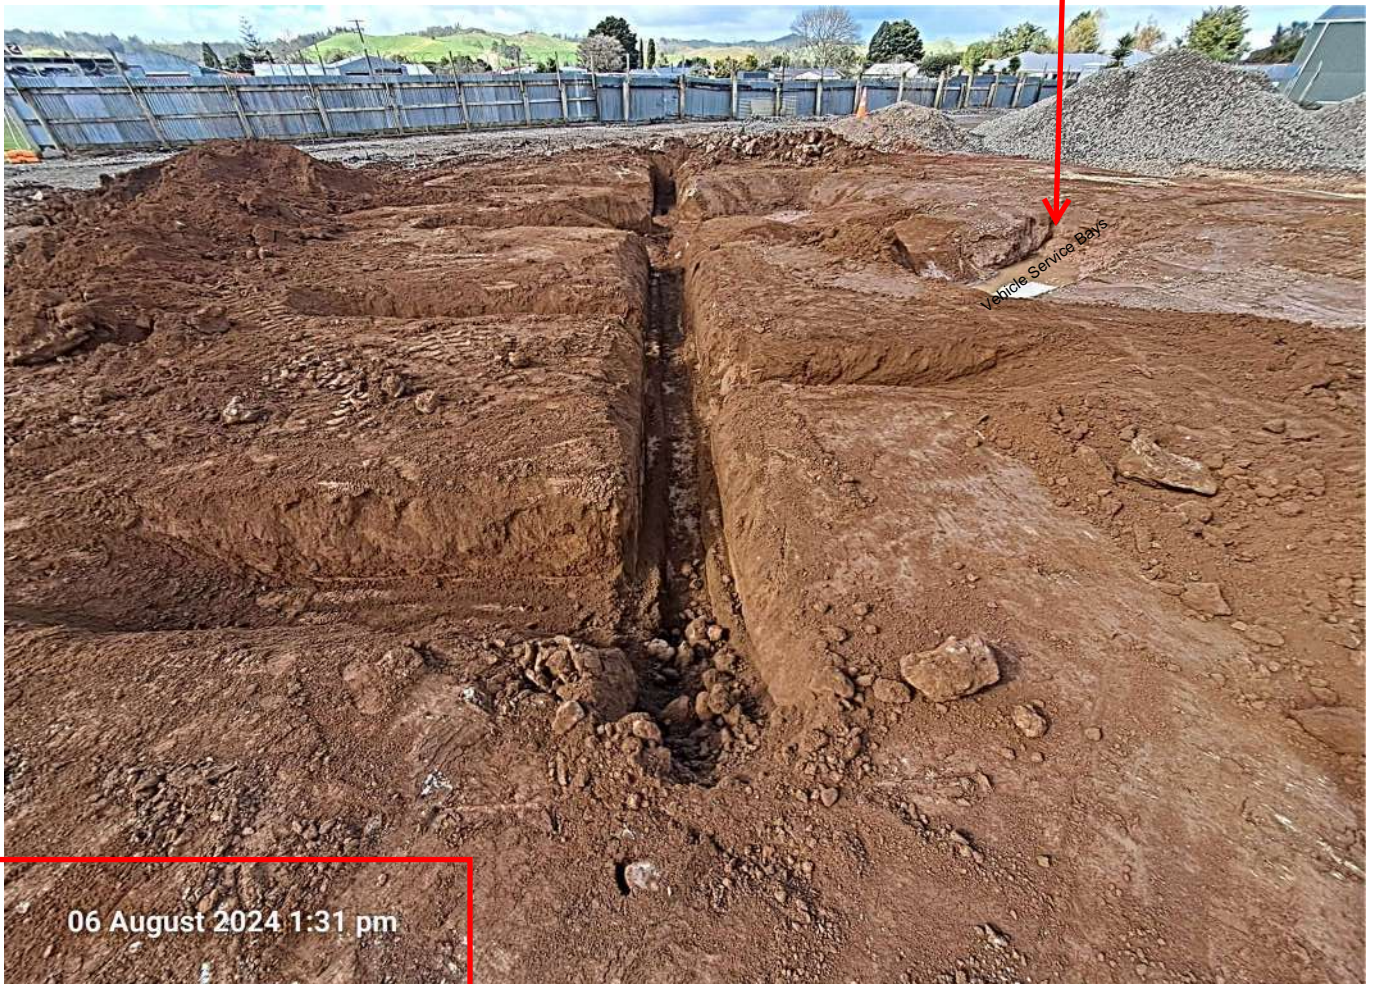
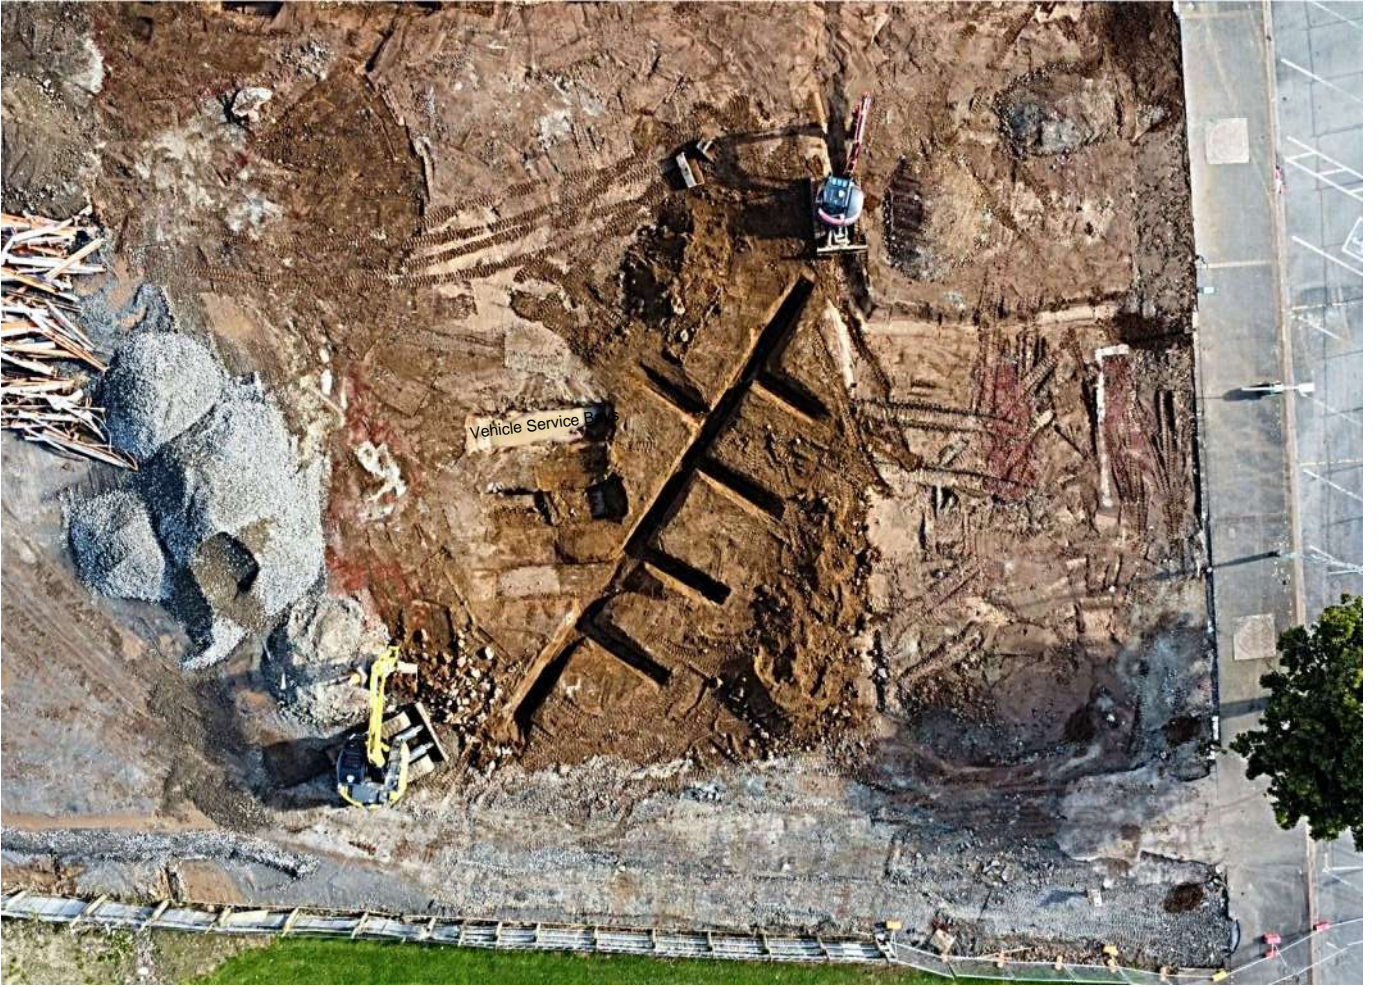
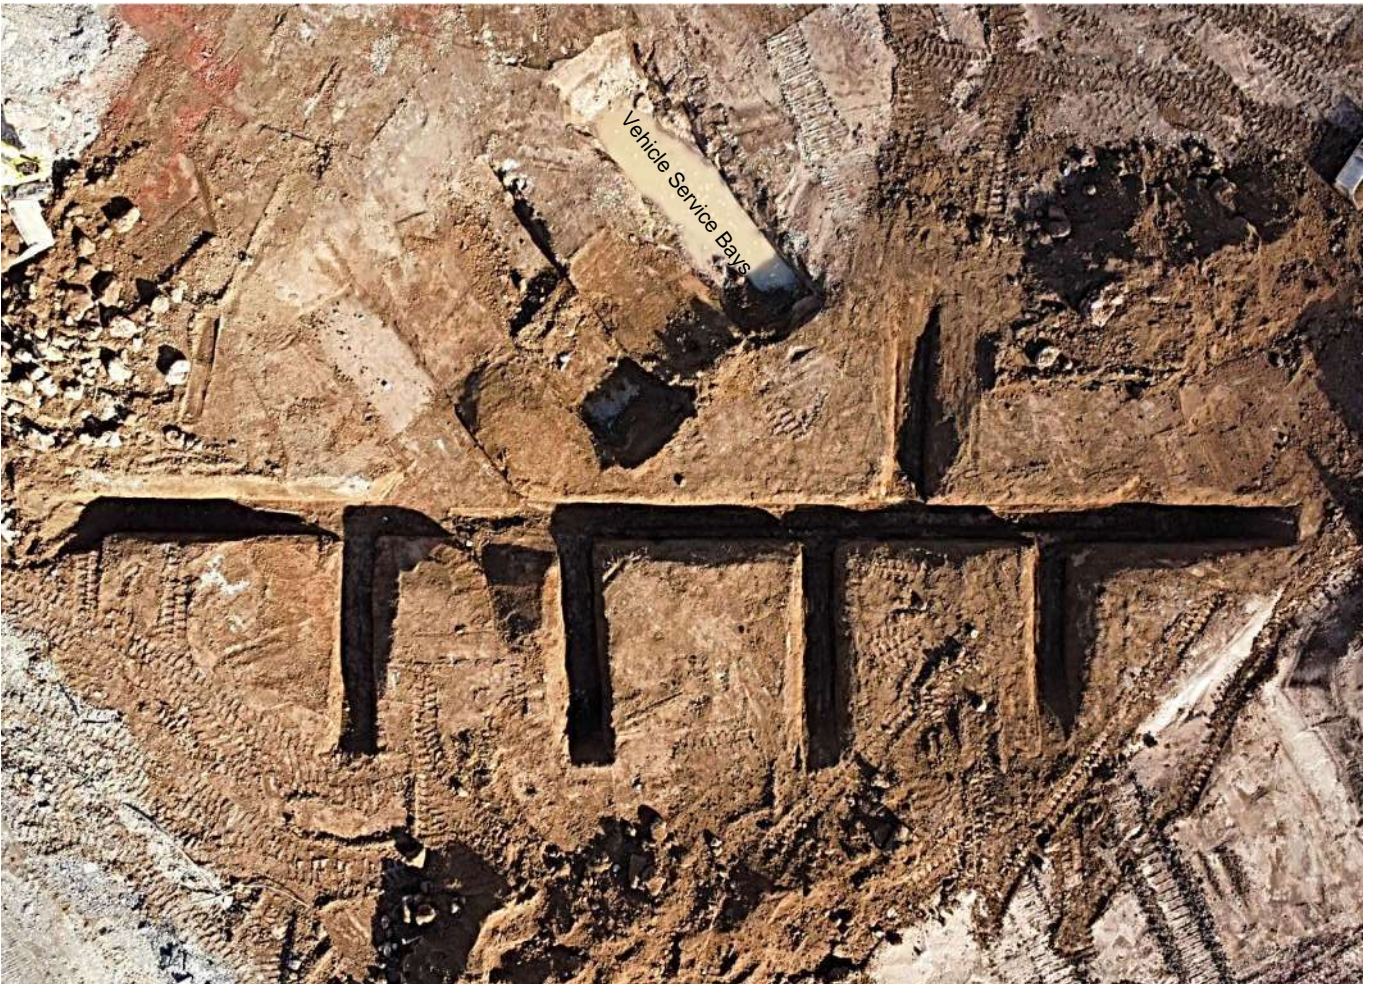
Jake (Keriland) happened to have his personal drone and offered to take aerial photographs indicating location and extent of work/excavations (see site photos attached).

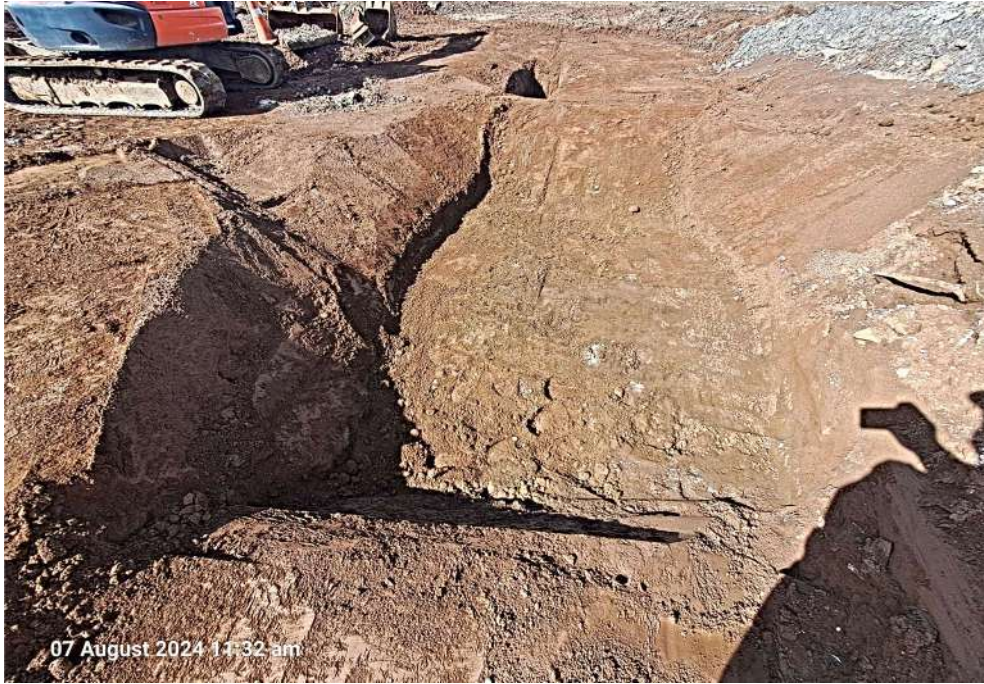
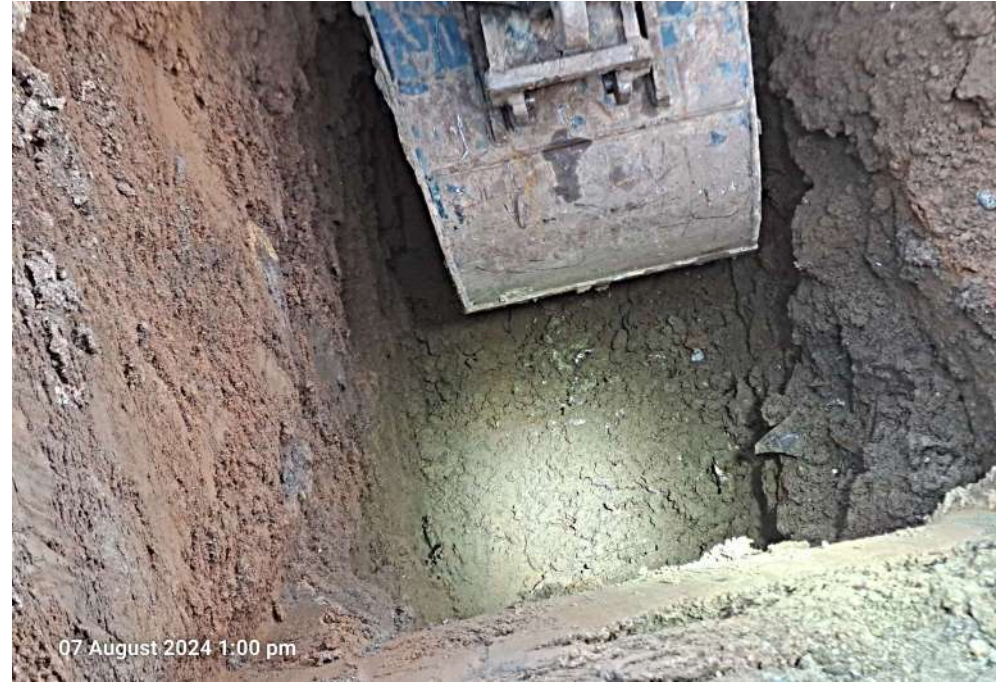
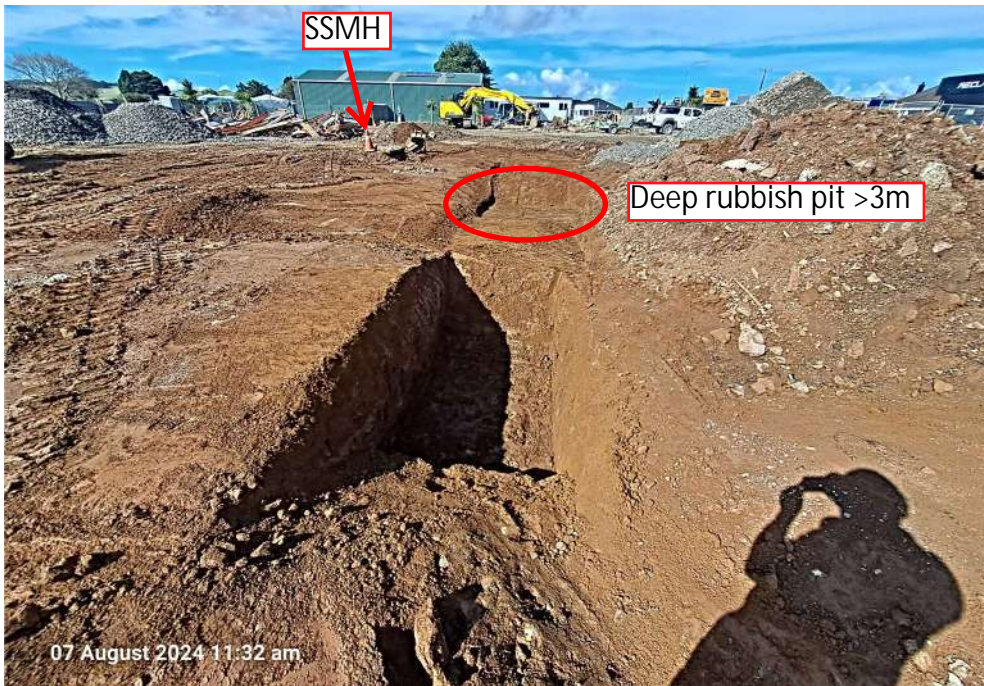
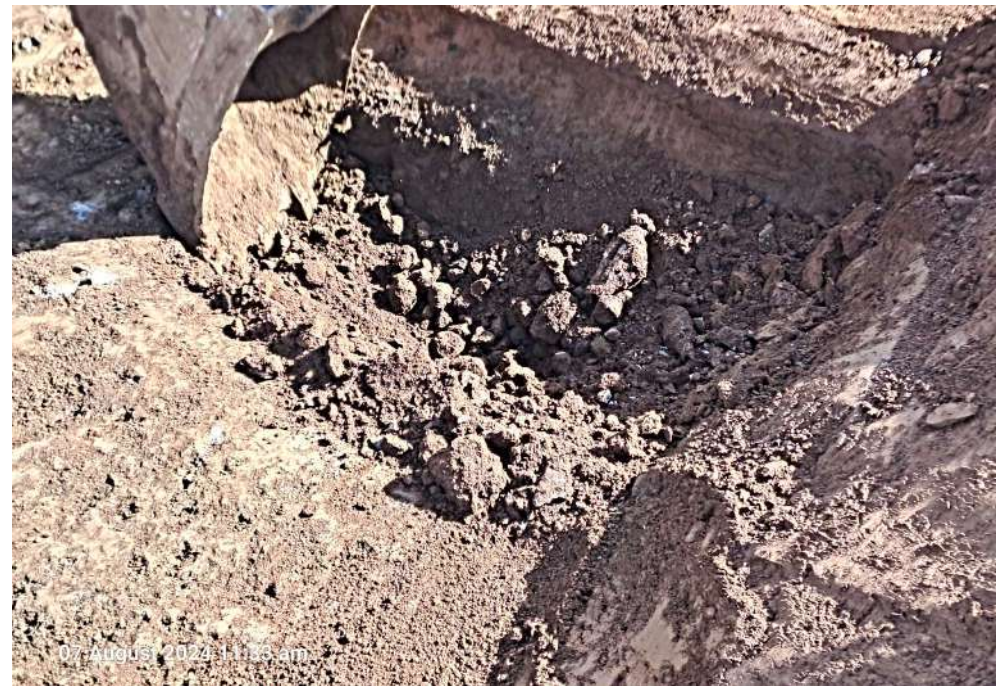
FOOTPRINTS ARE APPROXIMATE ONLY

Test pit with concrete unsuitable material observed.

Test pit with deep (>3m) unsuitable material observed.

Any unsuitable ground intended to support foundations will require removal and reinstatement with engineered fill to support foundations (including test pits excavated during site investigations), no ground has been "made good" over the course of the demolition visits, all excavations have been reinstated to a safe standard - not engineered standard.

All excavations within the final building footprint's zone of influence that were excavated during investigations and clearing must have unsuitable backfill removed and excavations reinstated with engineered hardfill - refer geotech report for test pits locations.

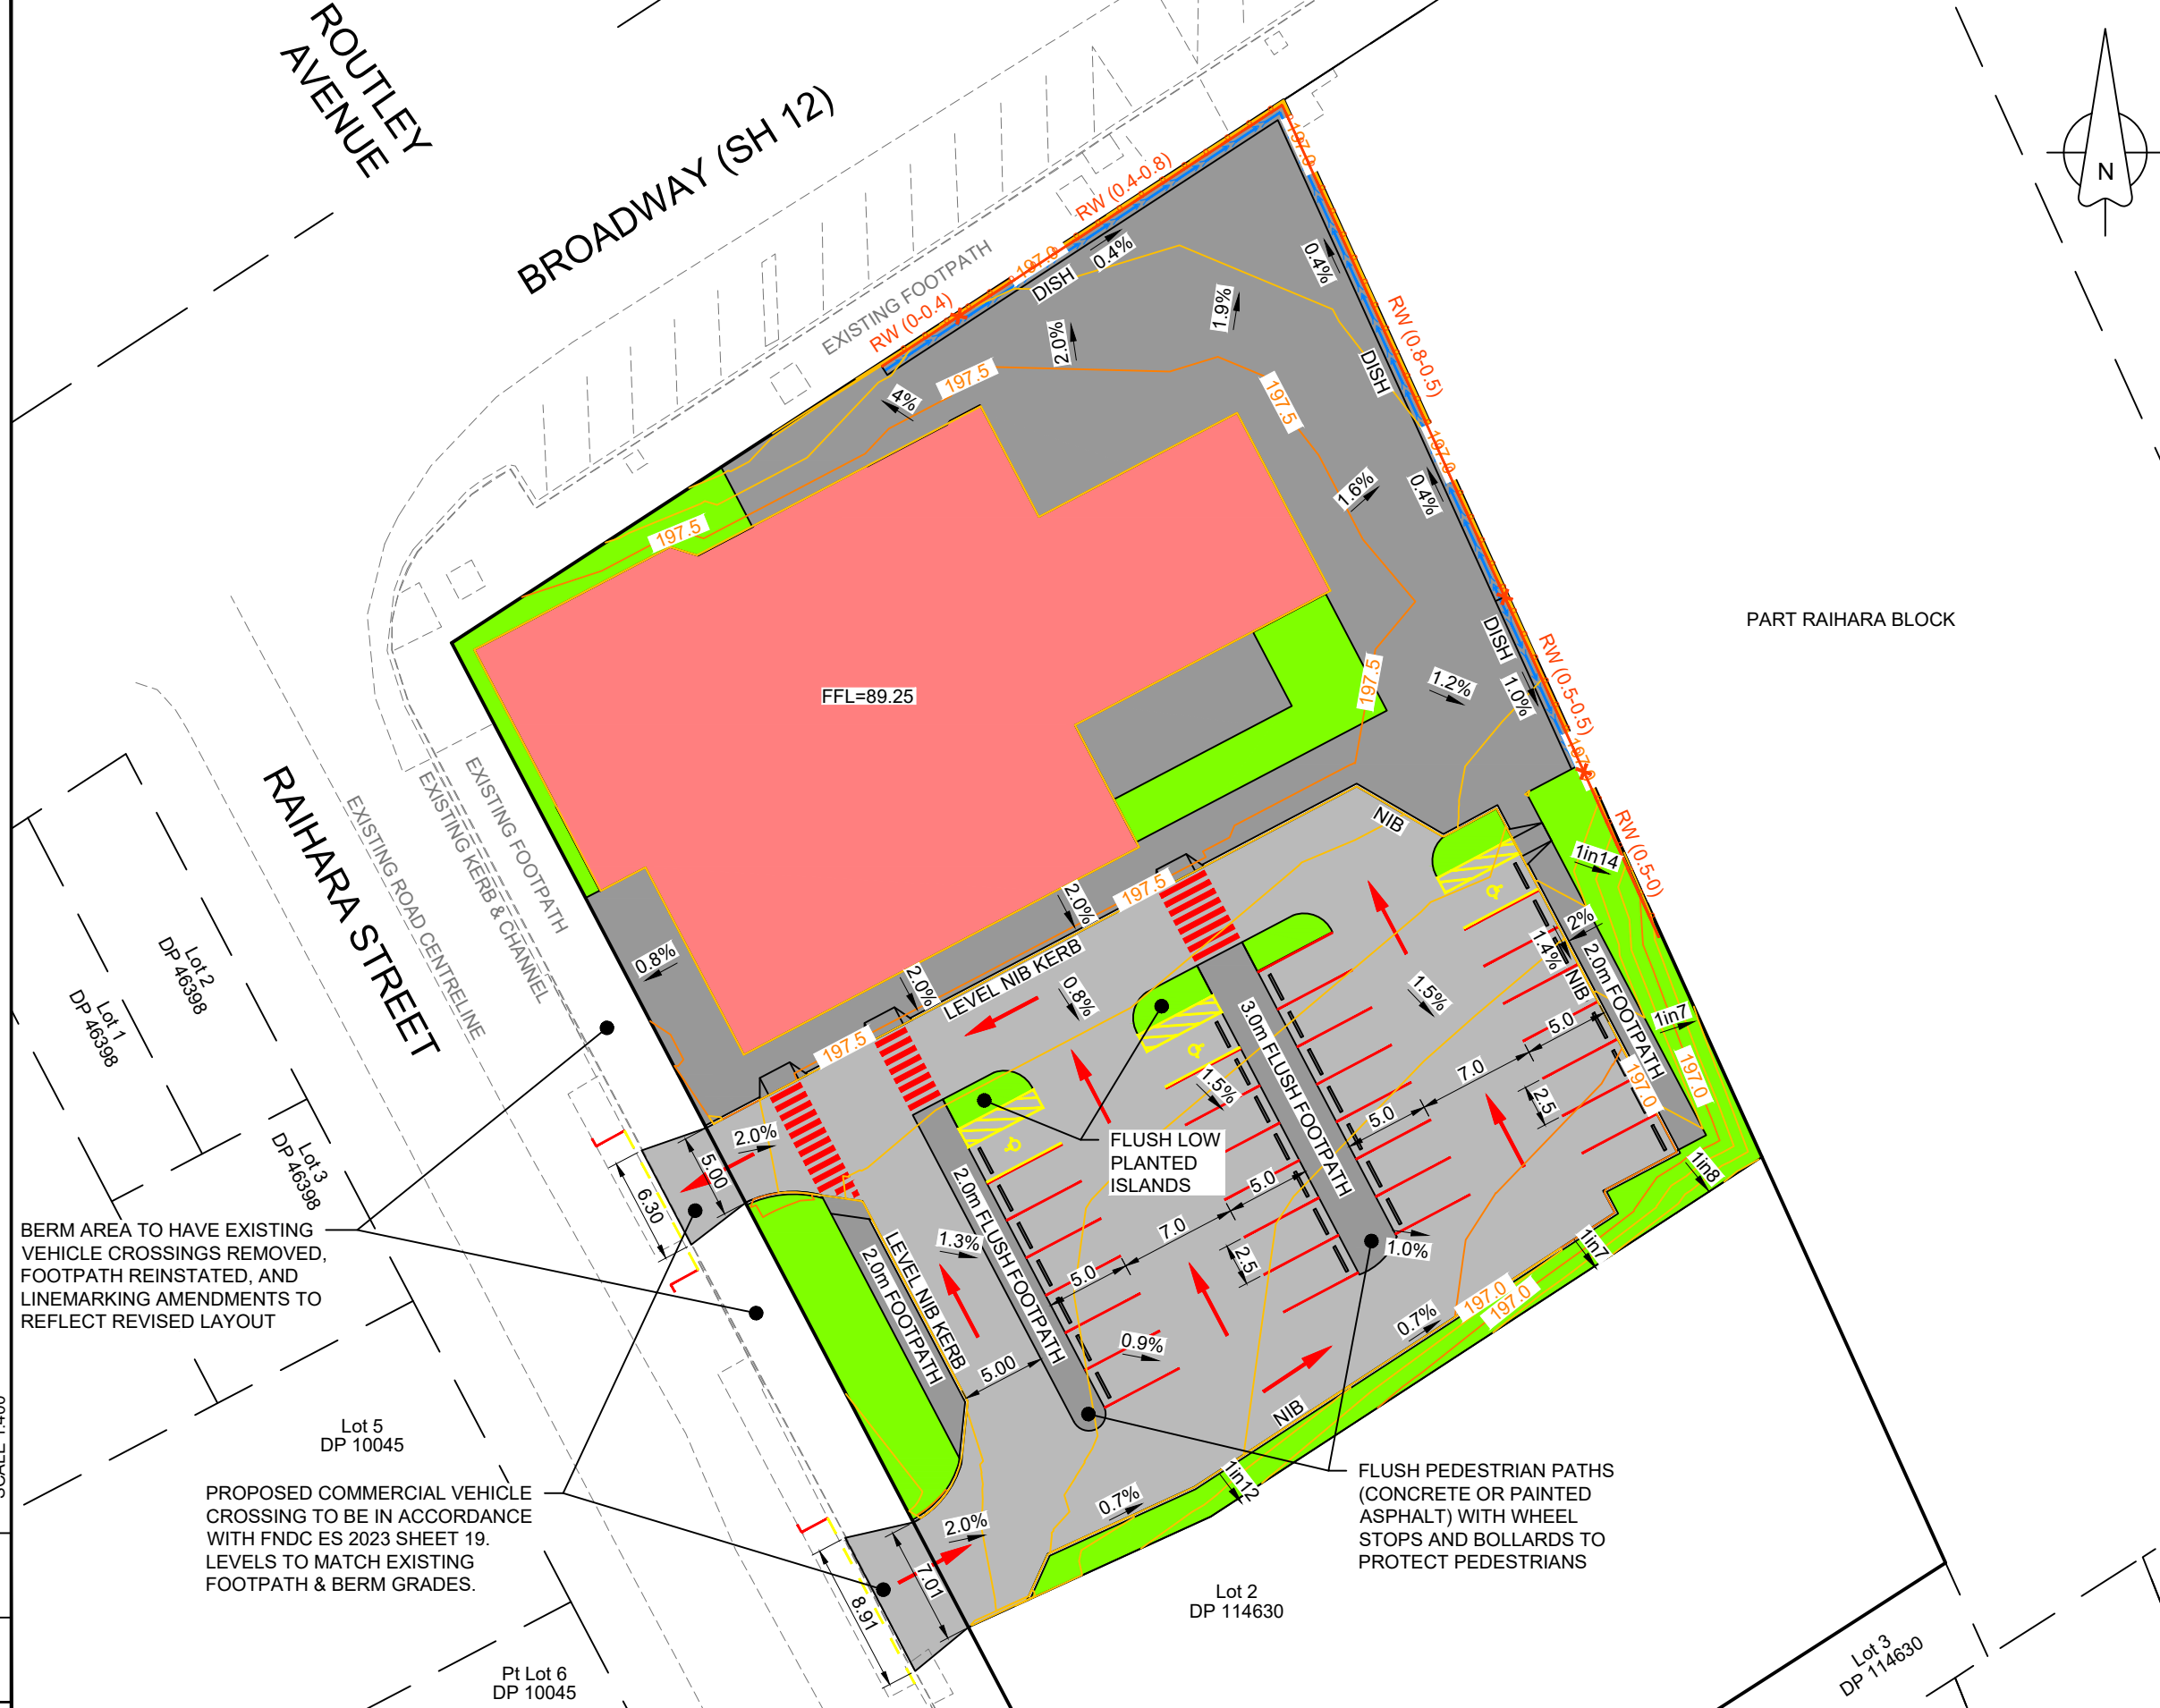
BERM AREA TO HAVE EXISTING VEHICLE CROSSINGS REMOVED, FOOTPATH REINSTATED, AND LINEMARKING AMENDMENTS TO REFLECT REVISED LAYOUT

PROPOSED COMMERCIAL VEHICLE CROSSING TO BE IN ACCORDANCE WITH FNDC ES 2023 SHEET 19. LEVELS TO MATCH EXISTING FOOTPATH & BERM GRADES.
