Archaeological Assessment of the Proposed New
Shed and House

Lot 2 DP 200787

Paroa Bay, Bay of Islands

22 June 2016

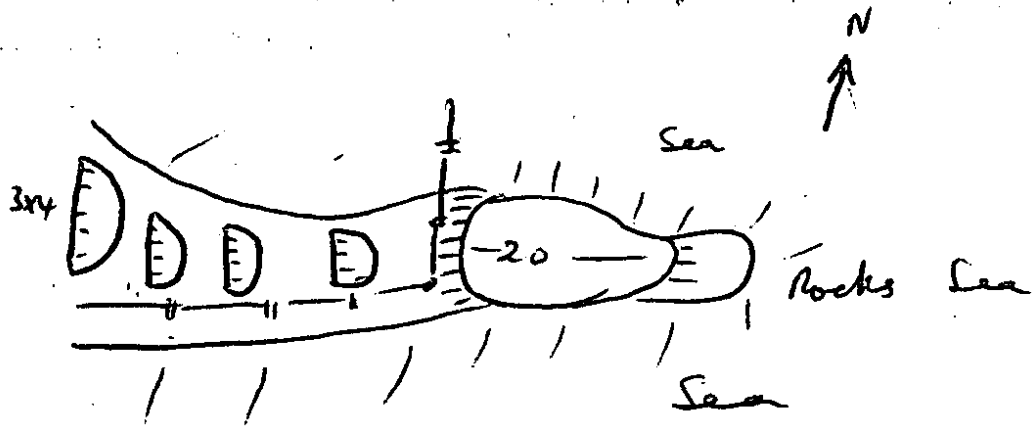
Pa site Q05/246 (Figure 5) was recorded by A. Leahy in 1978. It is located on the small headland 300m north of the building sites on subject property, but adjacent to the northern end of the property. It consisted of at least six terraces divided by a defensive ditch. The site was truncated by a farm fence running along the headland. The site has not been revisited by an archaeologist since the original recording, but will not be affected by the proposed development.

Figure 5: Q05/246 pa, recorded by A. Leahy 350m north of the building sites, in 1978.

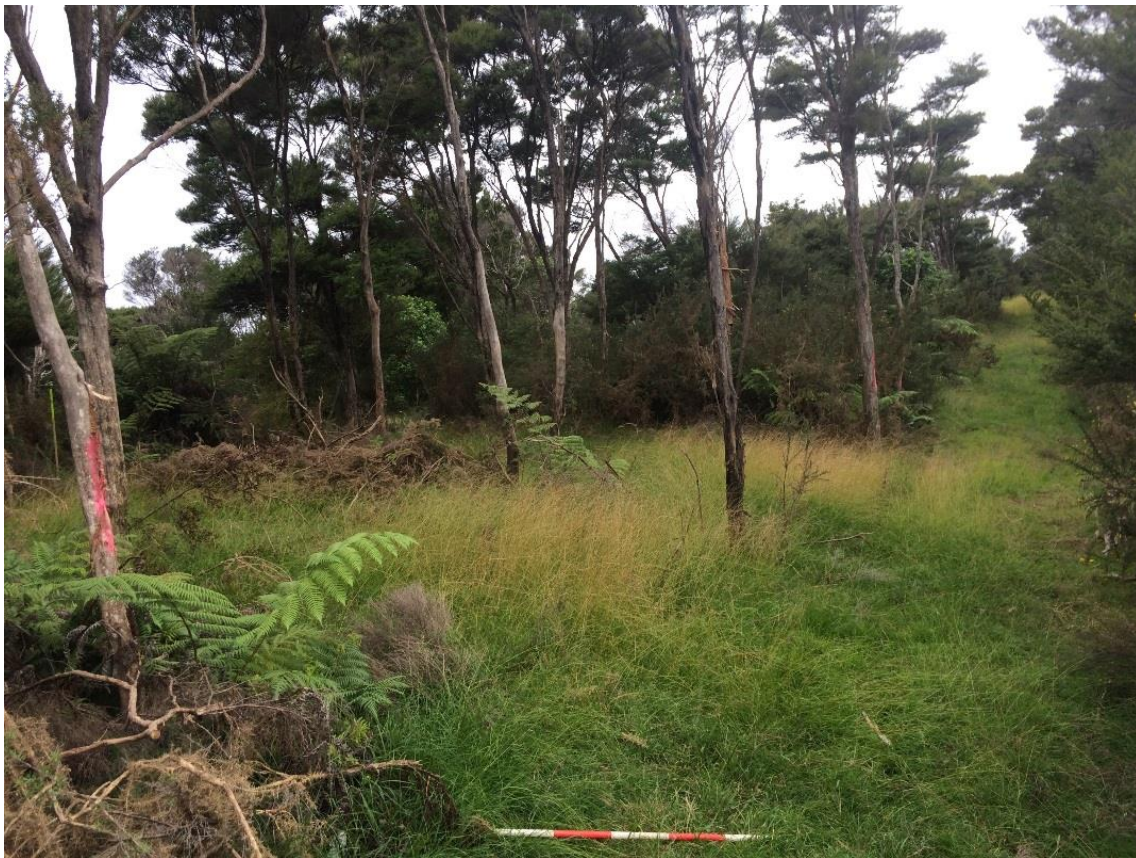
No archaeological sites or features were observed on the surface of the inspected portion of the property around the proposed building sites, in the test pits, or along the

Figure 7: Looking south east across shed site and driveway route/southern boundary.

An archaeological authority under the HNZPTA is not required and no archaeological mitigation is necessary for the proposed shed, house or driveway in the areas assessed.

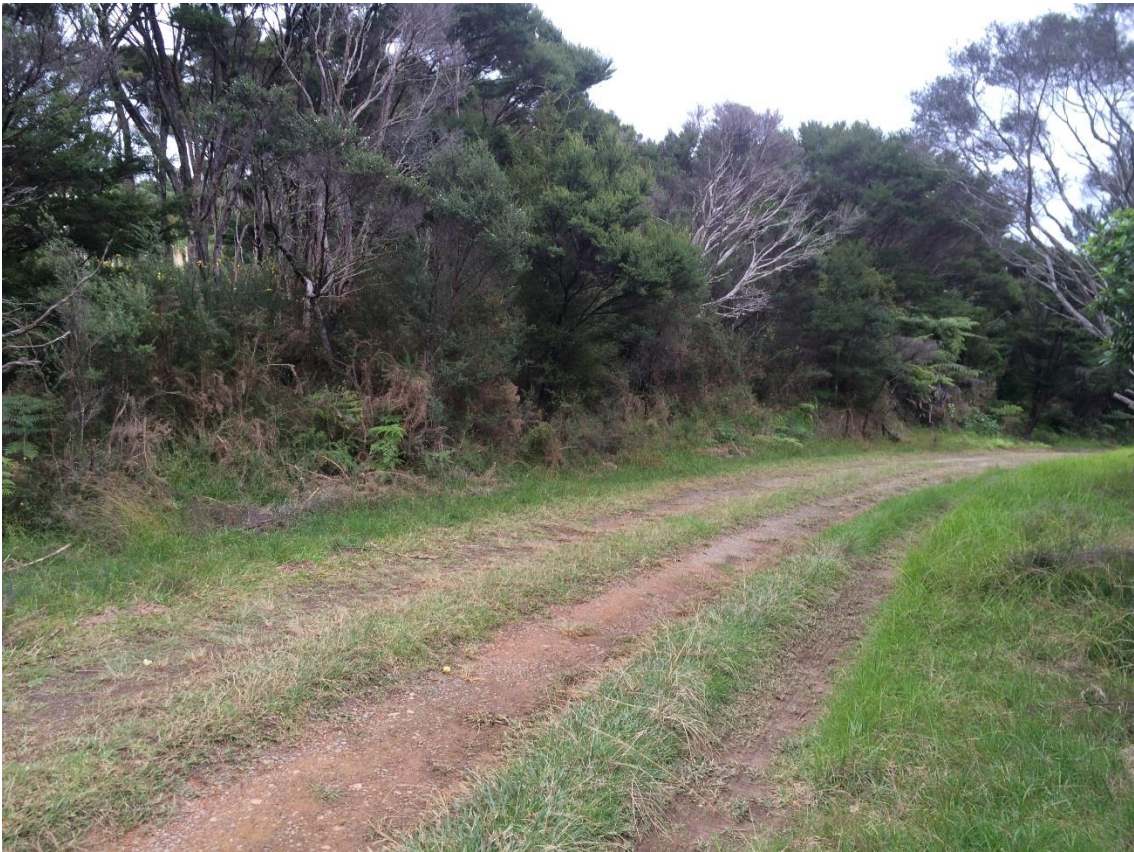
Figure 8: Looking north west towards rear of shed site, from access track.

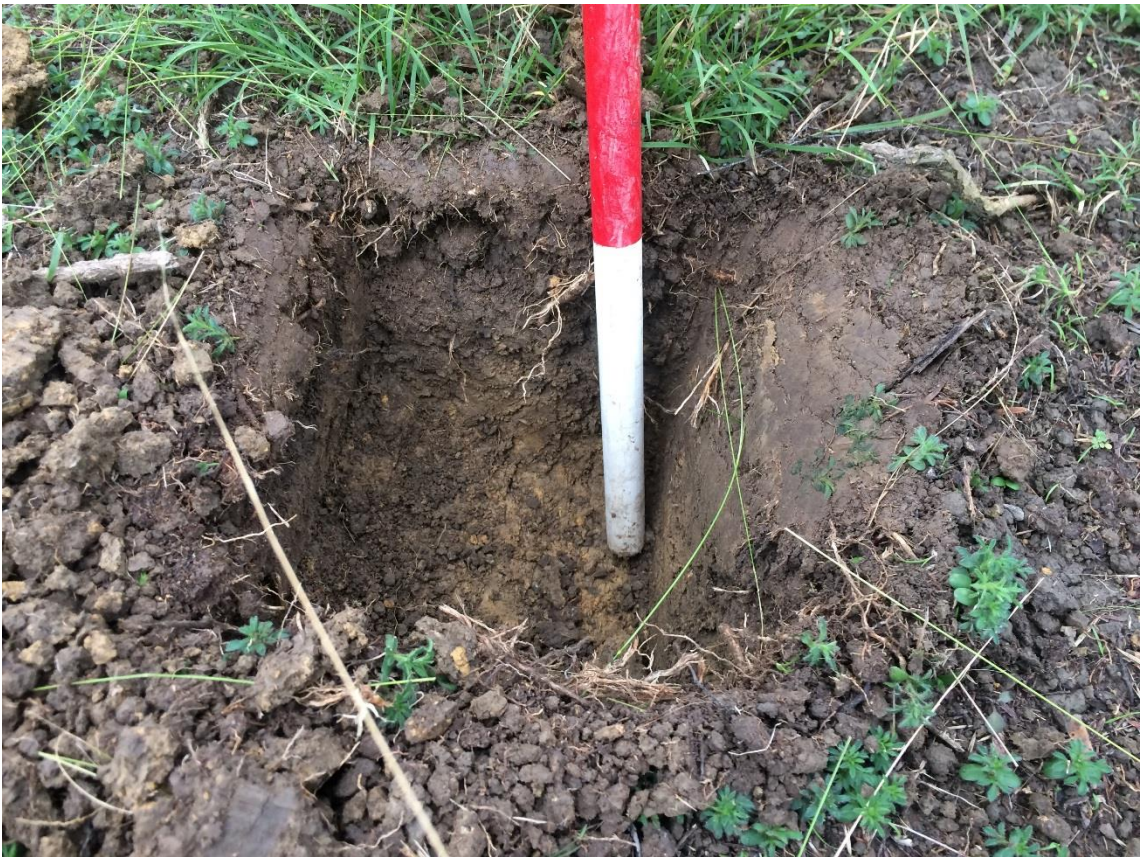
Eight spade test pits were excavated, four each across the shed sites and house site. The soil stratigraphy consisted of 10-15cm to grey brown silty clay topsoil grading into orange-yellow clay. No charcoal or other possible archaeological inclusions, layers or features were observed. The soil profiles appear to be typical for coastal northland where clay soils have been cleared of native vegetation, lightly grazed and then retired and left to regenerate. There was no indication of greasy, charcoal-stained soils, shell midden, or 'made soils' indicating occupation of the immediate vicinity of the proposed building sites.

Figure 9: Typical soil profile, shed site.

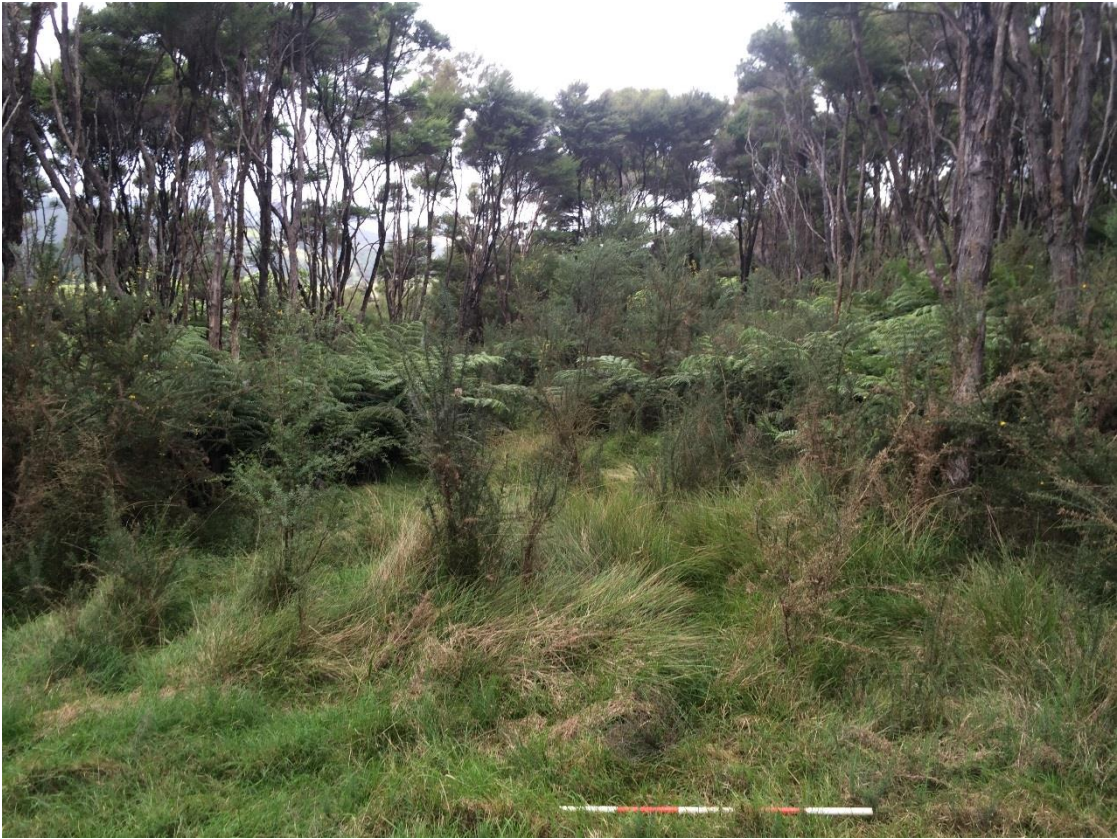
Figure 10: Future house site, looking south east.

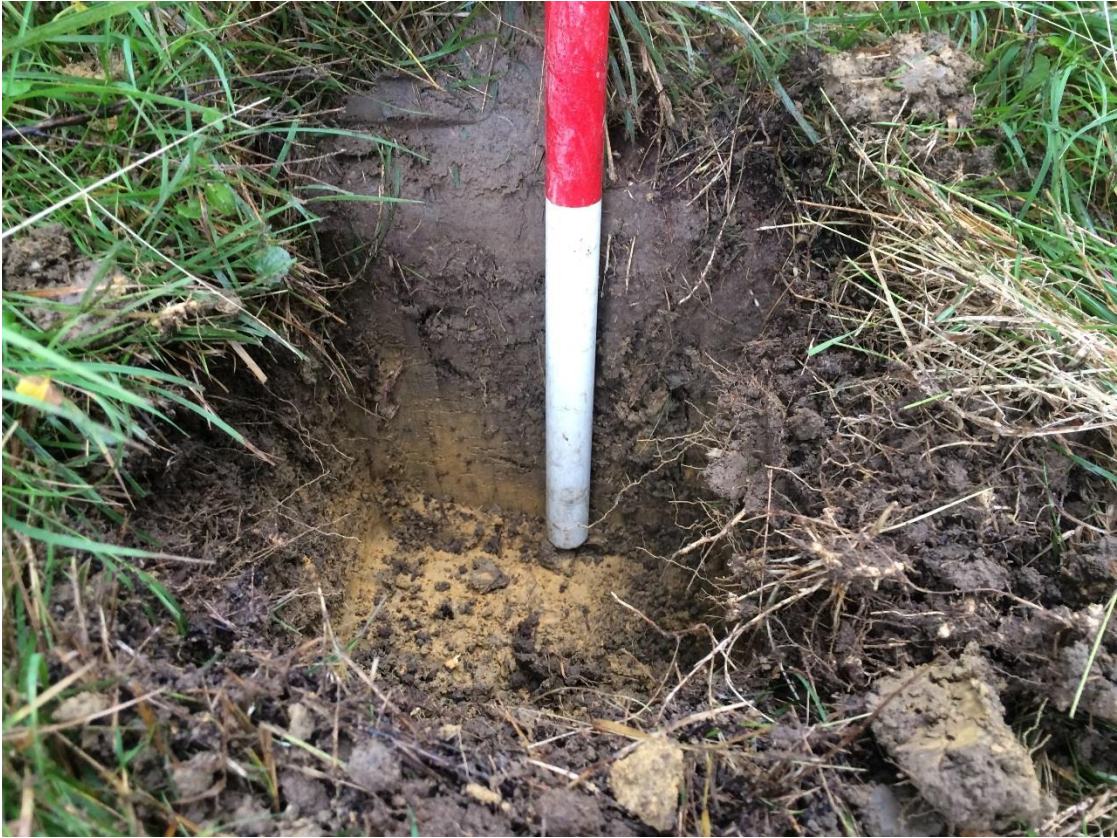
Figure 11: Typical soil profile, future house site.
