Site Suitability Report for Civil Design

♥174 Lamb Road, Pukenui, Northland Moekoraha Papakāinga Development

Job No.: 15657

Rev: 0 Date: 29 July 2024

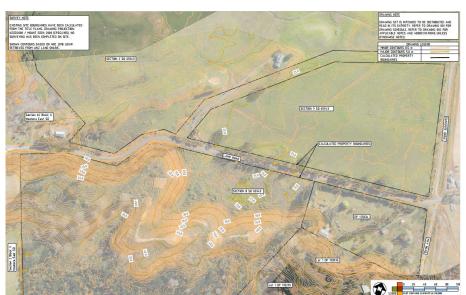
Figure 1: Aerial Image of Development Sites

The property on the southern side is currently vacant. A broad ridgeline traversing from east to west in a zig-zag fashion is present within the northern section of the property. The ridge side slope inclinations range from 20° to 30°. A wetland is present within the northeastern section of the property, between the ridge and the road. The wetland appeared to be dry at time of our site visit. Land to the south of the ridgeline is covered with dense native bush. The eastern section of the ridgeline has been cleared of vegetation and five building platforms and associated accessways have been created.

The property on the northern side is situated to the north and west of the property on the southern side. A dwelling serviced by a gravel driveway is present near the southeast boundary. Isolated elevated areas are present, including the location of the dwelling platform. The general area is currently used as grazing land.

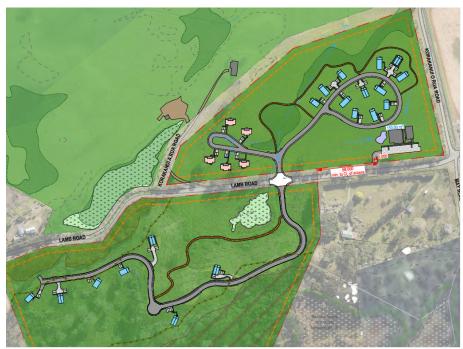
Figure 2: Proposed Site Plan by BDG (Dated 23 July 2024)

It is proposed to construct 24 new dwellings across the two sites with associated access roadways, a community centre, and servicing as shown in Figure 2 below and in Appendix A. This report is intended to support a Resource Consent application for Land Use.

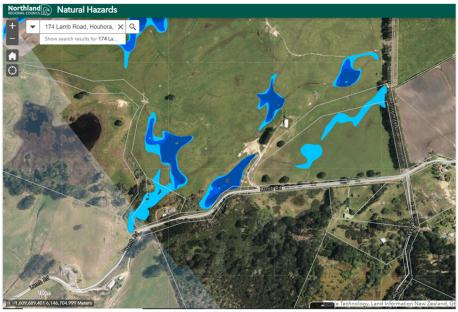
Figure 3: NRC Site Flood Hazard (NRC Priority Rivers Maps, 10/06/2024)

As per Figure 3 above, the NRC Natural Hazards Priority Rivers Flood mapping for 10-year, 50 year and 100 year events indicate that there is flooding on the site. However, it is not expected to significantly affect the proposed development as the proposed dwellings will be raised on pile foundations to a level sufficient to provide the minimum freeboard required by Council.

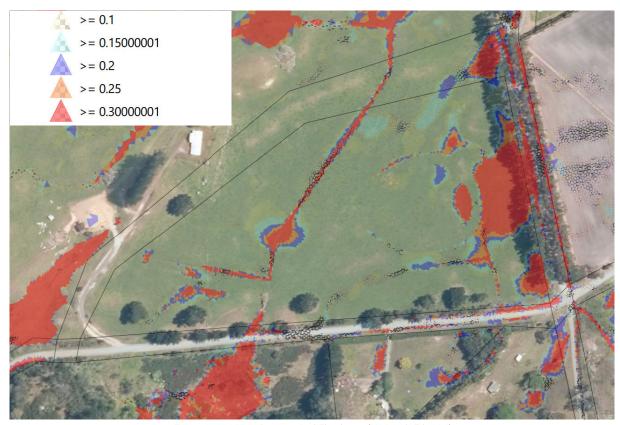
Figure 4: 100-Year Rain-on-Grid Flood map (ICM 26/07/2024)

A 2D Rain-on-Grid (ROG) flood model was created using InfoWorks ICM software to better understand site specific conditions for a typical 1% AEP climate change adjusted storm event. This flood model provided likely extents of localised flooding due to depressions and overland flowpaths within the development area.

The results from the stormwater modelling has identified overland flowpaths (that corresponds to the data from NRC Priority Rivers Maps, 10/06/2024) that need consideration during design and construction. Additionally, the deepest ponding areas identified in red (Figure 42) are caused by low lying land as identified within publicly available LiDAR topographical data. These areas should be avoided for buildings unless specifically designed drainage works are completed, most notably required immediately south of Lamb Road (drain to the stream/pond) and on the western side of Korakanui O Rua Road on the most easterly site boundary.

Given the above, we conclude that NRC priority rivers flood data, complimented with our own stormwater modelling analysis provides a fair representation of the flooding risk on the site which must be considered during design and construction stages of this project.

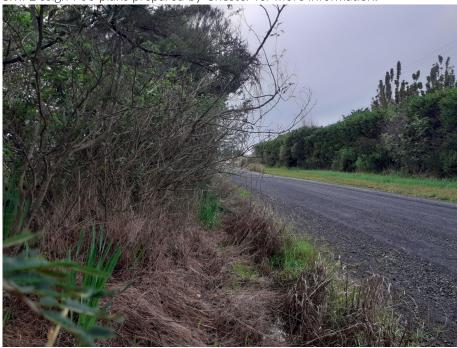
Figure 5: Lamb Road looking east from location of proposed vehicle crossing for community centre

The existing environment at the proposed location of the community centre's access fails to provide adequate sightlines to the east of the proposed vehicle crossing along Lamb Road because of vegetation—refer to Figure 5 below. Clearing of vegetation will be necessary to achieve suitable sightlines.

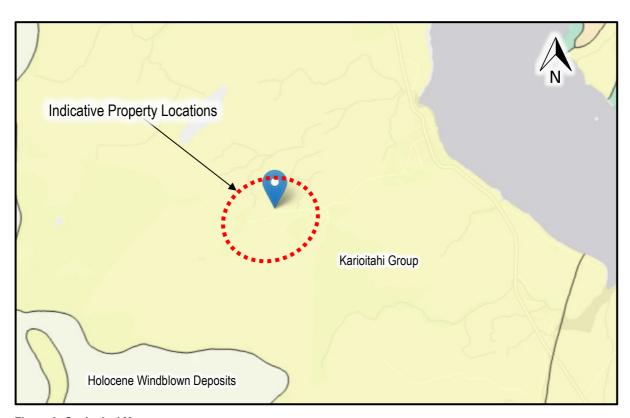
Figure 3: Geological Map (Source: GNS WebMaps Website)

Reference to the GNS New Zealand Geological Web Map 1:250,000 Geology map indicates the site is underlain by dune sand deposits of the Karioitahi Group (See Figure 3). Karioitahi Group soils are described as weakly cemented sand in fixed parabolic dunes with intermixed sand, mud, and peat in interdune deposits.

Loose to cemented sands were encountered during our investigation, with no mud or peat deposits encountered (apart from augerhole AH20, which showed organic-stained sand, drilled within the wetland area).

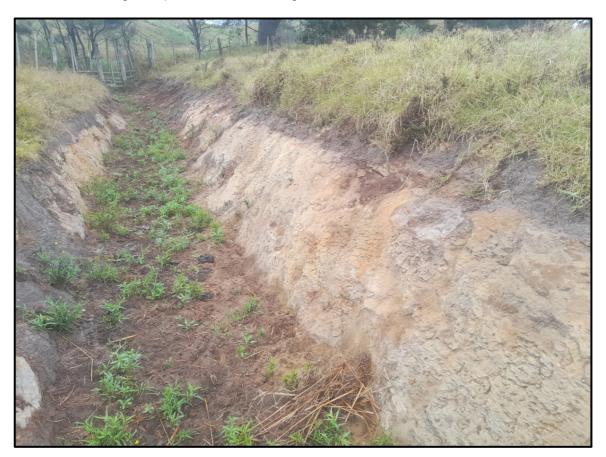
Figure 4: Exposed Sandstone/Heavily-Cemented Sand (Source: S&RC Site Photo – 13 March 2024)

Sandstone/heavily-cemented sand was observed within the excavation face of the main manmade drainage in Option 2 site, refer to Figure 4 below.

Rushes were observed in places, particularly within low/depressed areas. These plants thrive in wet places and generally indicate persistently wet land. Sands generally have good drainage characteristics however due the shallow sandstone/cemented sand (low permeability) surfacewater potentially ponds in low areas.

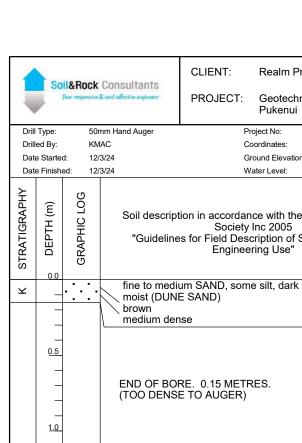
HAND AUGER LOG WITH SCALA NL230102 AH01 - AH20 174 LAMB ROAD 15MARCH24.GPJ S+R_2013.GDT 15/3/24

Realm Property Group Ltd Auger Hole No: AH01 Geotechnical Investigation, 174 Lam Road, Sheet 1 of 1 NL230102 Logged By: JN Shear Vane No - Calibration Date: Ground Elevation: Surface Conditions: Near Level, Sand

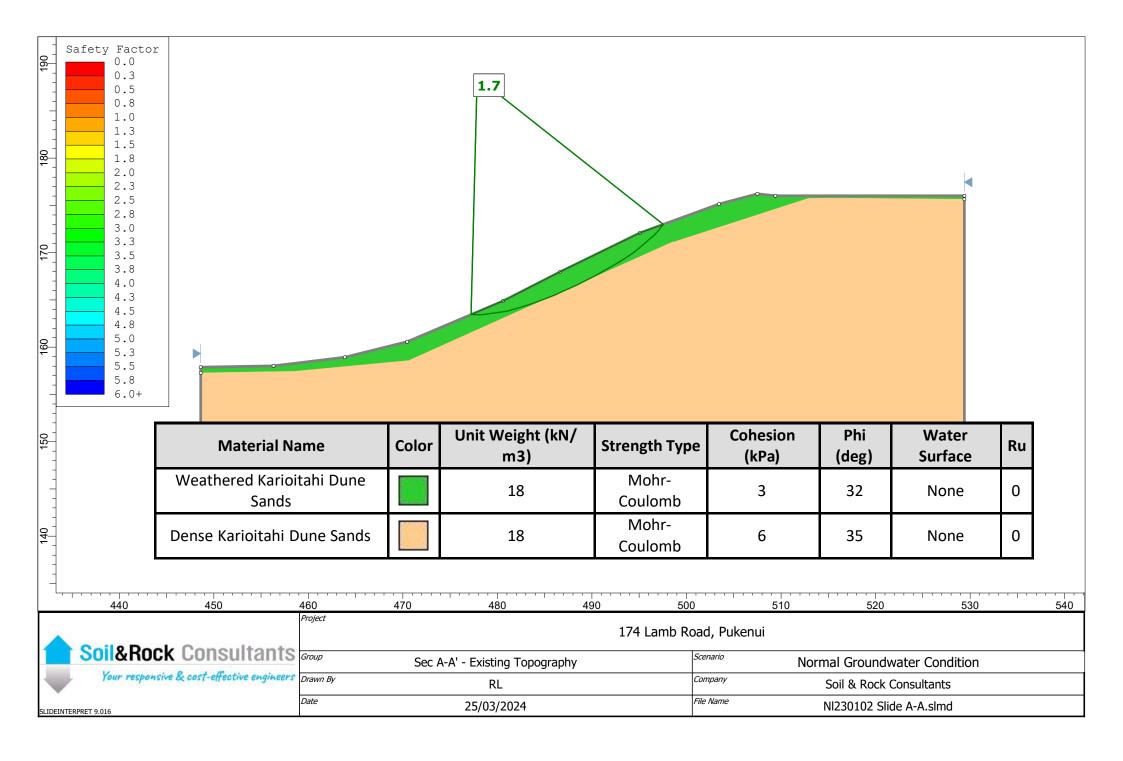
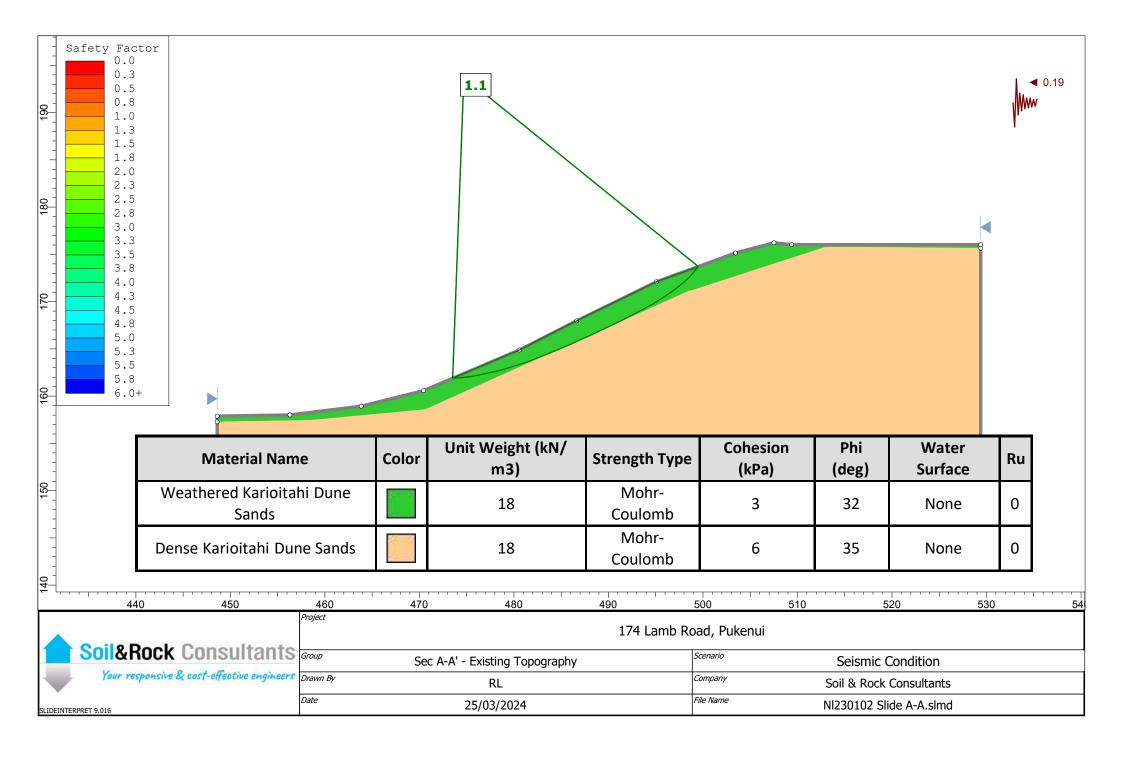
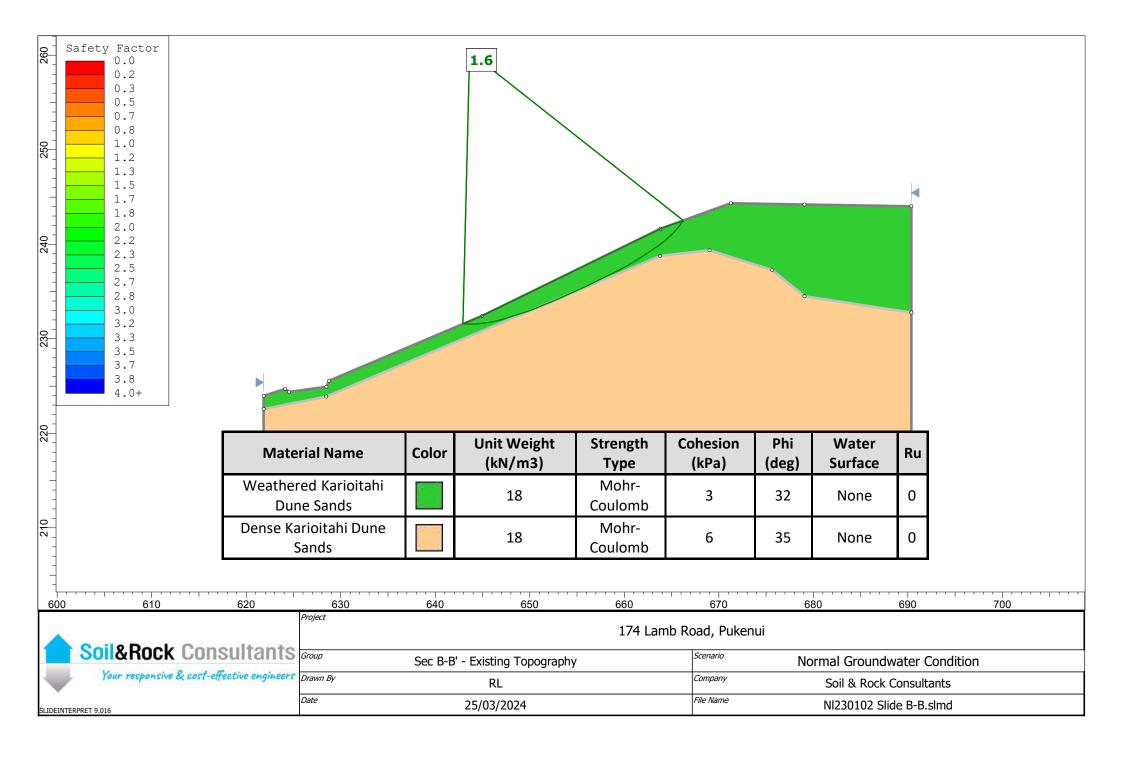
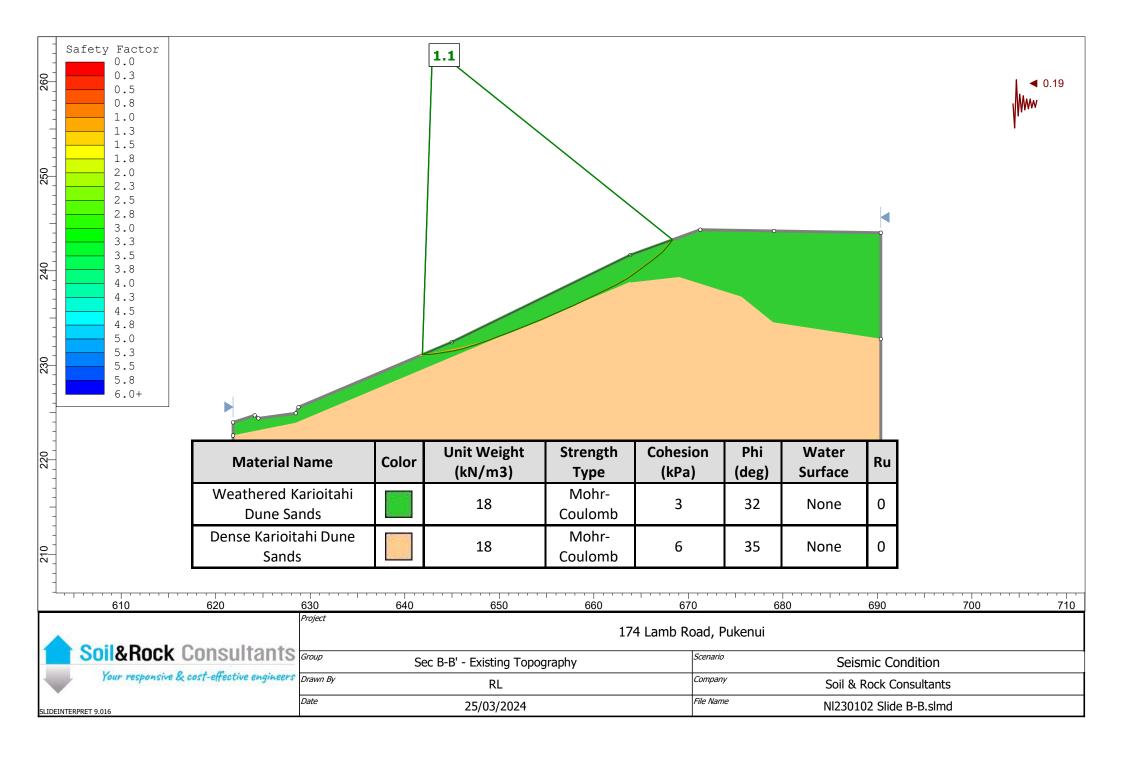
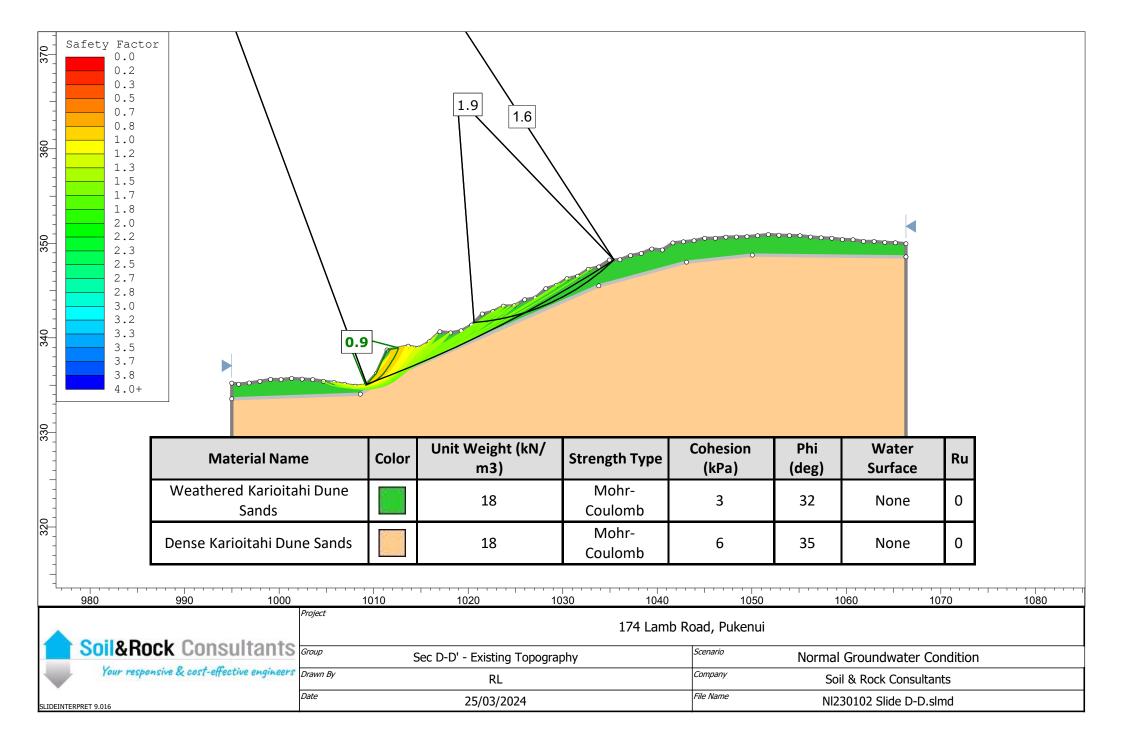
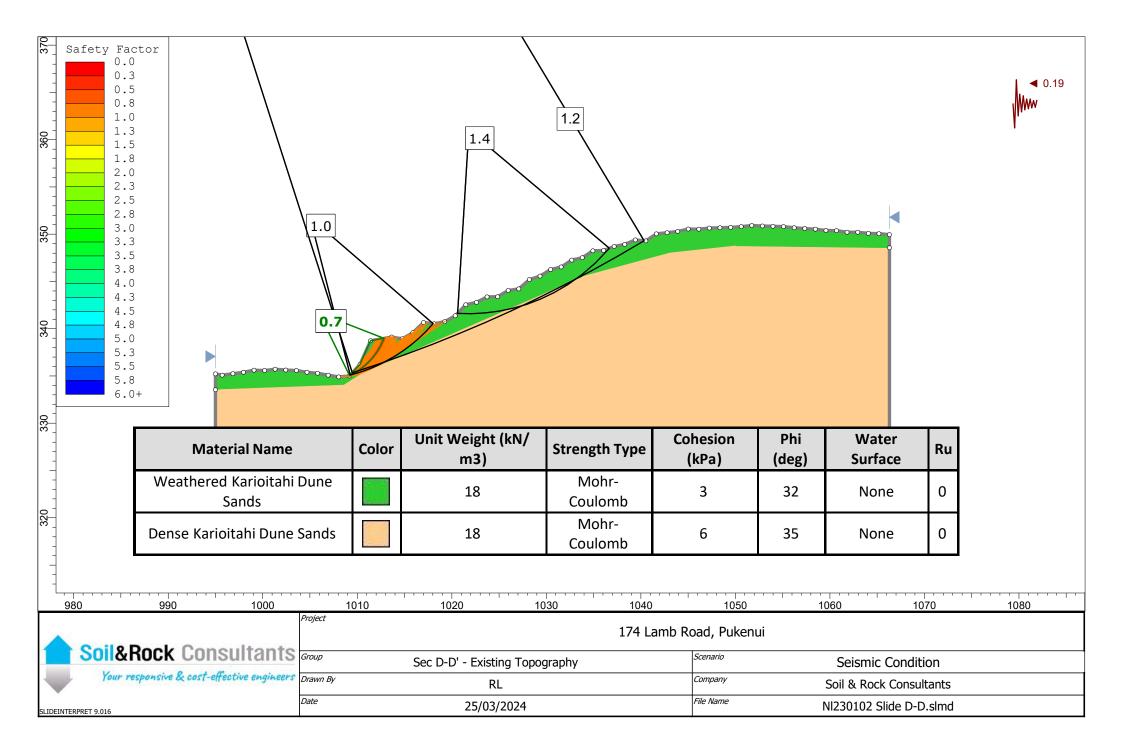
Slope Stability Results

Section	Modelled	Global Factor of platforms at	Compliant			
	Conditions	Required	Calculated			
A-A'	Normal Groundwater	1.5	1.7	Yes		
	Seismic Loading	1.0	1.1	Yes		
B-B'	Normal Groundwater	1.5	1.6	Yes		
	Seismic Loading	1.0	1.1	Yes		
D-D'	Normal Groundwater	1.5	1.6	Yes		
_	Seismic Loading	1.0	>1.0	Yes

We therefore consider the potential building areas (ridge top) to be suitable for future development from a global land stability point of view contingent upon the recommendations of this report being adopted in design and construction.
