2.3 Proposed Development

Figure 2 - Proposed subdivision

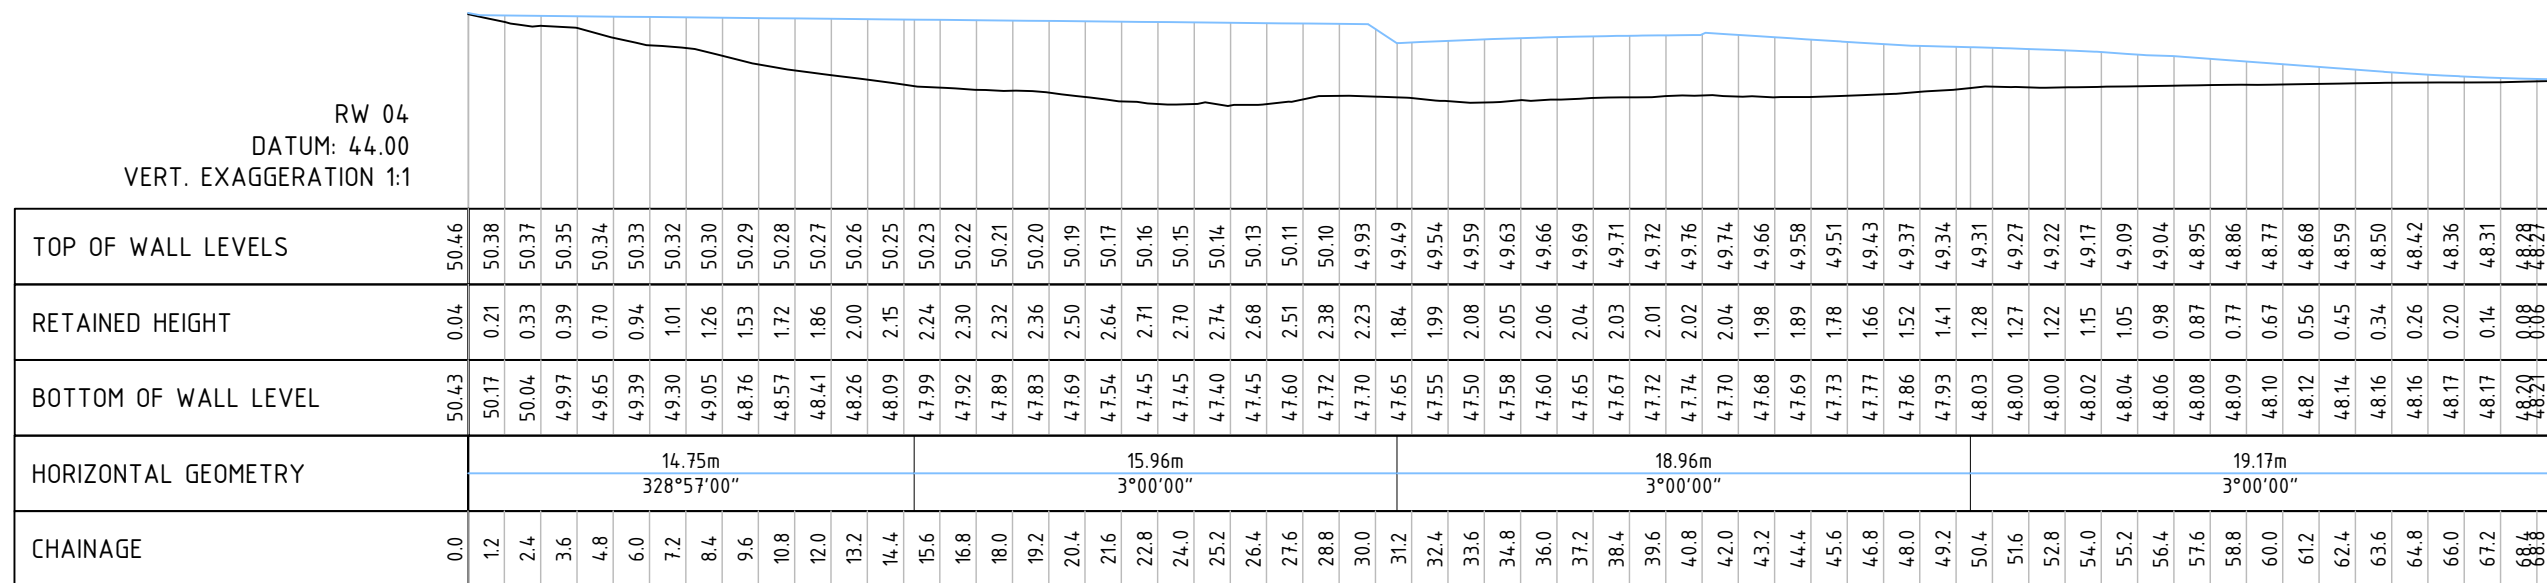
RW 04
DATUM: 44.00
VERT. EXAGGERATION 1:1

The maximum fill thickness within a proposed building lot, as shown on the provided plans, indicates 2.0 m of filling in Lot 10, supported by RW04. Consolidation settlement is estimated to be in the order of 50 mm. We recommend earthworks is completed at least 6 months in advance of building. Alternatively, foundation design can consider the effects of the filling and down drag on the piles and will be subject to specific geotechnical and structural design.

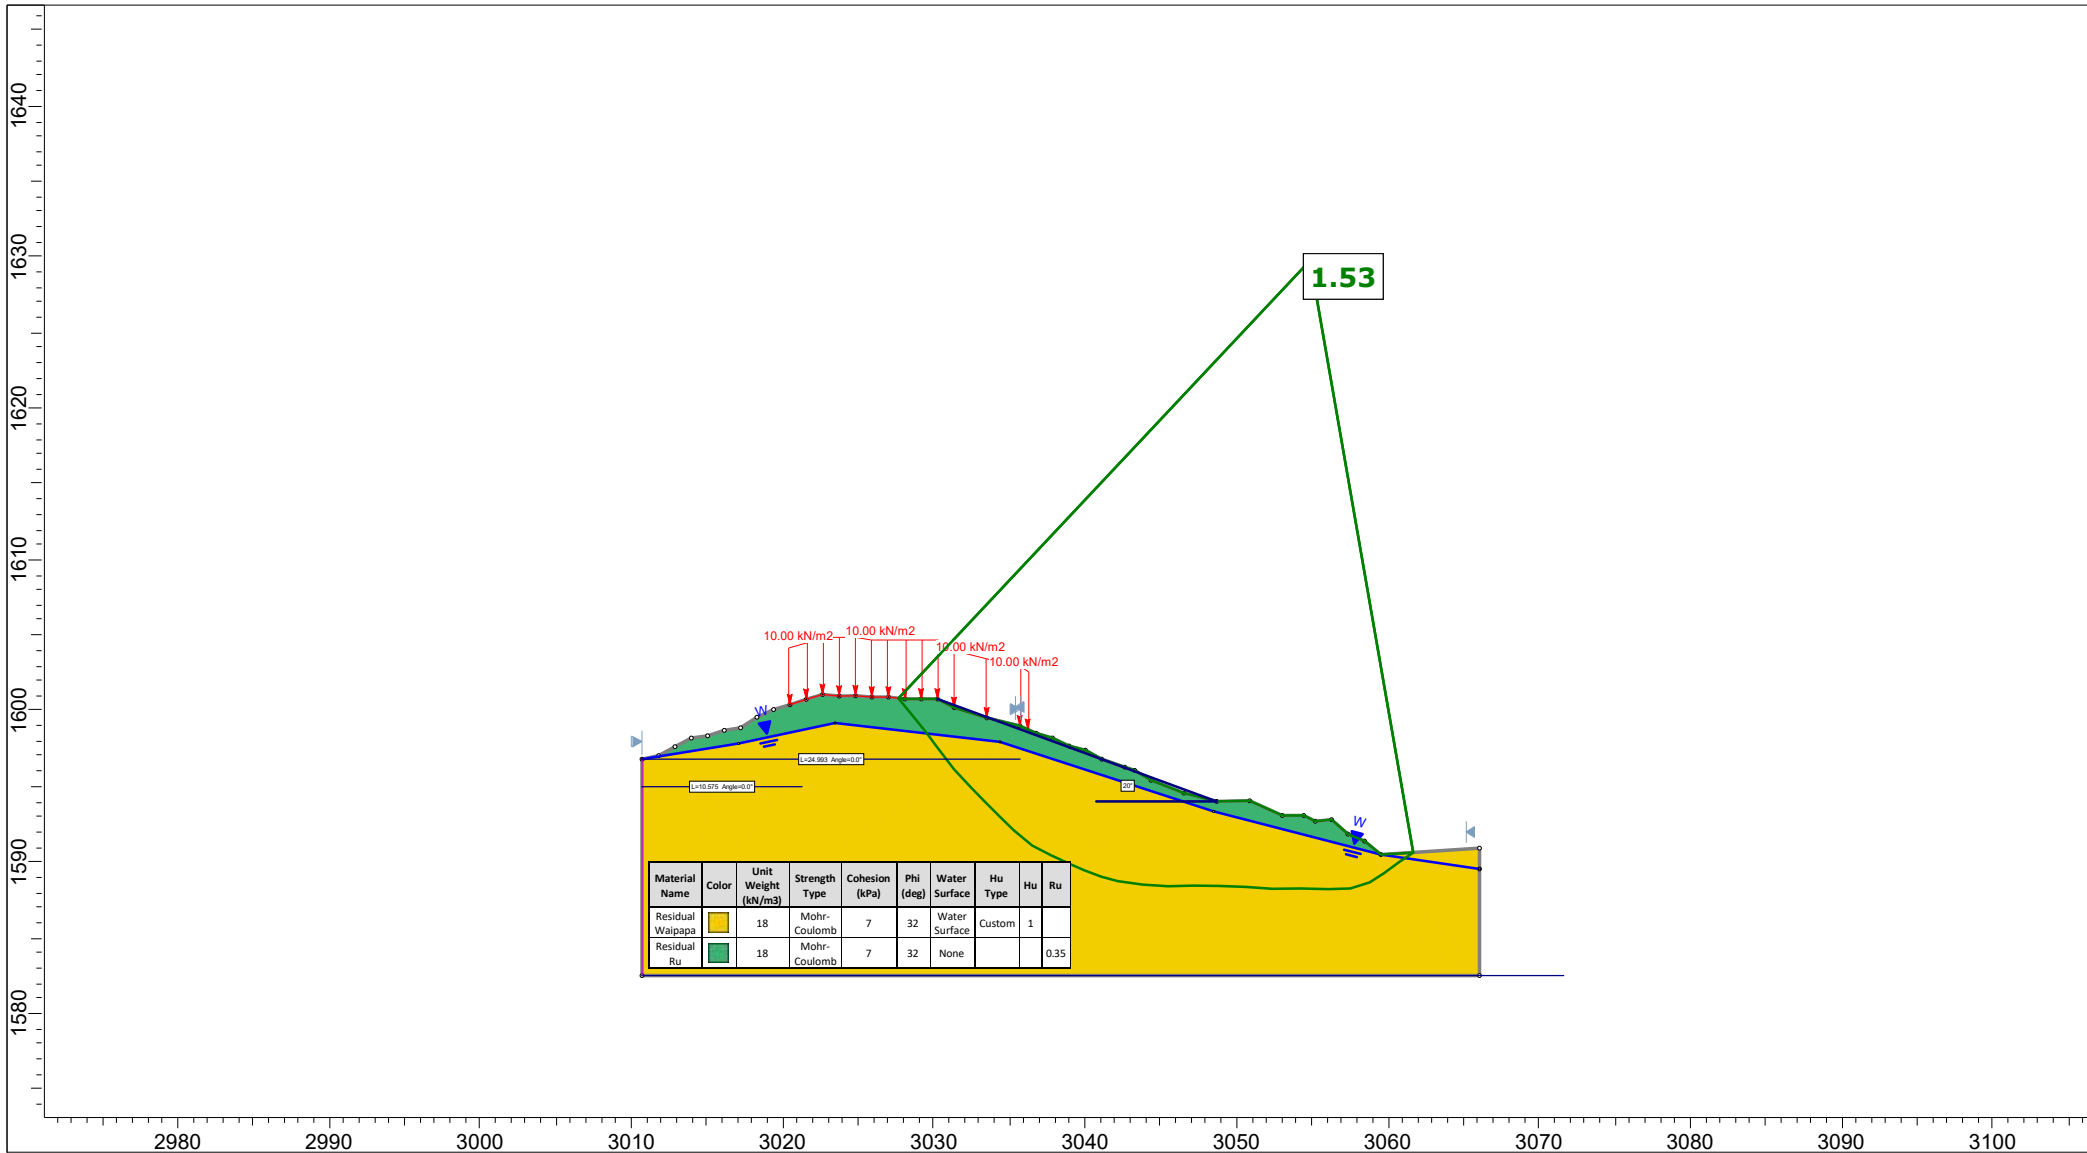
Material Name	Color	Unit Weight (kN/m³)	Strength Type	Cohesion (kPa)	Phi (deg)	Water Surface	Hu Type	Hu	Ru
Residual Waipapa	Yellow	18	Mohr-Coulomb	7	32	Water Surface	Custom	1	
Residual Ru	Green	18	Mohr-Coulomb	7	32	None			0.35

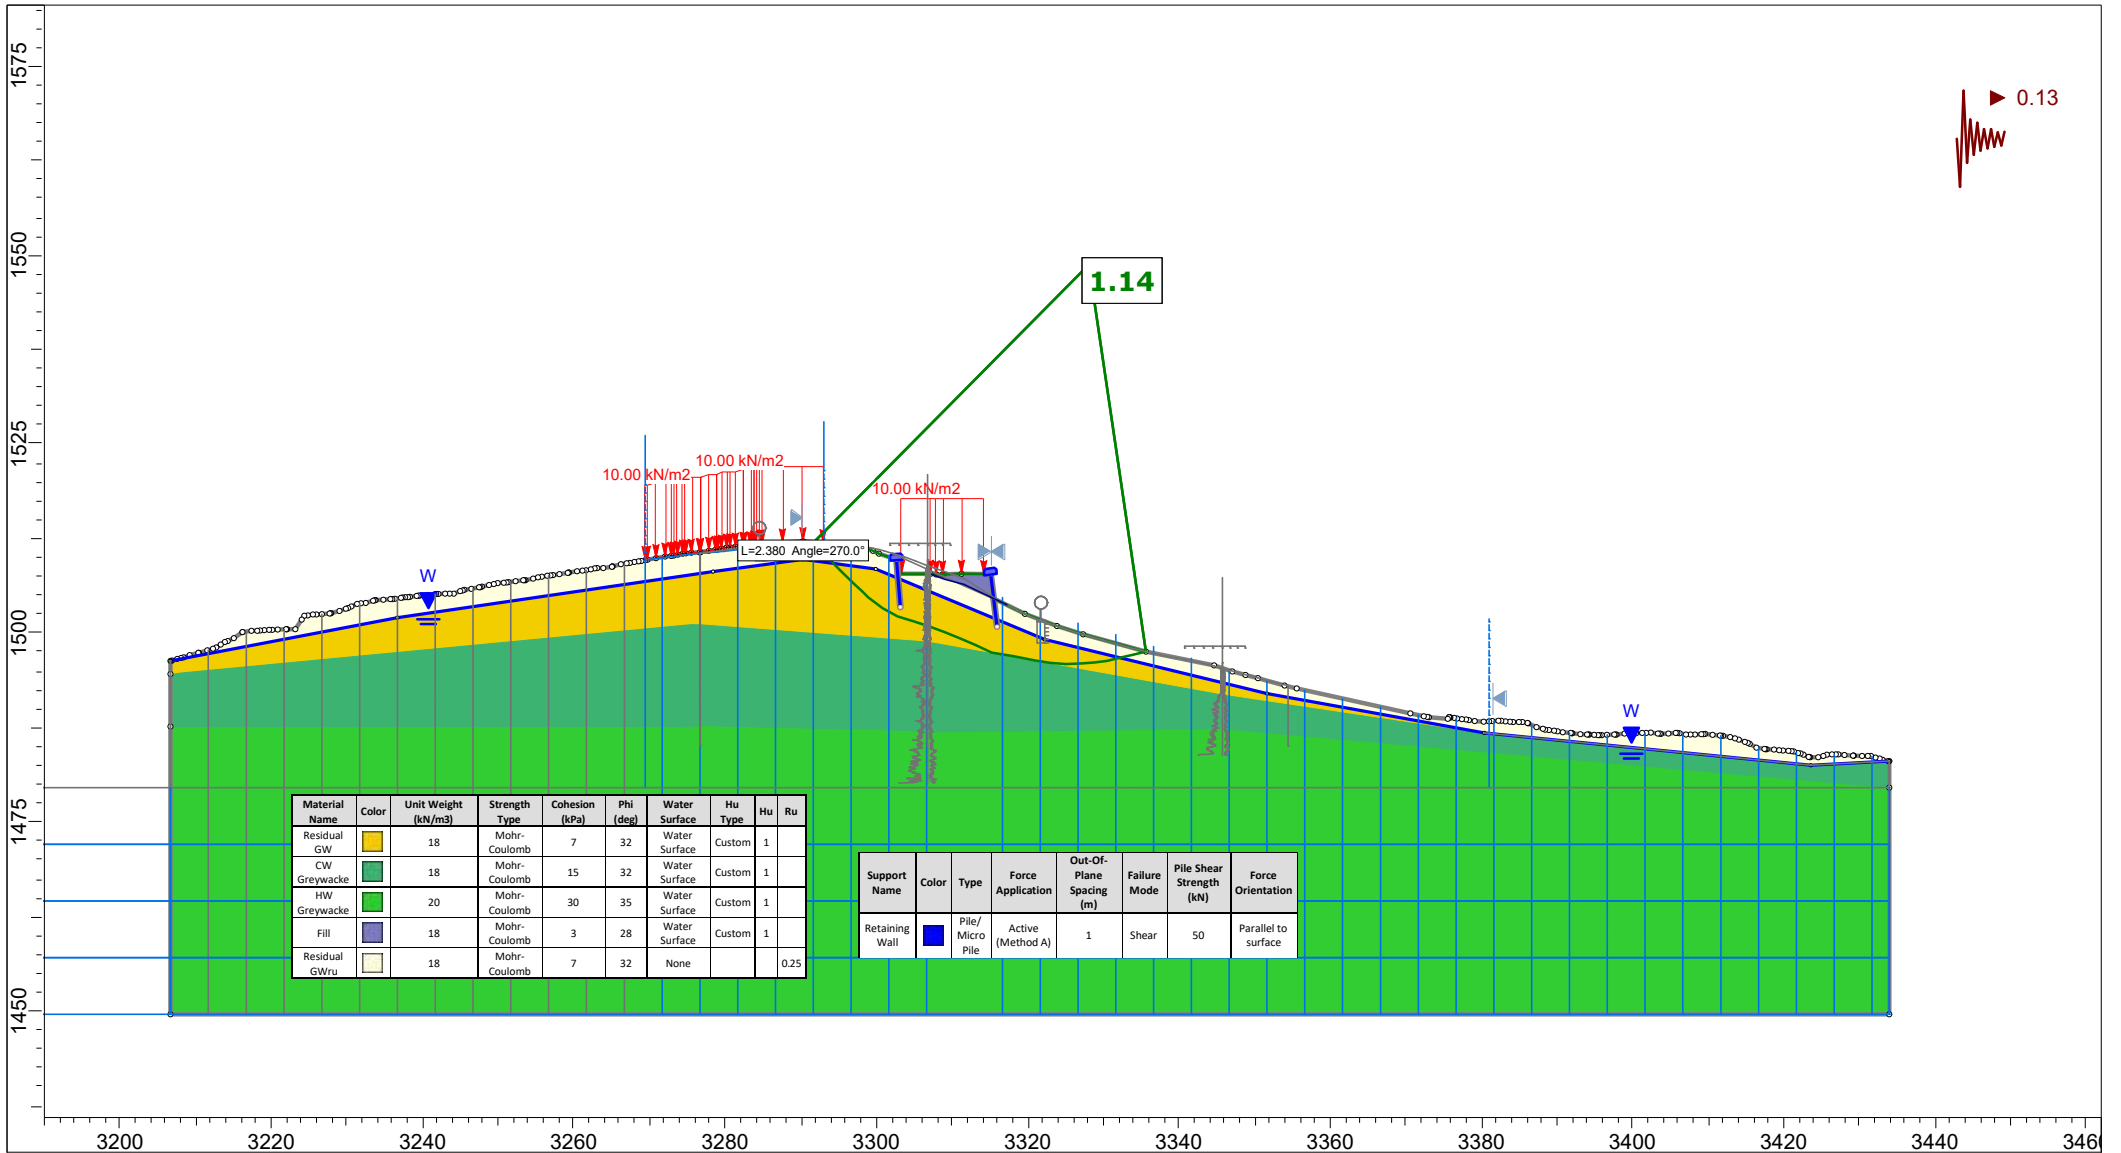
Material Name	Color	Unit Weight (kN/m3)	Strength Type	Cohesion (kPa)	Phi (deg)	Water Surface	Hu Type	Hu	Ru
Residual GW	Yellow	18	Mohr-Coulomb	7	32	Water Surface	Custom	1	
CW Greywacke	Light Green	18	Mohr-Coulomb	15	32	Water Surface	Custom	1	
HW Greywacke	Dark Green	20	Mohr-Coulomb	30	35	Water Surface	Custom	1	
Fill	Purple	18	Mohr-Coulomb	3	28	Water Surface	Custom	1	
Residual GWru	Light Yellow	18	Mohr-Coulomb	7	32	None			0.25

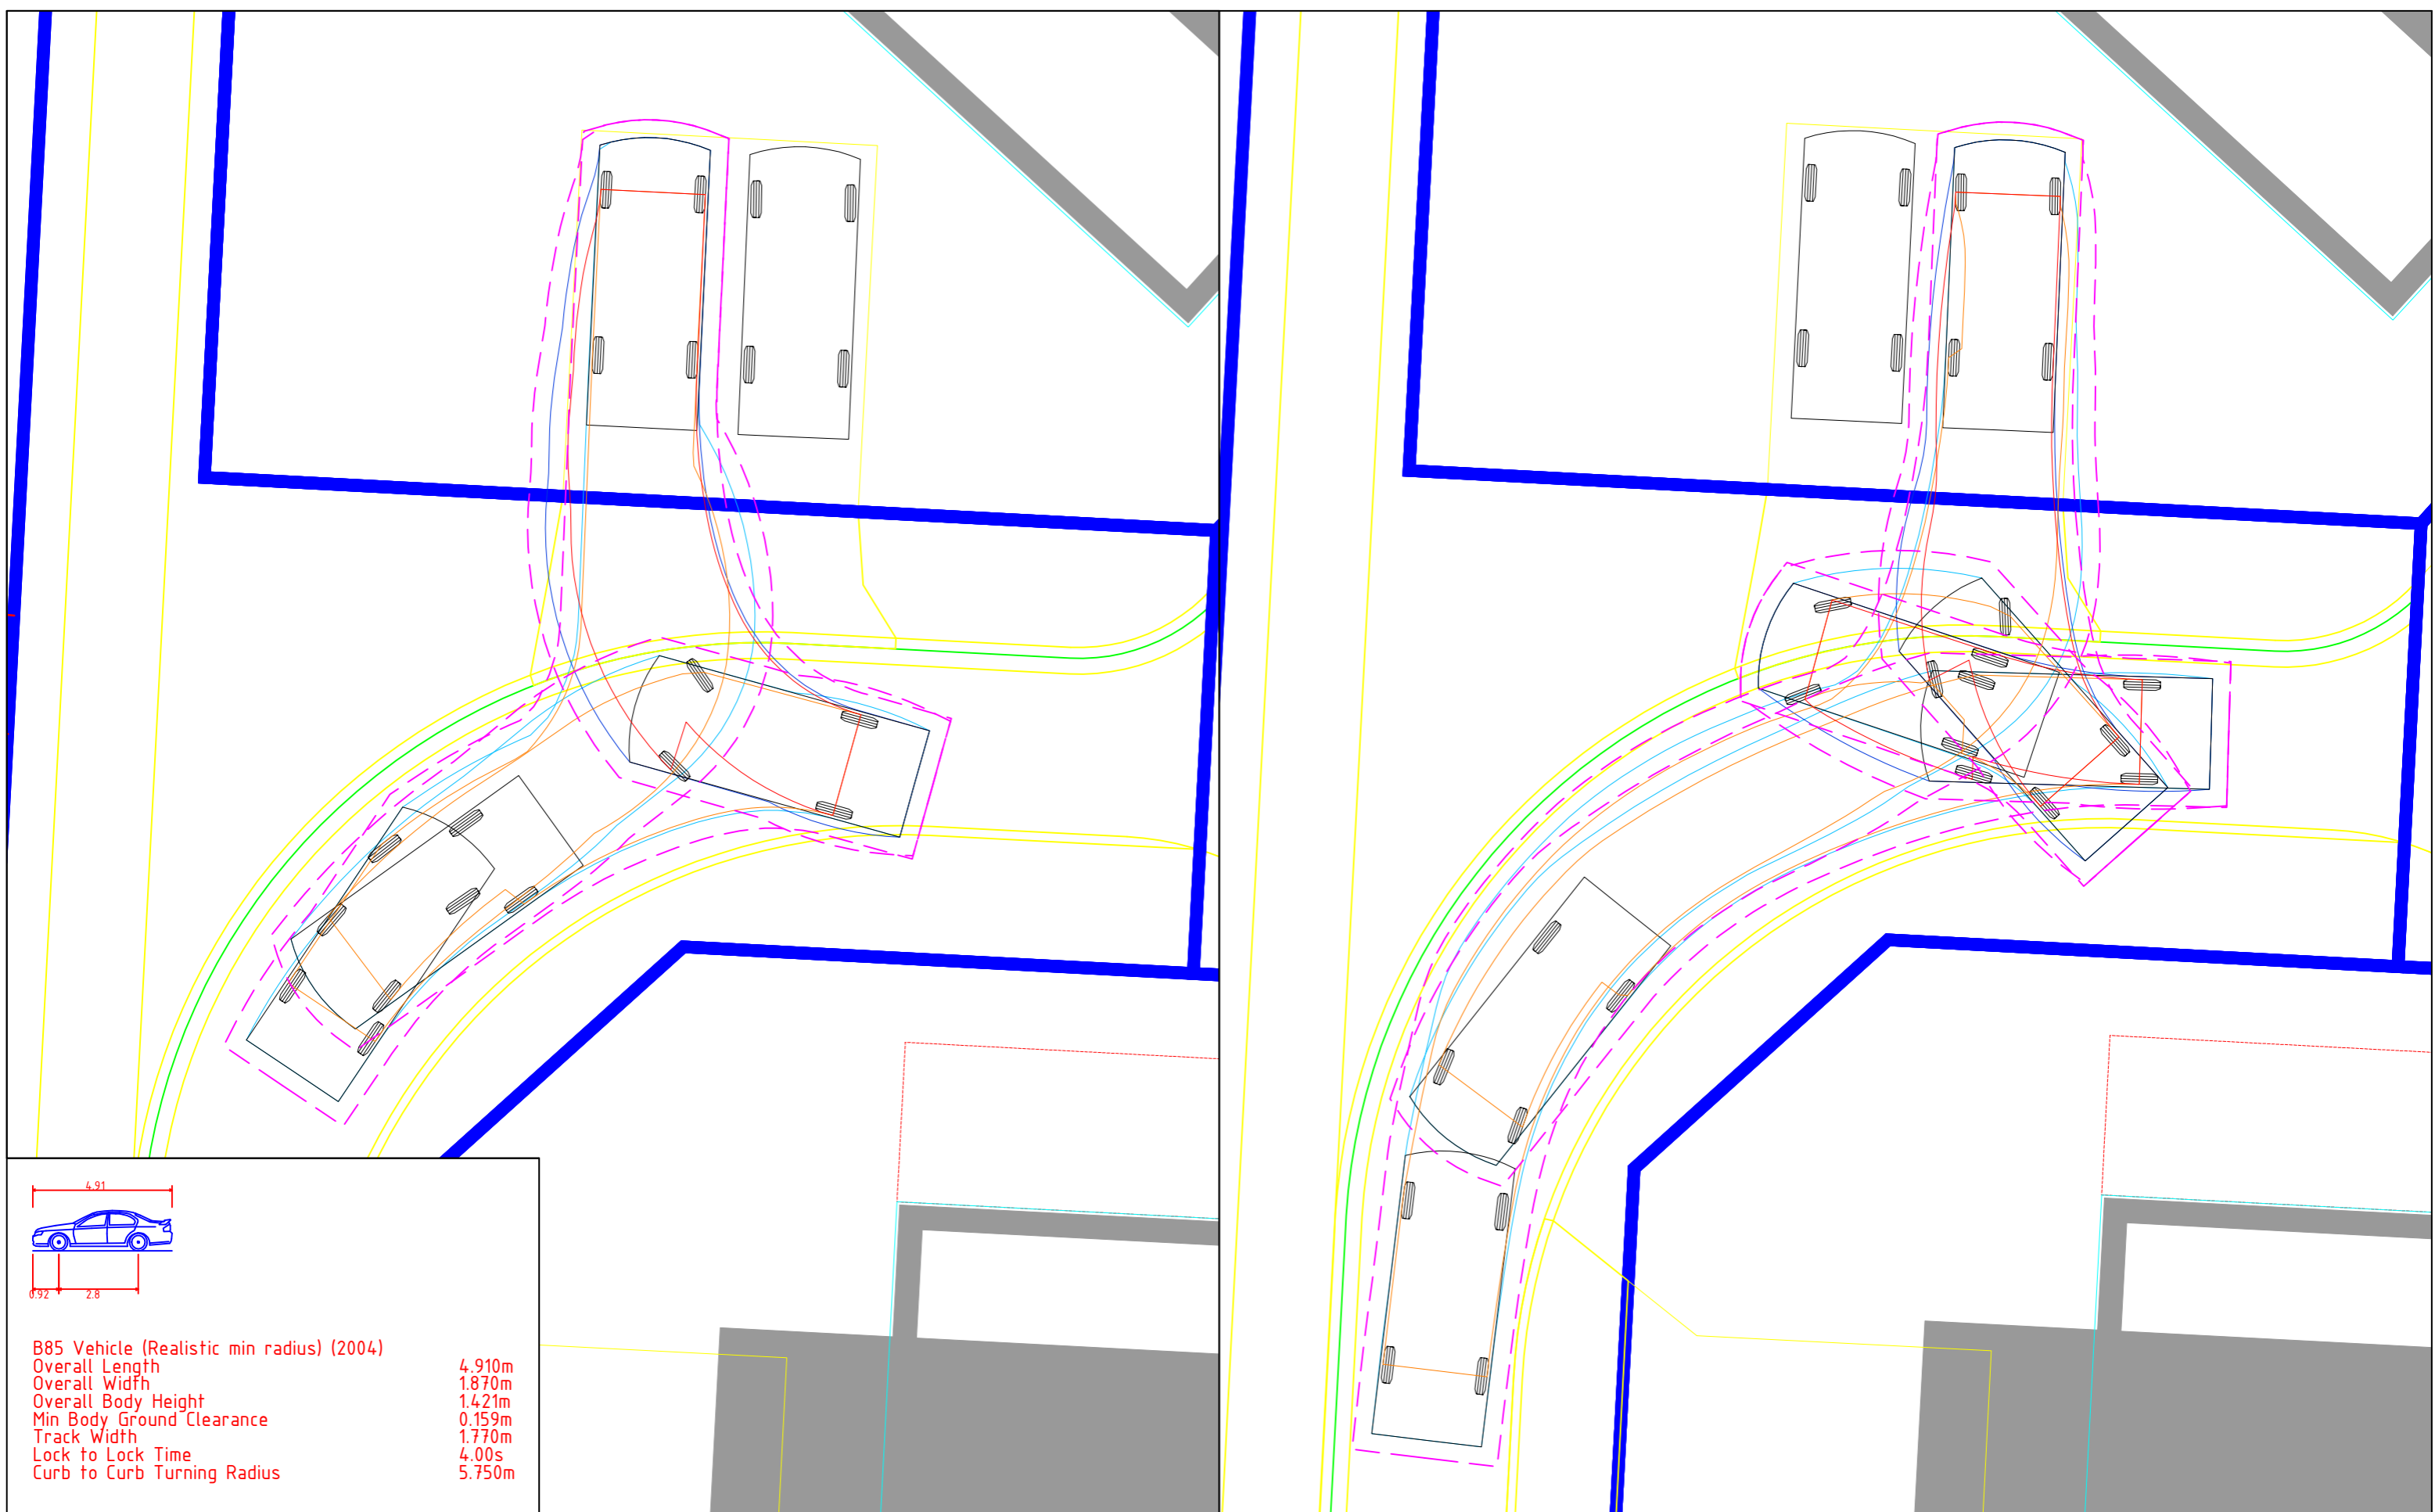
B85 Vehicle (Realistic min radius) (2004)
 Overall Length 4.910m
 Overall Width 1.870m
 Overall Body Height 1.421m
 Min Body Ground Clearance 0.159m
 Track Width 1.770m
 Lock to Lock Time 4.00s
 Curb to Curb Turning Radius 5.750m

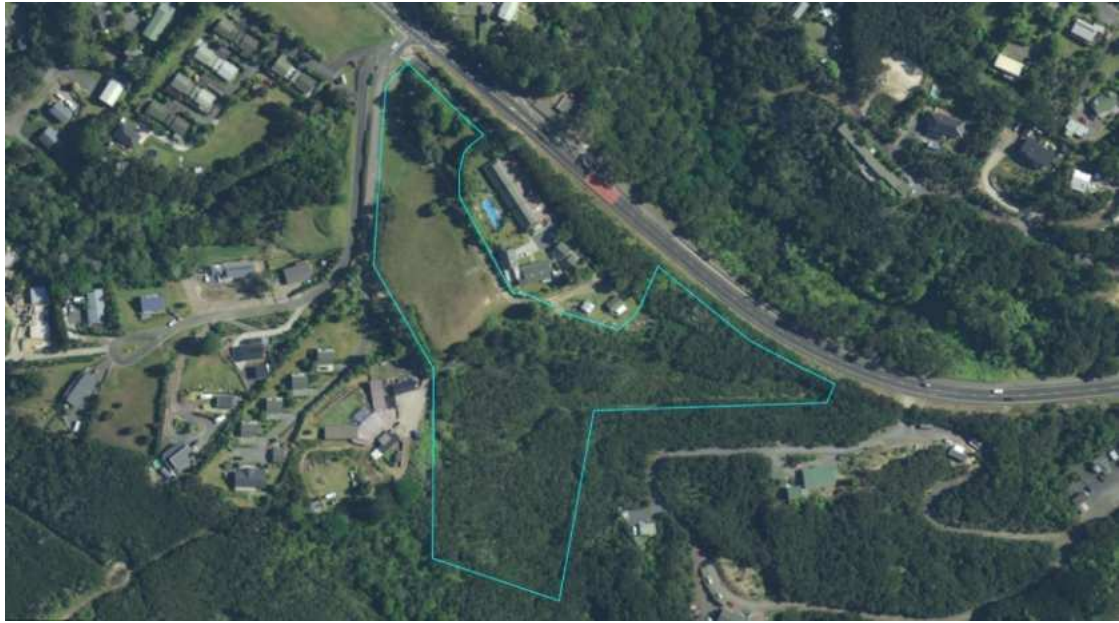
Fig 1: The site property boundary overlaid on an aerial photo circa 2023/2024.

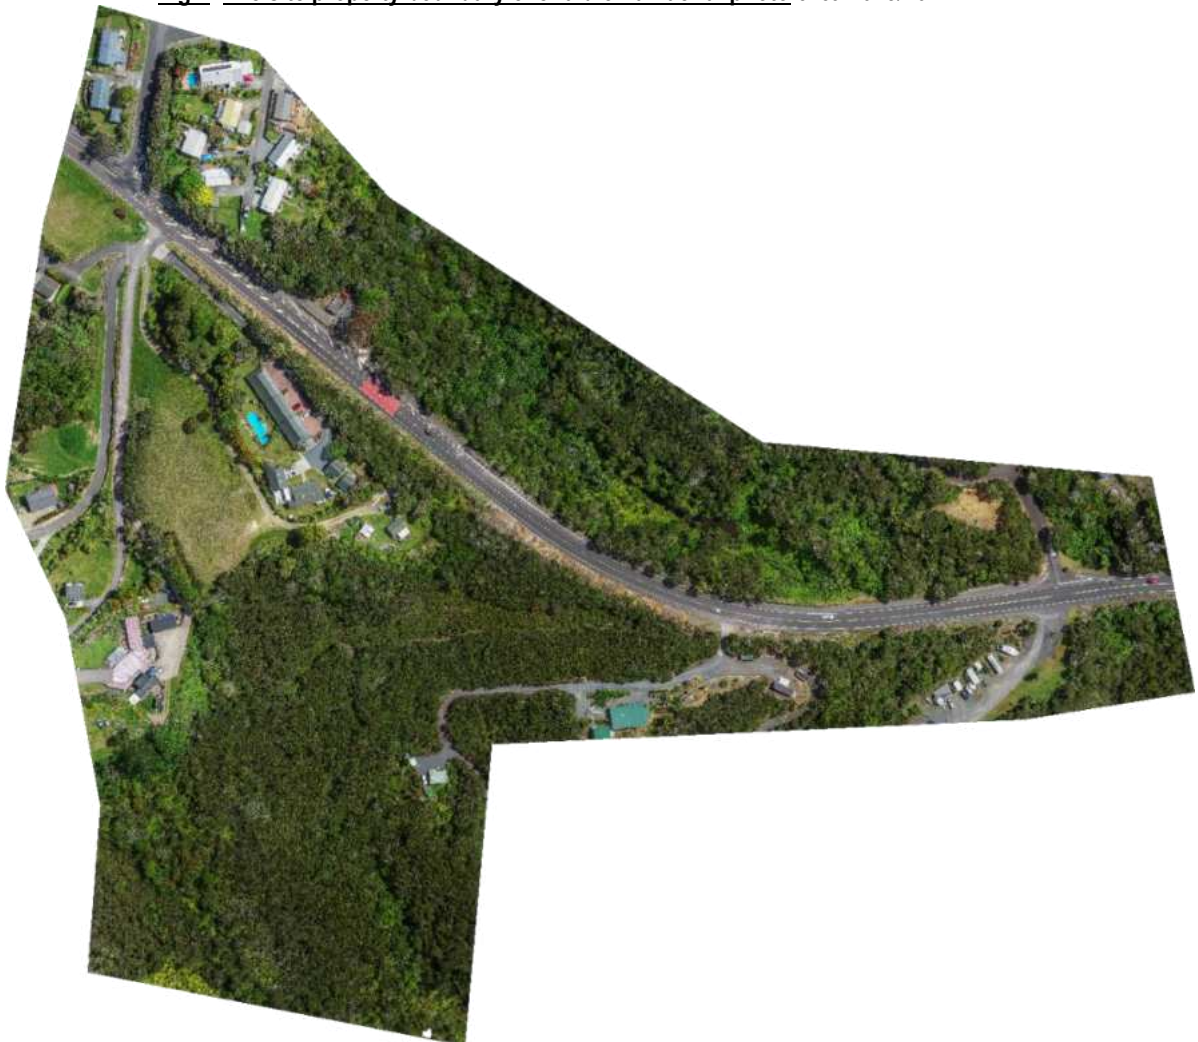
Fig 2: Current drone aerial coverage of the site (20 November 2024). This is the clearest image of the existing bush canopy that is currently available.

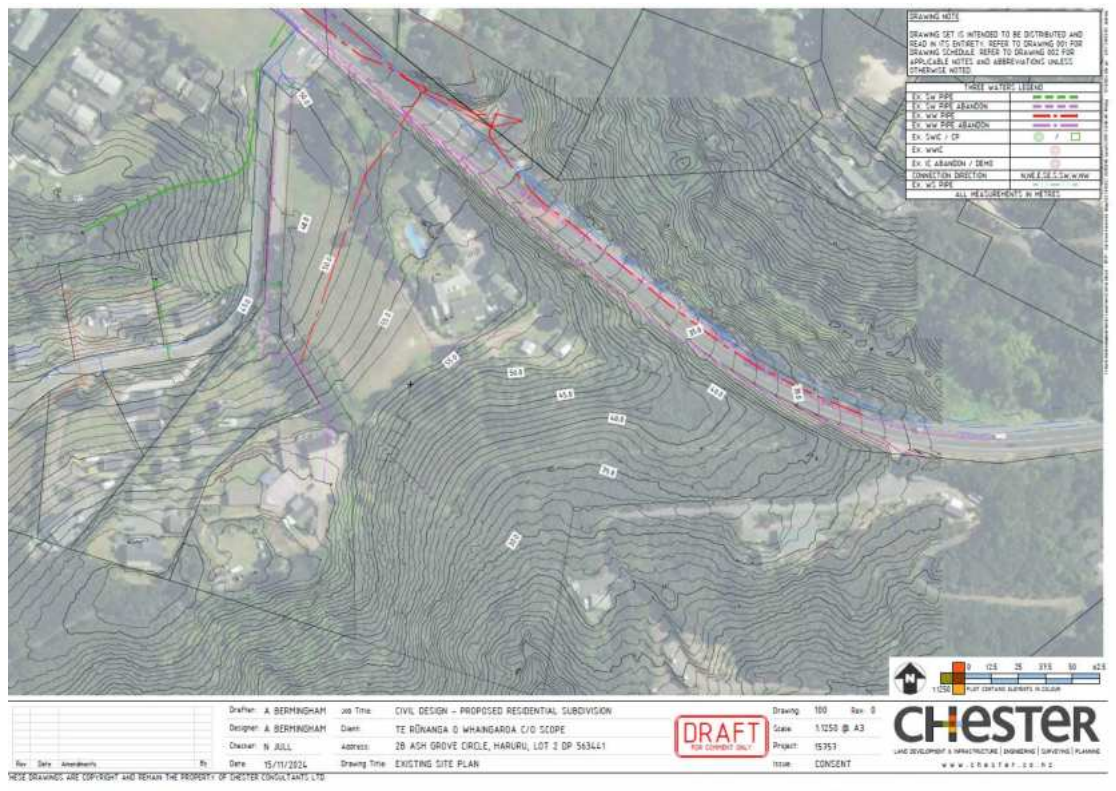
Fig 3: The existing site. Note 1 metre contours over the site and adjoining areas.

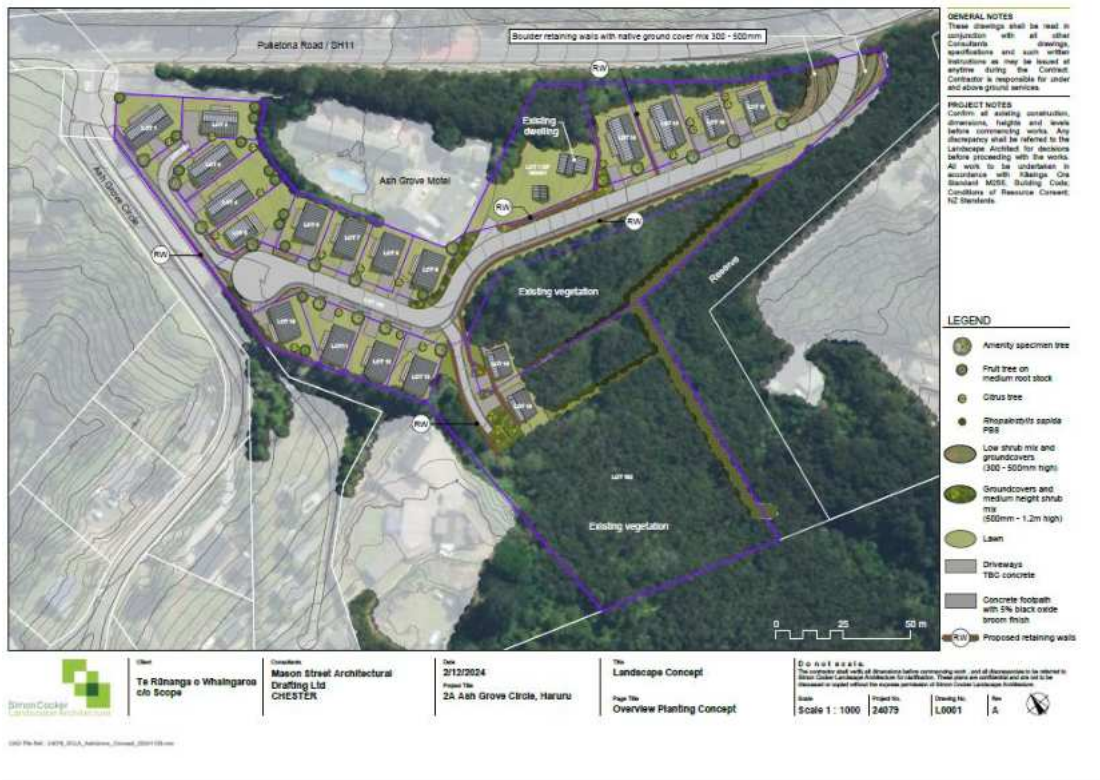
Fig 6: Proposed landscape plan includes footprint of the 19 houses to be built for rental. The areas of retained bush are highlighted

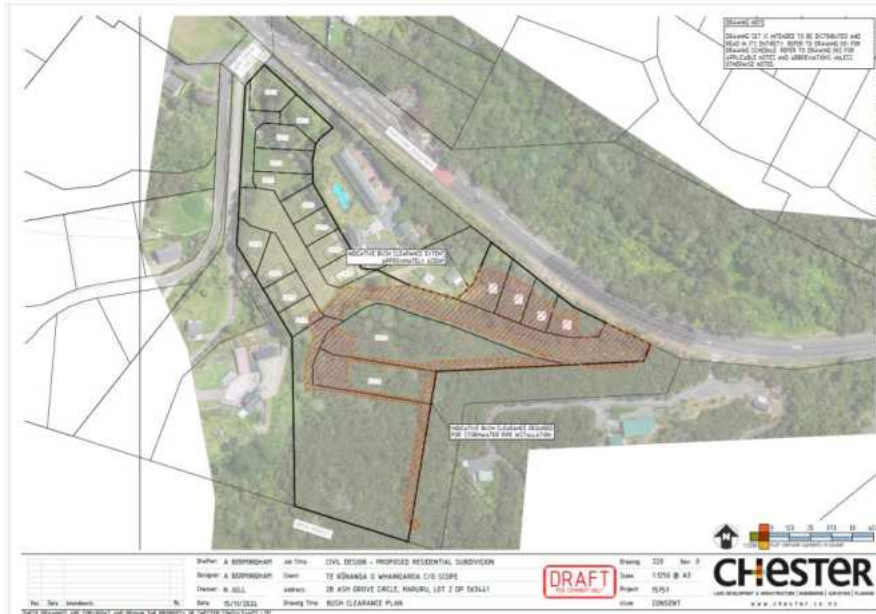
Fig 8: Bush clearance plan. Indicative bush clearance extent is shown in orange hatch. Note: Lots 1-13 have existing grass cover. The entire retained bush area is to be enhanced through the removal of invasive exotic species, pest weeds, dead / dying / unhealthy and fallen Manuka / Kanuka and other highly combustible matter.

Limited bush clearance is required for the houses on lots 18 & 19. Also, the stormwater easements on these two lots are to be cleared of vegetation for the installation of the stormwater system (refer to *Figure 8: "Bush clearance plan"*). The cleared easement areas are to be left to successfully regenerate naturally. Otherwise, the existing indigenous vegetation cover on these two lots, which is down slope of the proposed earthworks elsewhere on the subdivision, is to be retained.

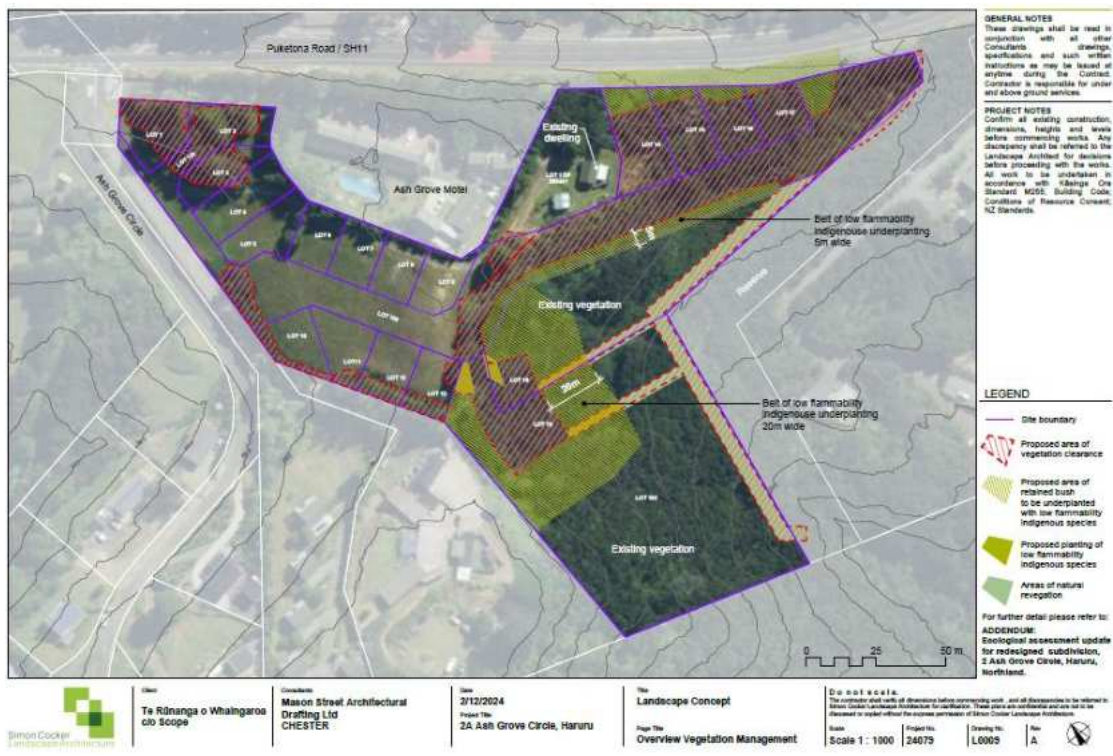
Fig 9: Areas of bush clearance (red hatch) / bush edge understory planting (mid green) are shown on this overview vegetation management plan. Part of the retained bush is to be enhanced to form a ‘green belt bush edge buffer zone’ through understory planting of low flammability indigenous species. This includes: **1.** Within the first 5m back from the northern edge of the bush clearance line below the main access road. Where retained bush adjoins the houses on Lots 18 & 19, the planting will extend through the bush area within 20m of the houses, to reduce fire risk. **2.** Within the bush area to be retained adjoining lot 13 (i.e. to the west of the access road to lots 18 & 19). **3.** Within the bush to be retained on the northern portions of lots 14 to 17 (adjoining Puketona Road). **Note:** The strips cleared for the installation of stormwater pipes are to be left to regenerate naturally.

The understory planting of low flammability indigenous species is to be carried out where indicated in *Figure 9: "Areas of bush clearance / bush edge understory planting"*. This planting is also to enhance bush edge protection. The low flammability broadleaf species are to be planted within retained bush areas to a depth of 20 metres back from any adjoining houses. For example, on lots 18 & 19.

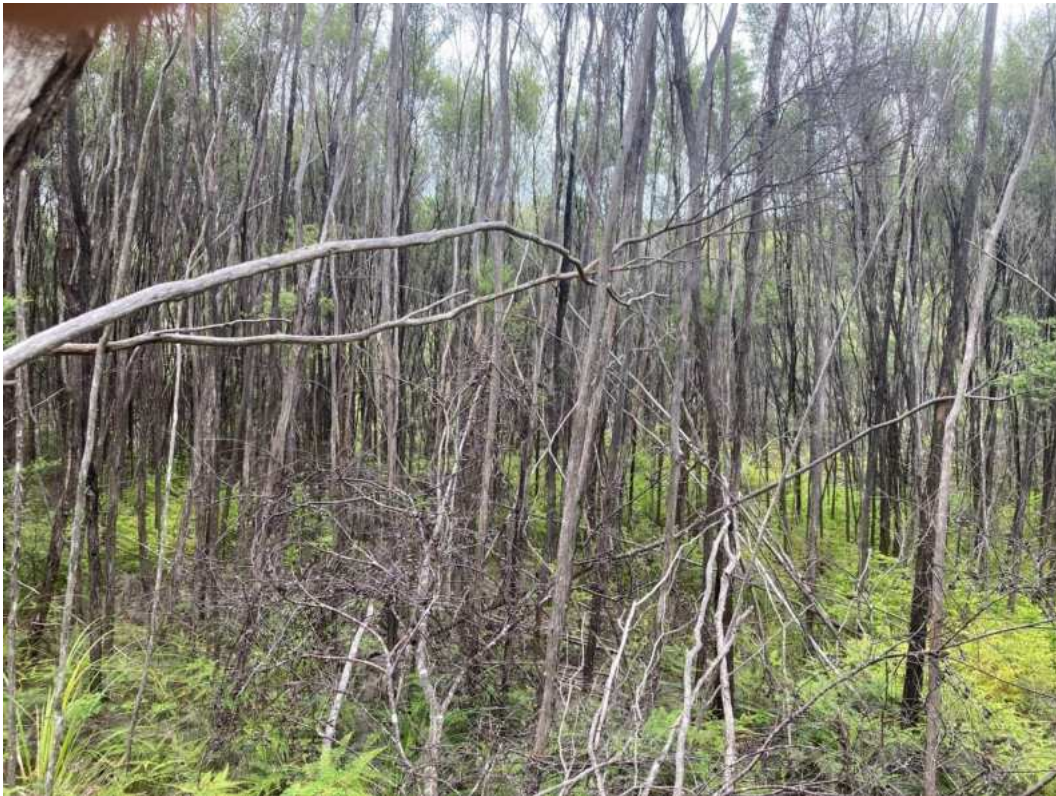
Fig 11: The pioneering species, Manuka / Kanuka (approximately 15-20 years old) have reached the end of their growth cycle, with indigenous broadleaf species having failed to colonise the subcanopy areas. (Refer to Fig 4 in the 2021 report). There is no natural indigenous regeneration taking place under the bush canopy except for bracken and groundcover. Photo 1 November 2024.

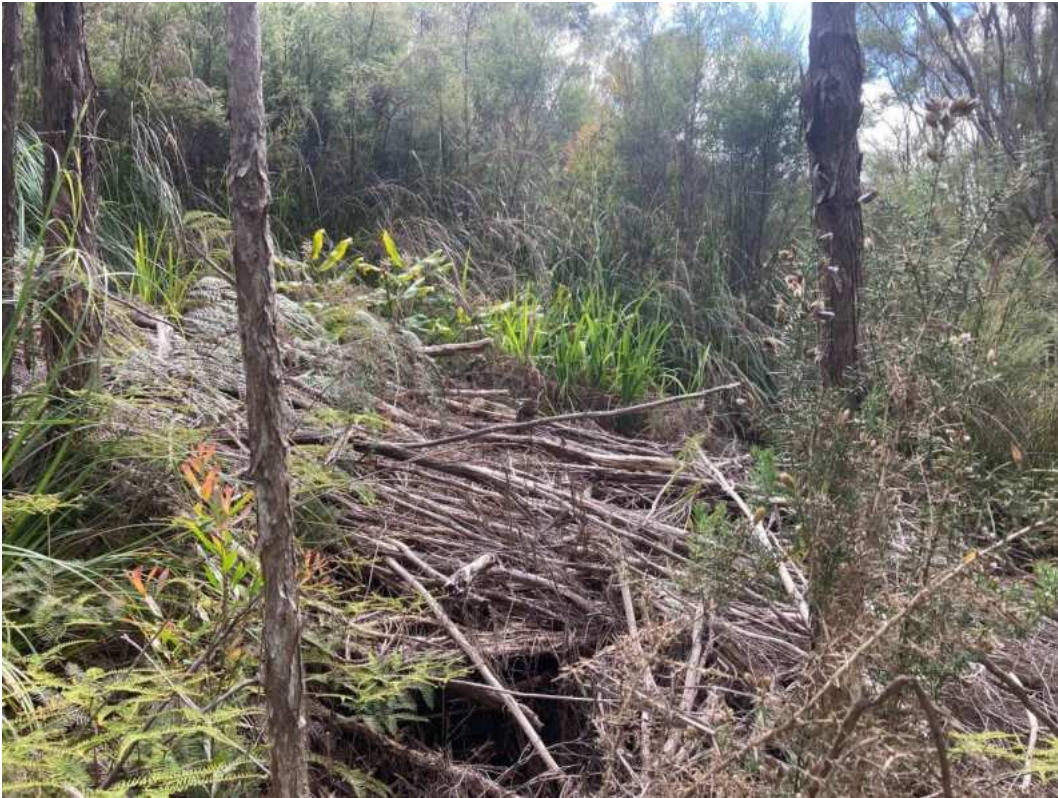
Fig 12: The piles of fallen Manuka / Kanuka after around four years have not broken down. Photo 1 November 2024.

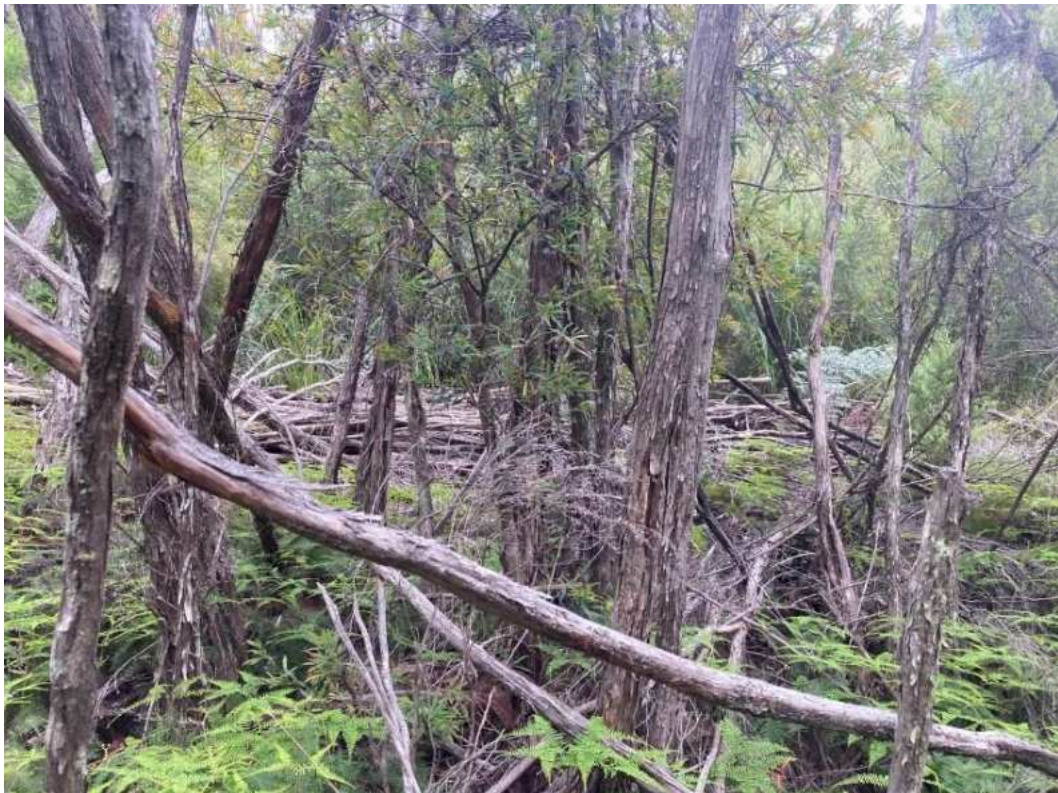
Fig 13: A further example of stacks of Manuka / Kanuka stems that have remained in place over the past four years or so, with little to no further deterioration / decomposition. Photo 1 November 2024.

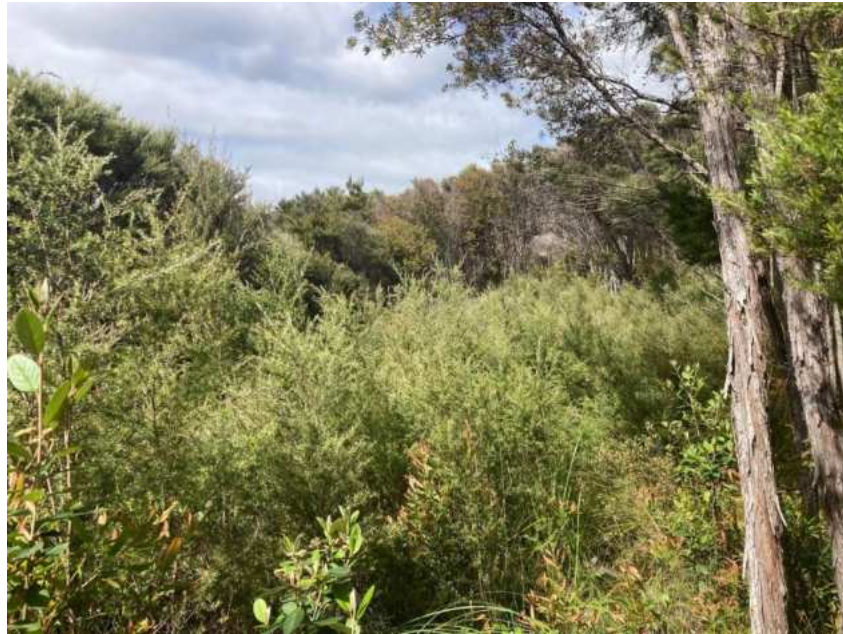
Fig 14: Regeneration in the areas that were originally cleared for access is remarkable after around four years. The coverage is predominately Manuka. The regrowth, which is around 2 metres tall, is healthy and dense. This illustrates that any areas that are to be temporarily completely cleared e.g. for the installation of storm water pipes etc., can be left to regenerate naturally. Photo 1 November 2024. Refer Fig 5 in 2021 report.

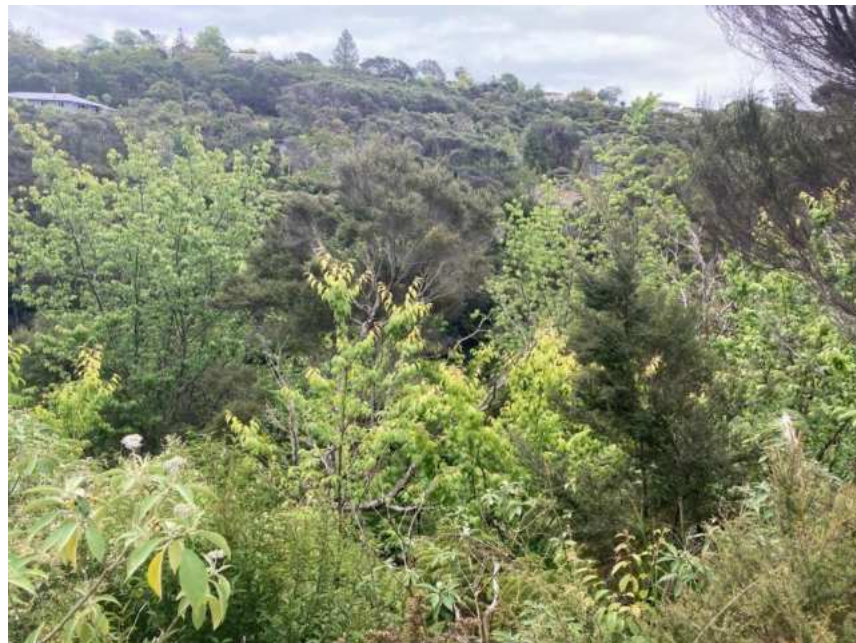
Fig 15: This section of nearby bush (on the opposite side of Puketona Road) is a good illustration of a forest of invasive and exotic species similar to those also becoming established in the Ash Grove property. Photo 1 November 2024.

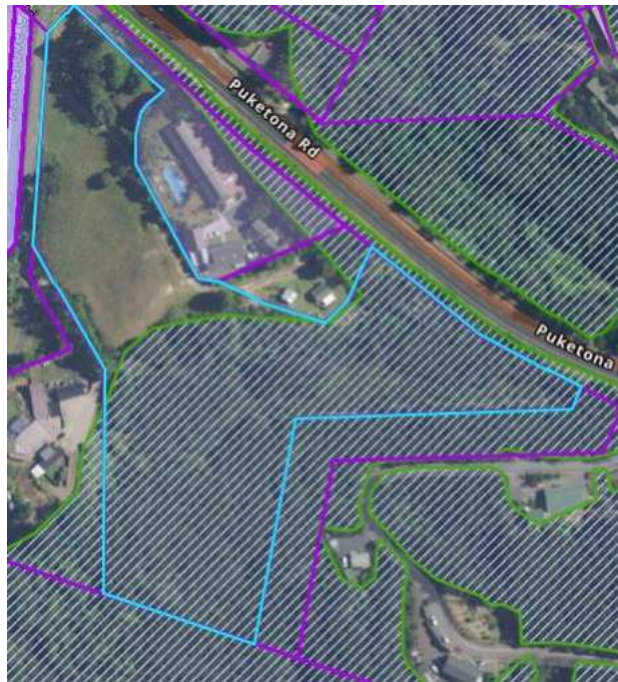
Sometime after the original consent application was approved in March 2021, part of the site was designated as a Significant Natural Area (SNA). The plan below shows the outline of the project boundary in blue, with the area of the site that was designated as SNA cross hatched.
