Assessment of Environmental Effects

One dwelling

25 Wihongi Street, Kaikohe

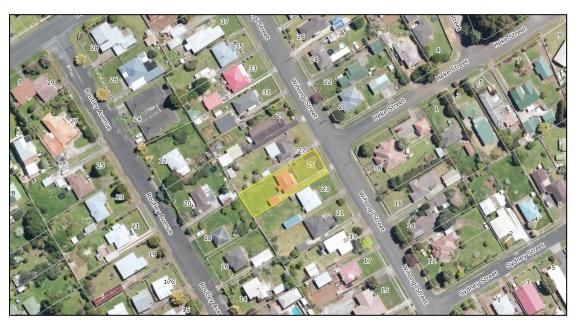
2.1 Description of Site

Figure 1: Aerial map of application (outlined in yellow). Source: GRIP Mapping

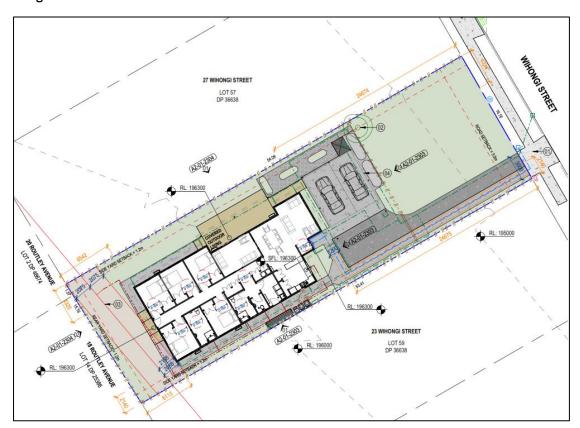
Figure 2: Site plan. Source: Appendix 2: Architectural Drawings.

It is proposed to construct one, five-bedroom single storey dwelling. The site layout is shown in **Figure 2** below.

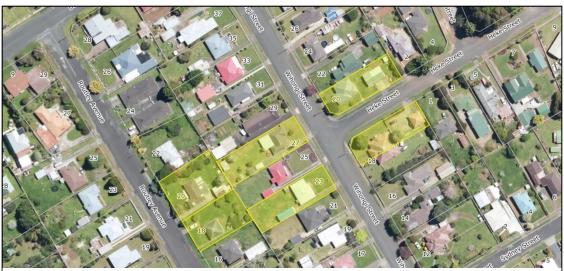
Importantly, for the purposes of Step 3, positive effects and any effects on persons owning or occupying the subject site and any adjacent land must be excluded from consideration. The land which must be excluded is shown in **Figure 3** below.

Figure 3: Adjacent properties to be excluded from s95A consideration (outlined yellow) in relation to the application ite.

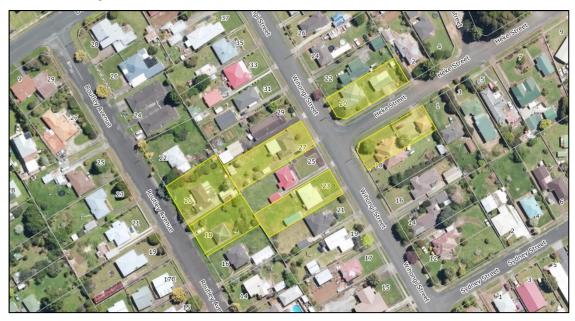
In the following assessment, particular regard was had to those owners and occupiers of land identified in **Figure 4** below.

Figure 4: Adjacent properties to be considered in the s95E (outlined in yellow) in relation to the application site.

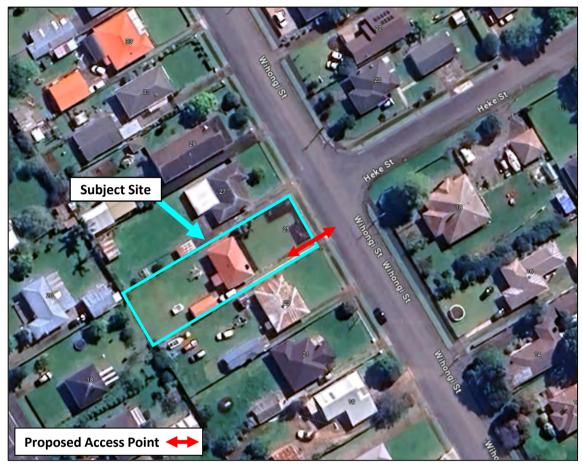
The proposal consists of constructing one \times five-bedroom dwelling with two parking spaces, accessing onto Wihongi Street. The site is zoned as General Residential under the Far North District Council (FNDC) Operative District Plan. **Figure 1** displays the subject site location and proposed access point.

Figure 1: Site Location
Image Source: Google Maps

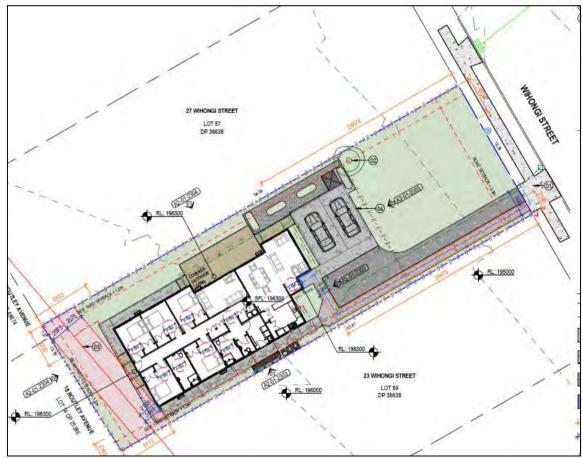
Figure 2: Proposed Site Plan Image Source: Young + Richards

The proposal consists of constructing one \times five-bedroom dwelling with two parking spaces, accessing onto Wihongi Street. The plan used for the basis of this assessment is shown in **Figure 2**.

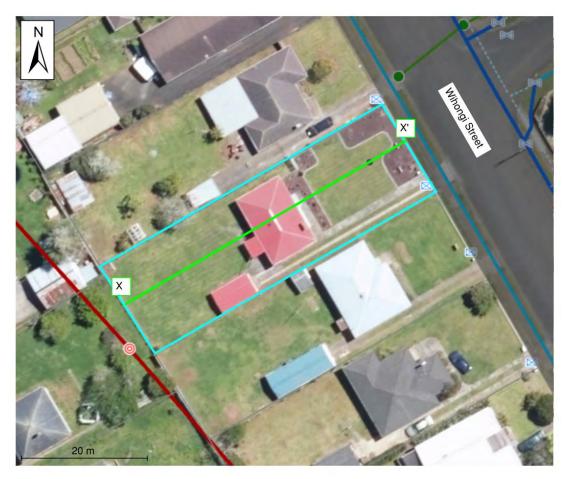
The house redevelopment is located in Kaikohe, at 25 Wihongi Street. The site is being uplifted from a single dwelling to a single dwelling on a plot covering an area of 900m². The site has predominately flat topography and is located 565 m west from the nearest waterway (Far North District Council, 2024). A review of historic aerial imagery shows the land was previously used for agricultural purposes. Residential development started in the area between as early as 1950 (Retrolens, 2016). The existing dwelling was built in 1952 (Kāinga Ora, 2023). The site location of the development is presented in Figure 1.

Figure 1: Site location plan

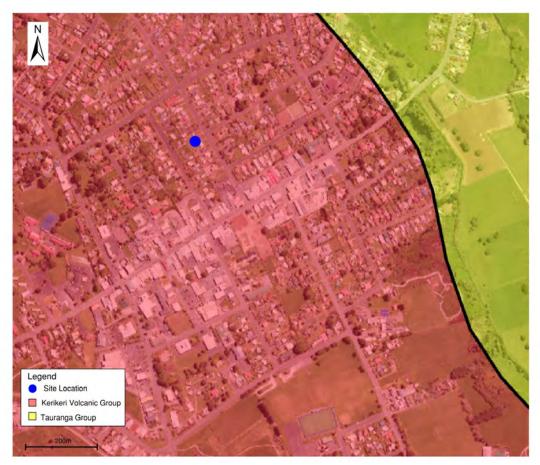
Figure 2: Geological map of Kaikohe (Geology 2.0.0 (gns.cri.nz)) showing property location.

The geological map can be seen in Figure 2.

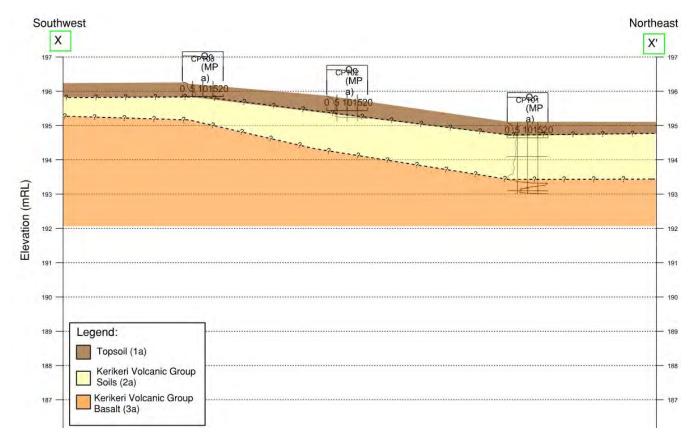
Figure 3: Ground Model Cross Section

CPT investigations encountered Kerikeri Volcanic Group Basalt rock at a depth of 1.00-2.00 m bgl. A review of the geological map, Beca data and publicly available information suggests that Kerikeri Volcanic Group Basalt rock is expected from depths of approximately 1.60 – 4.10m bgl. As such, site subsoil Class C – Shallow Soil Sites will be adopted for this assessment. Class C refers to shallow soil sites with a limit concerning the maximum depth of soils depending on soil behaviour and density. The maximum depth of a Class C site for a loose to medium dense cohesionless soil is 45m and a very stiff or hard cohesive soil is 60m.

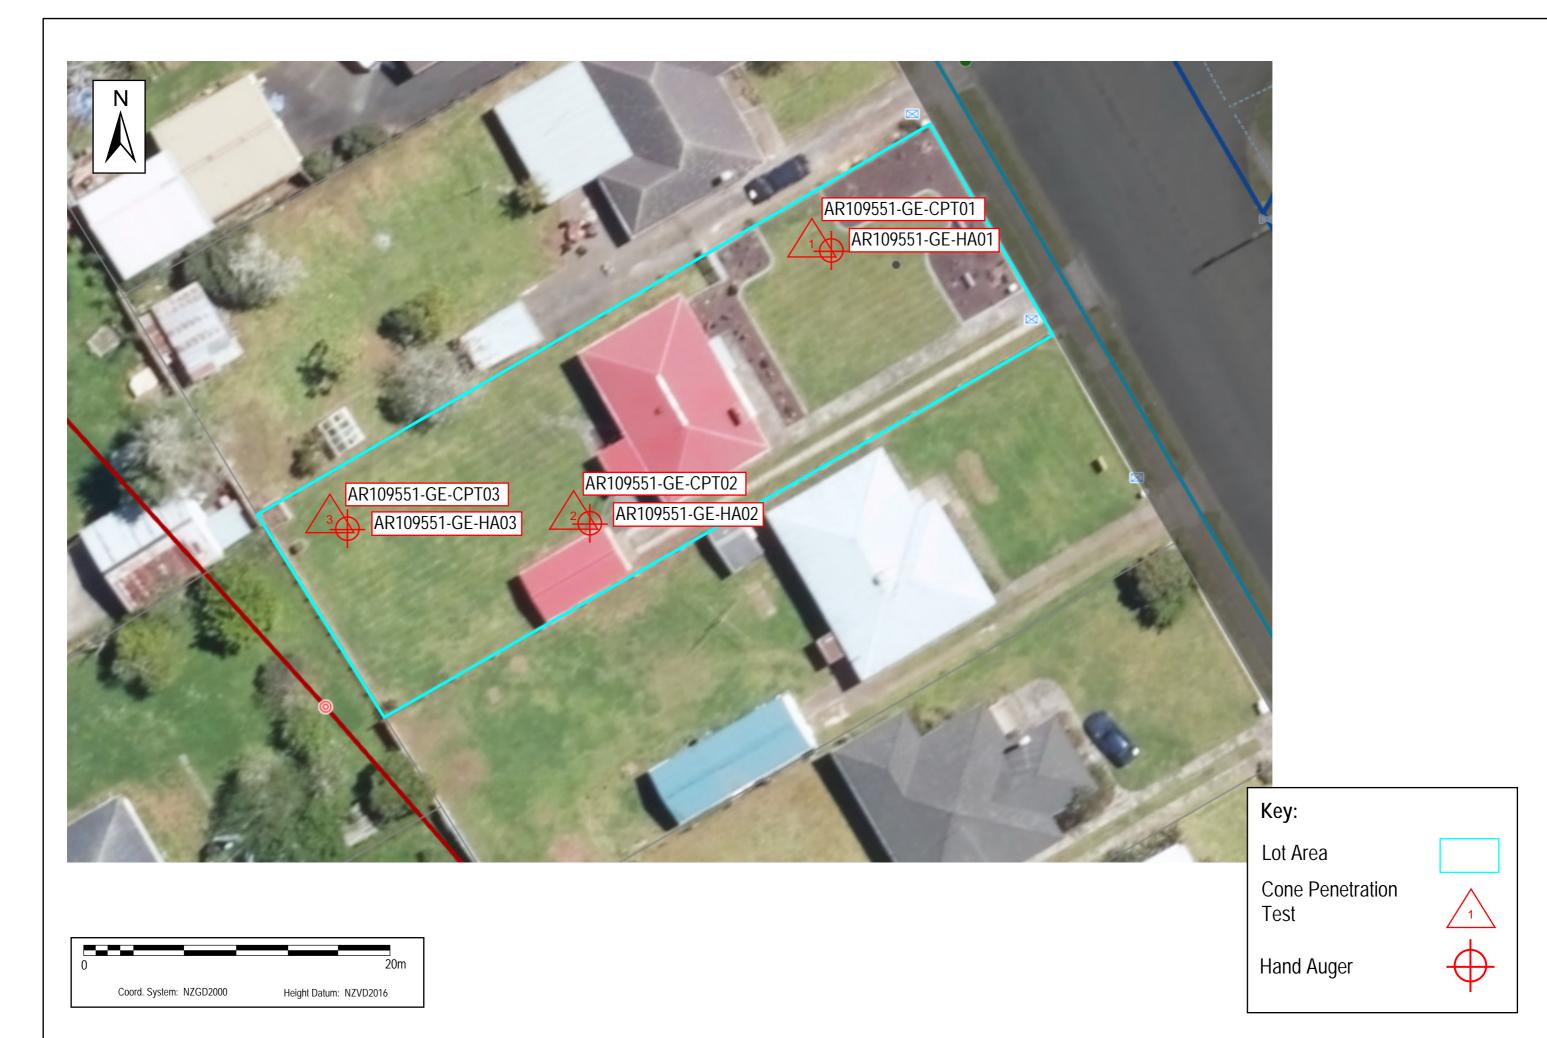
Appendix A – Site Investigation Plan

Geotechnical site investigations were undertaken on 8th of April 2024. Investigation locations were surveyed before construction in terms of NZTM2000 and NZVD2016 and are presented in Appendix A. Site investigations were observed and logged by two Beca Geo-professionals, and the logs have been verified by a Beca Senior Engineering geologist.

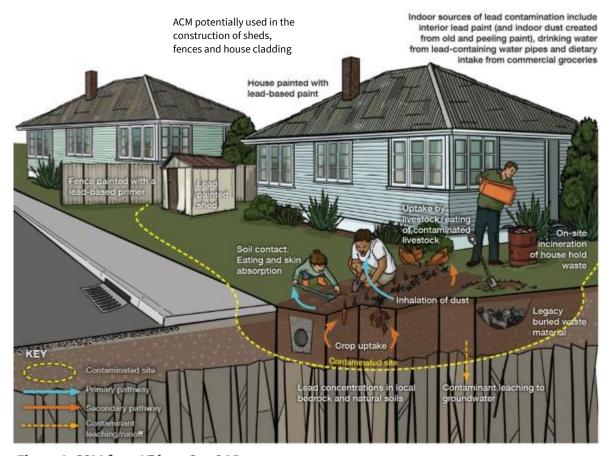
Figure 1. CSM from Kāinga Ora SAP

The soil sampling and analysis plan for the site is provided in Table 5. The Kāinga Ora Soil Sampling and Analysis Plan (SAP15) was used to estimate the soil sampling density for the DSI. The selection of analytes was based on the Conceptual Site Model (CSM) below and guidance presented in the Kāinga Ora SAP.

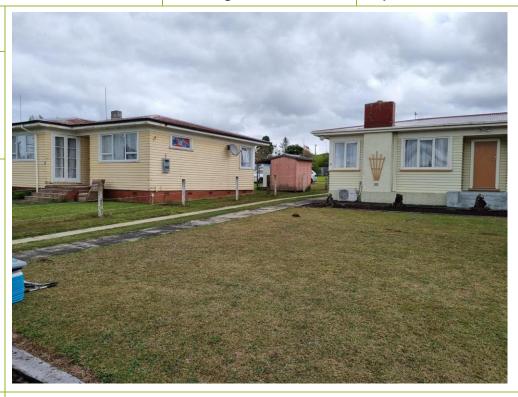
Photo 1.
No.

Direction
Photo Taken:
Facing south.

Description: Front yard of 25 Wihongi Street.

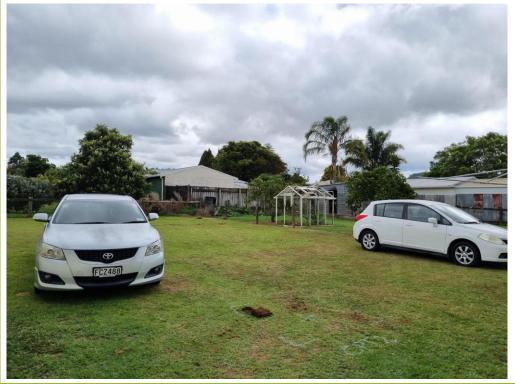
Photo 2.

Direction
Photo Taken:
facing west.

Description: Back yard of 25 Wihongi Street.

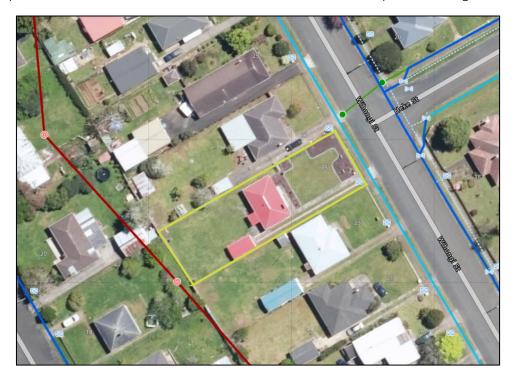
The legal description of the site is Lot 58 DP 36638. An aerial view of the site is provided in Figure 1 below.

$Figure \ 1-Aerial\ view\ of\ the\ development\ site,\ taken\ from\ Far\ North\ District\ Council\ 3\ Waters\ Maps$

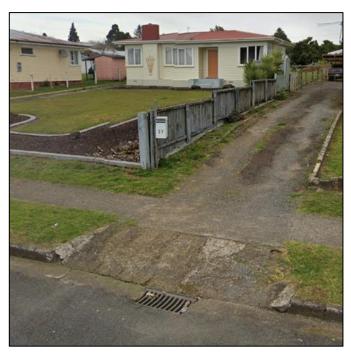
Figure 4 – Existing public stormwater catchpit located at the end of the vehicle crossing of 27 Wihongi Street.

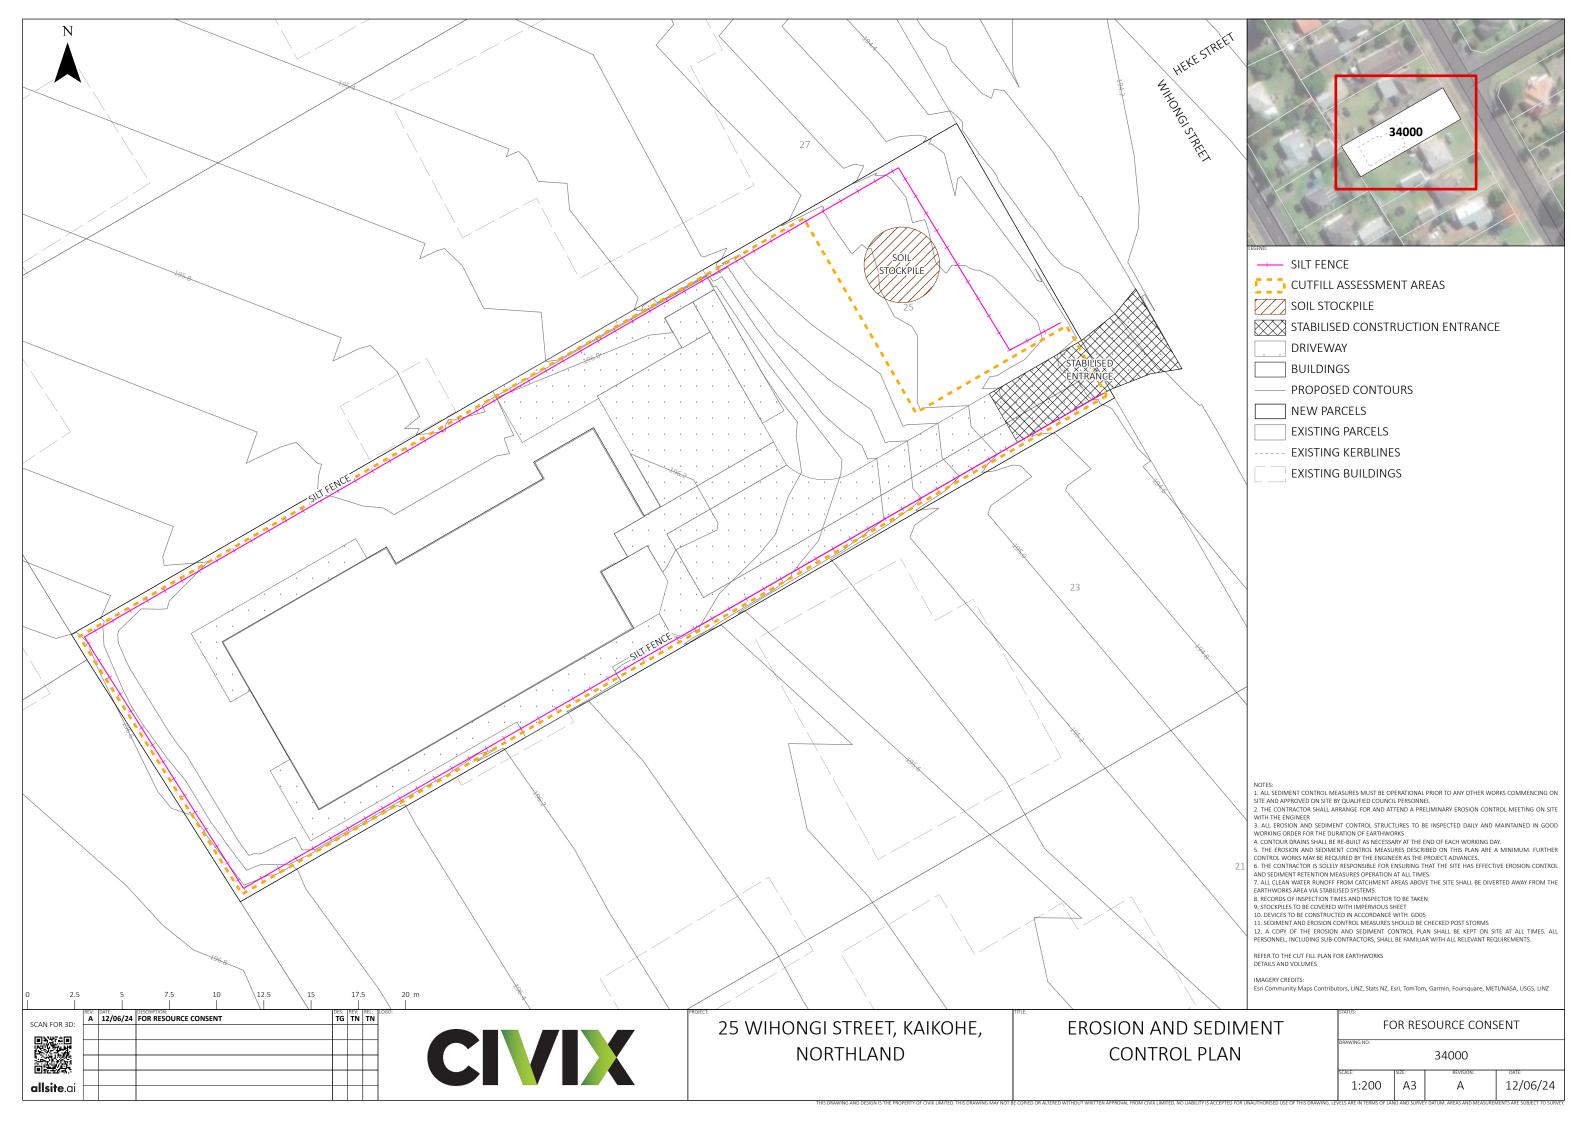
GD05 F1.3 SILT FENCES

- DO NOT REMOVE SILT FENCE AND ACCUMULATED SEDIMENT UNTIL THE CATCHMENT AREA HAS BEEN APPROPRIATELY STABILISED.
- REMOVE AND CORRECTLY DISPOSE OF ACCUMULATED SEDIMENT
- BACKFILL TRENCH, RE-GRADE AND STABILISE THE DISTURBED AREA.
