Application for resource consent or fast-track resource consent

INDEPENDENT BUILDING INSPECTION SECOND HAND RELOCATION REPORT 34 Lavery Place Sunnynook

INDEPENDENT BUILDING INSPECTION SECOND HAND RELOCATION REPORT 69a Walworth Avenue Pakuranga

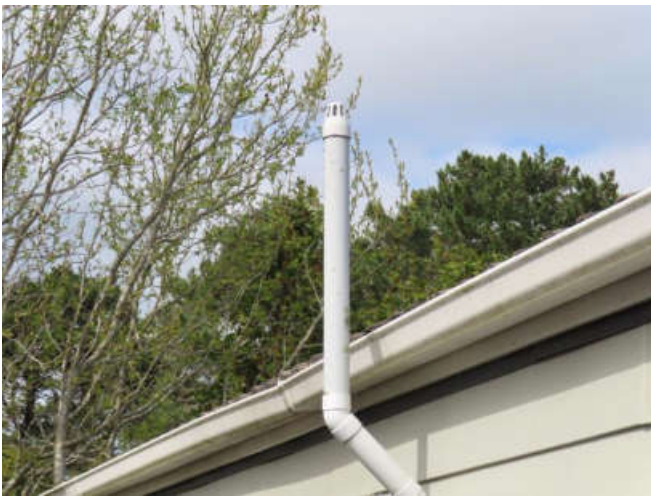
Vents:

To be replaced upon re-siting.

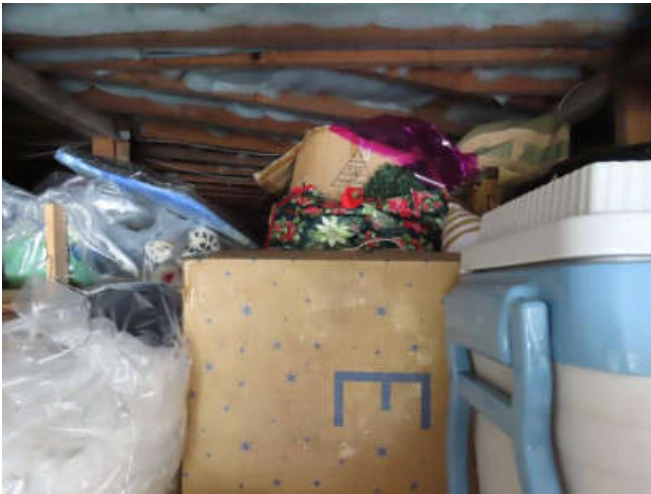
We were unable to access the foundations due to stored items. Photos were taken from the opening.

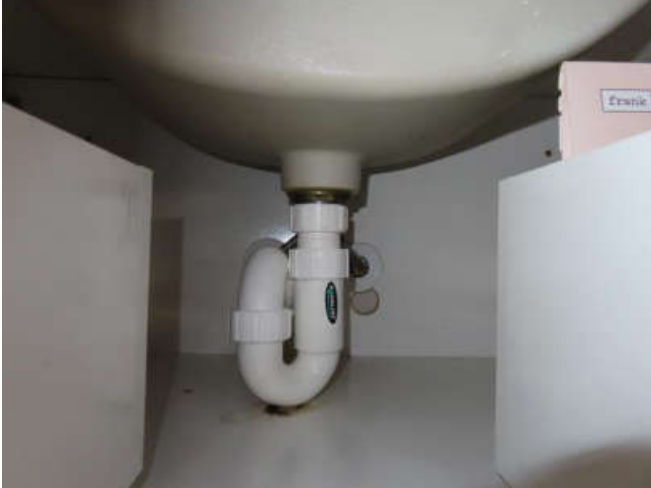
Plumbing/Drainage:

Some underfloor plumbing may be required to be replaced upon re-siting.

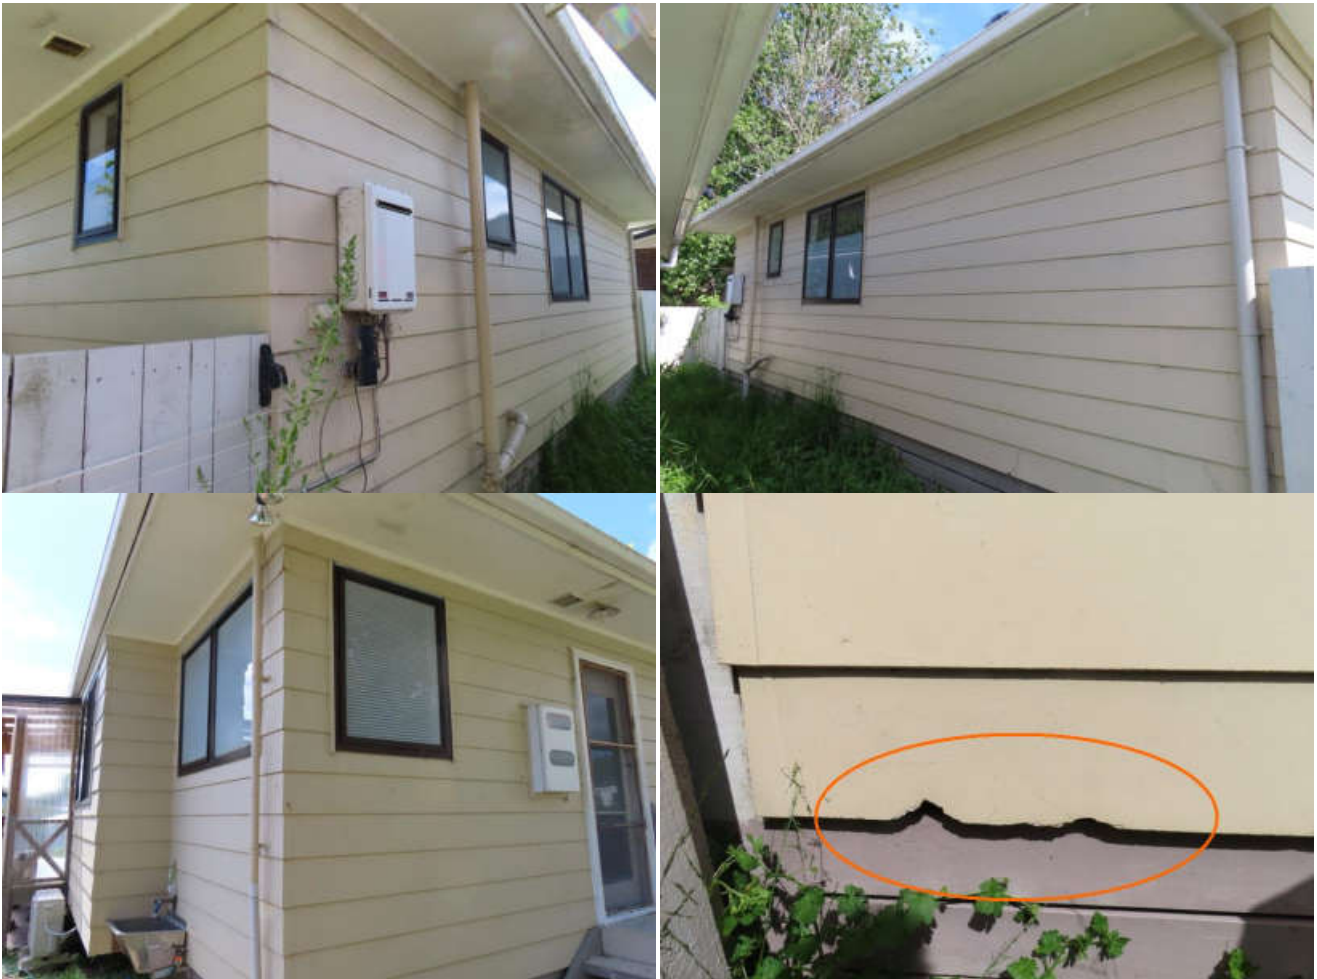
Fibre cement weatherboard. **There is minor damage to some cladding that requires repair, or replacement.**

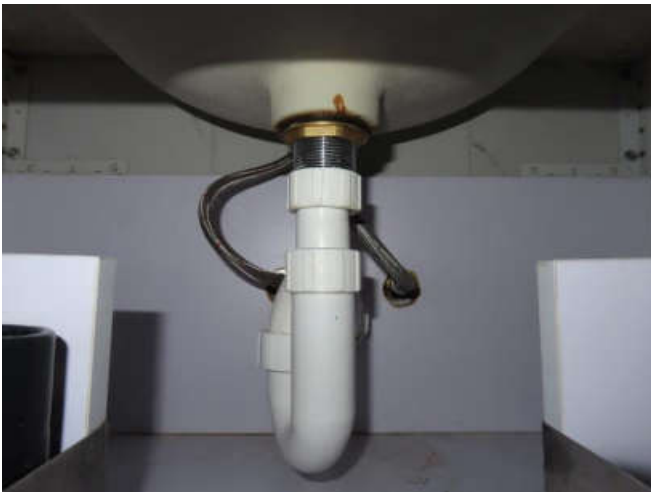
Plumbing/Drainage:

Some underfloor plumbing may be required to be replaced upon re-siting.

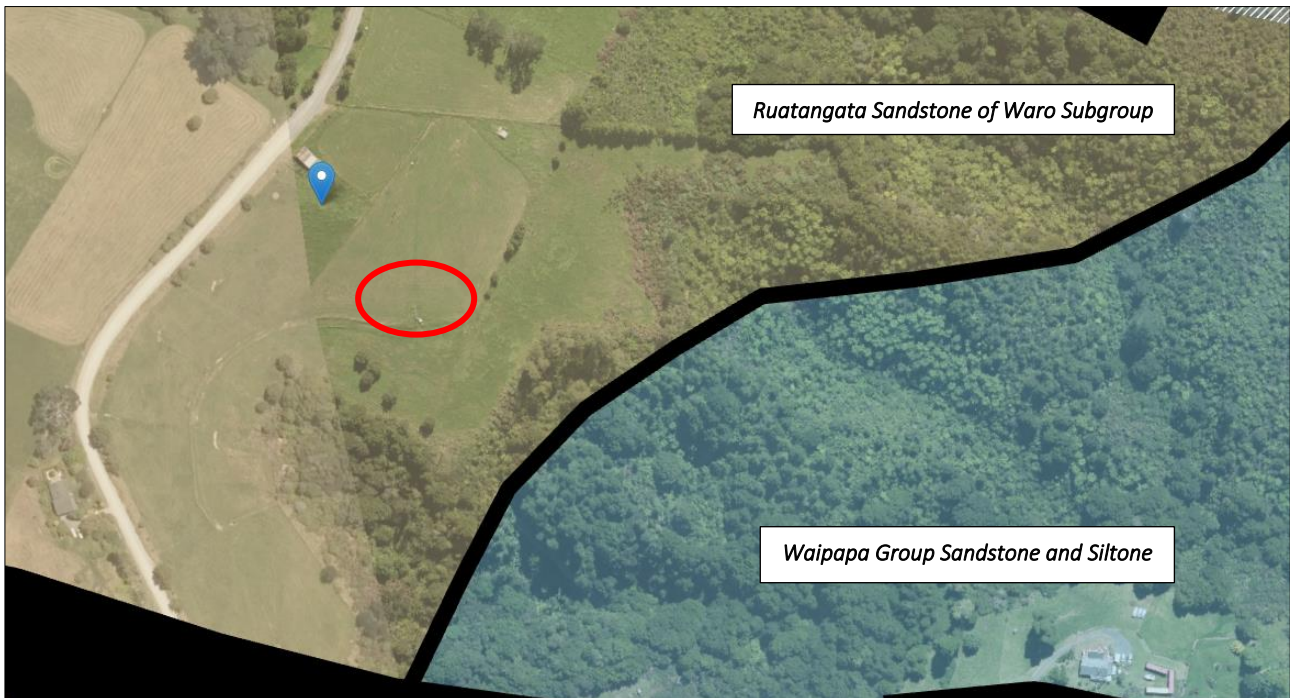
Figure 2: Screenshot aerial view of the subject site from the New Zealand Geology Web Map. Red circle depicts development location.

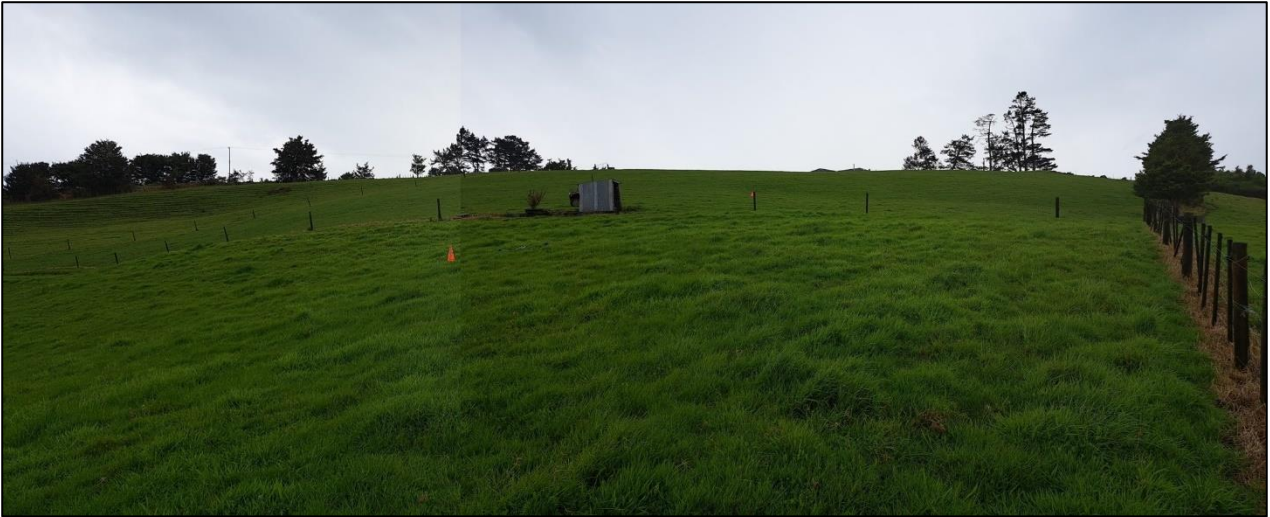
Figure 4: Site Photo – Facing North towards the Nominated Building Platform. Orange Cones indicated Field Testing Locations.

Reeds were noted growing within the nearby arcuate feature heading the nearby gully formation, on land that is dipping downwards into this feature. Although it is noted that outside of the arcuate head of the gully that reeds are not widely observed.

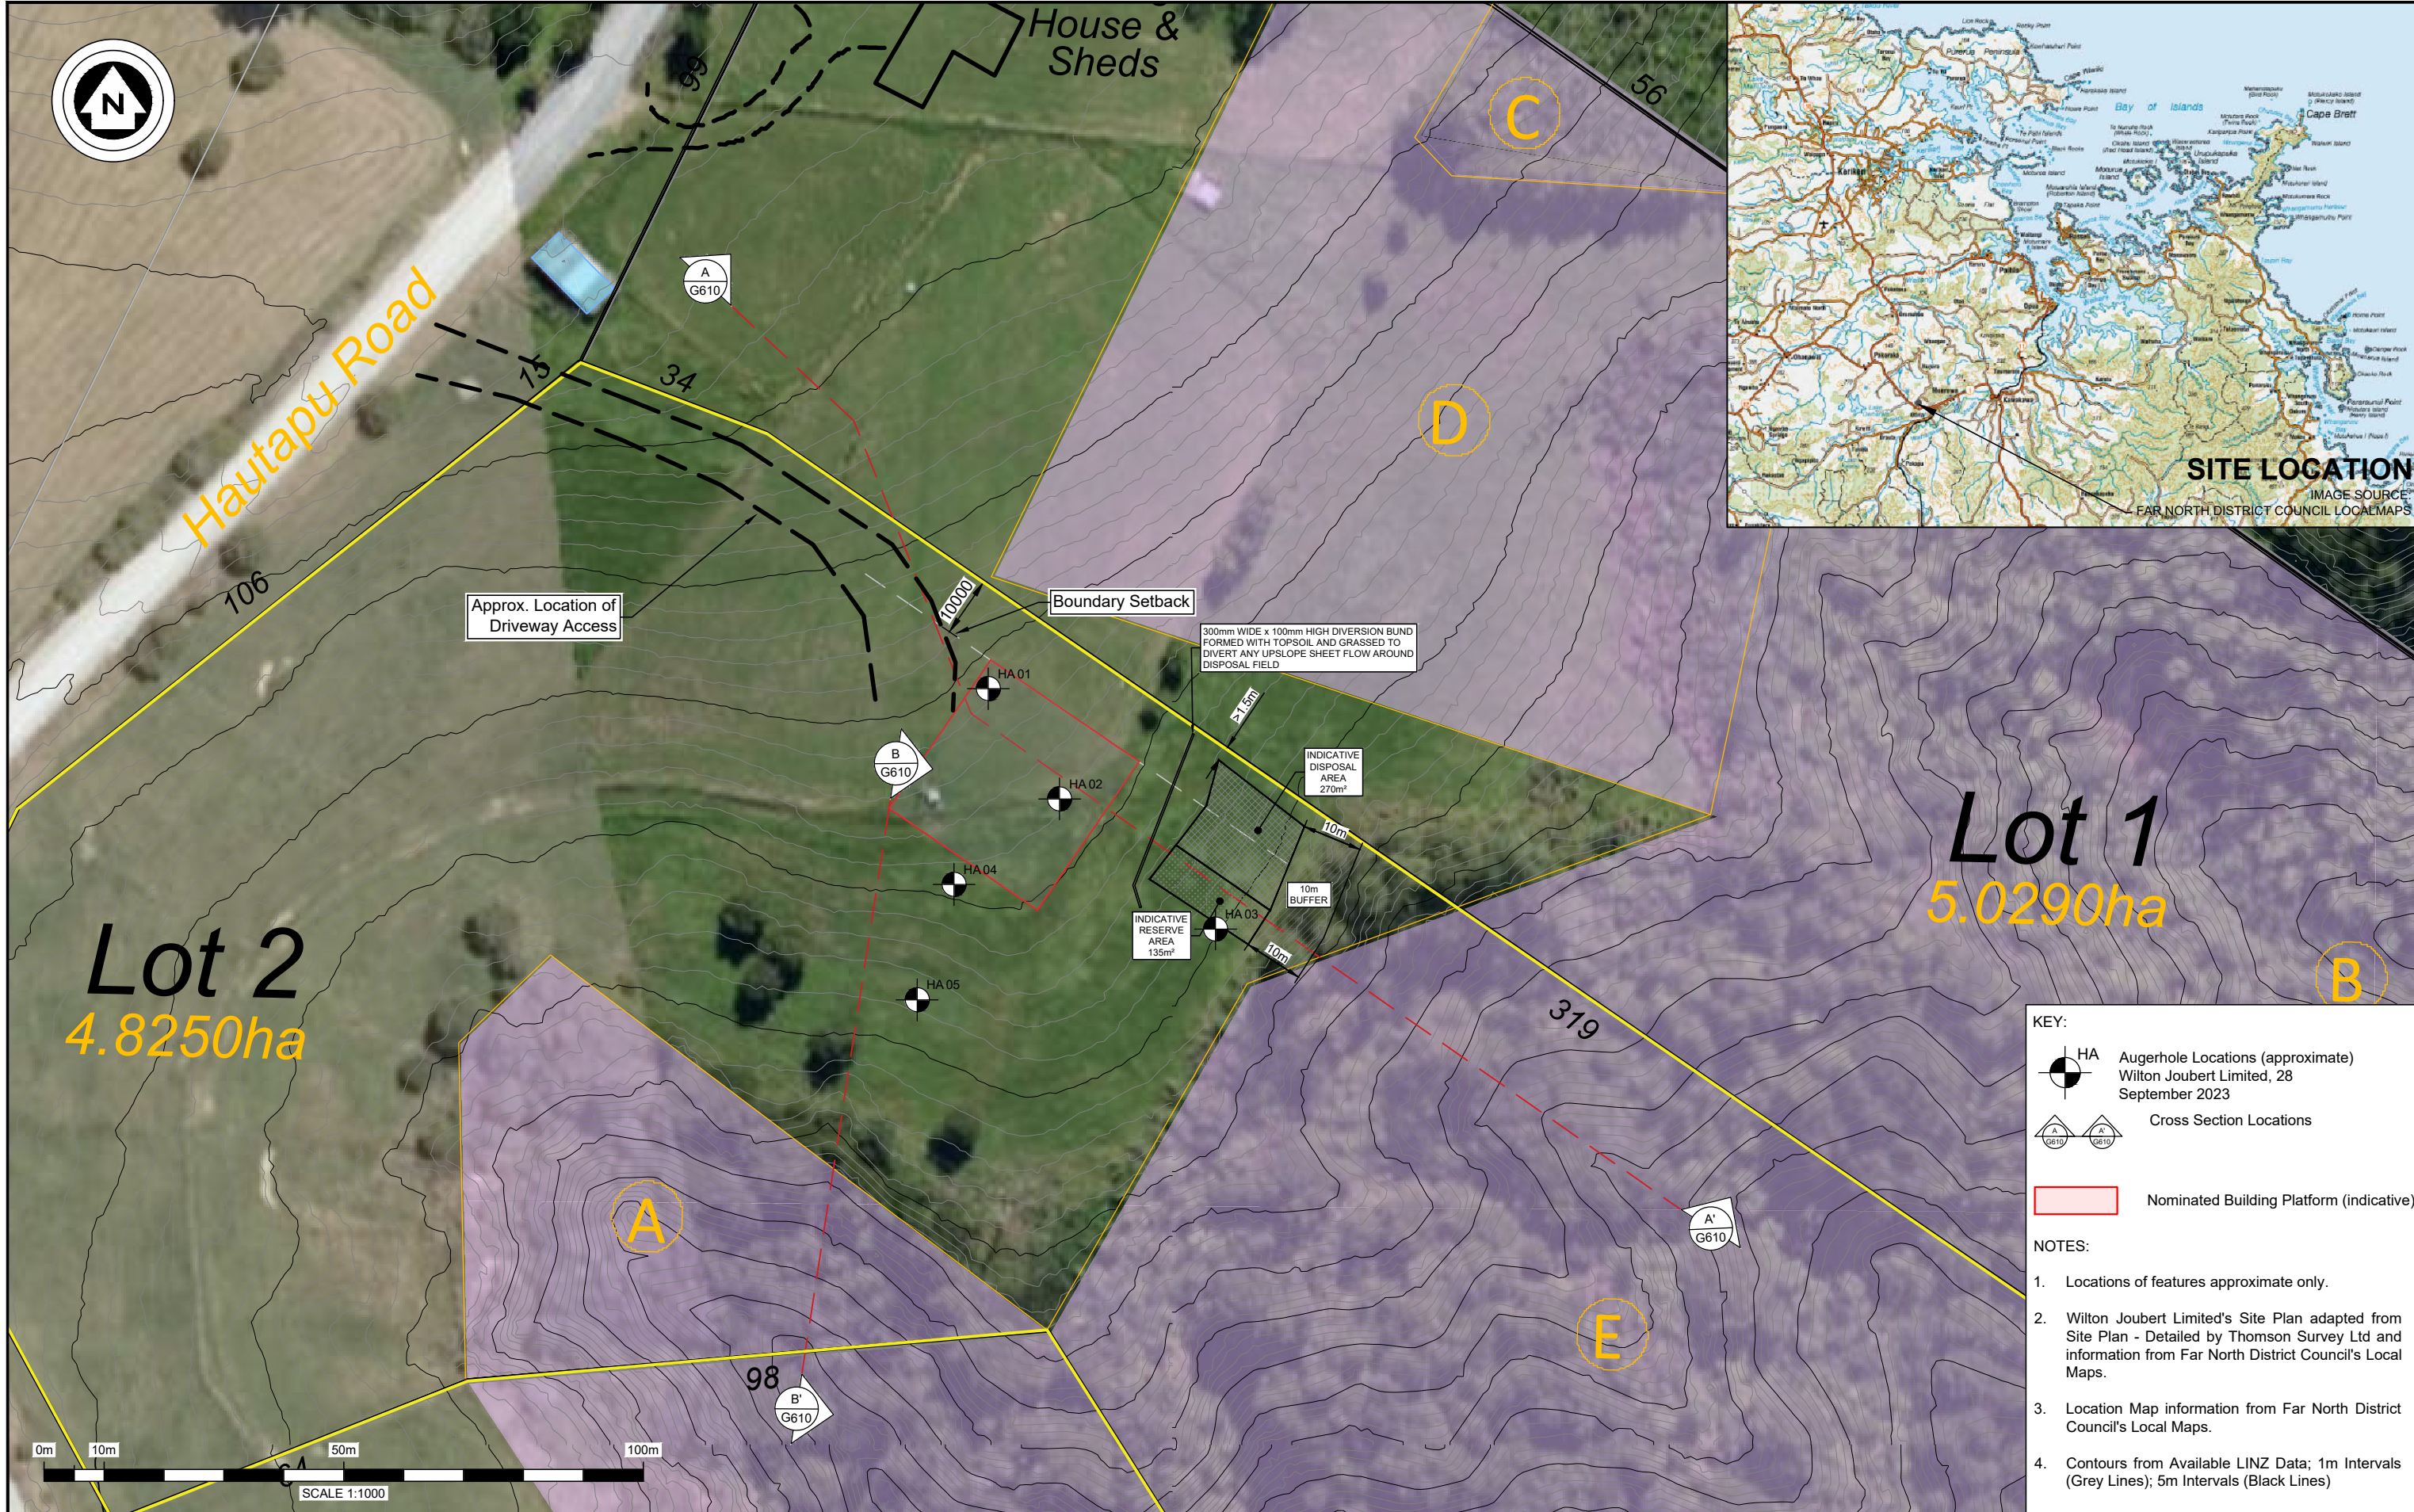
- KEY:**
- HA Augerhole Locations (approximate)
Wilton Joubert Limited, 28
September 2023
 - Cross Section Locations
 - Nominated Building Platform (indicative)
