# Application for resource consent or fast-track resource consent

New Zealand Transport Agency Waka Kotahi (NZTA)

<b>NPSHPL</b>	National Policy Statement for Highly Productive Land 2022
<b>NRC</b>	Northland Regional Council
<b>NZCPS</b>	New Zealand Coastal Policy Statement 2010
<b>NZEM</b>	New Zealand Environmental Management Limited
<b>NZTA</b>	New Zealand Transport Agency Waka Kotahi
<b>pFNDP</b>	Proposed Far North District Plan 2024
<b>Project</b>	Establishment and operation of a cleanfill site
<b>pRPN</b>	Proposed Regional Plan for Northland 2024
<b>RMA</b>	Resource Management Act 1991
<b>RoT</b>	Record of Title
<b>RPS</b>	Regional Policy Statement for Northland
<b>SH1</b>	State Highway 1
<b>Site</b>	Lot 1 DP 35169 adjacent to 184 Peria Valley Road, Kaitaia
<b>Slip Response</b>	Mangamuka Slip Response Project 2022

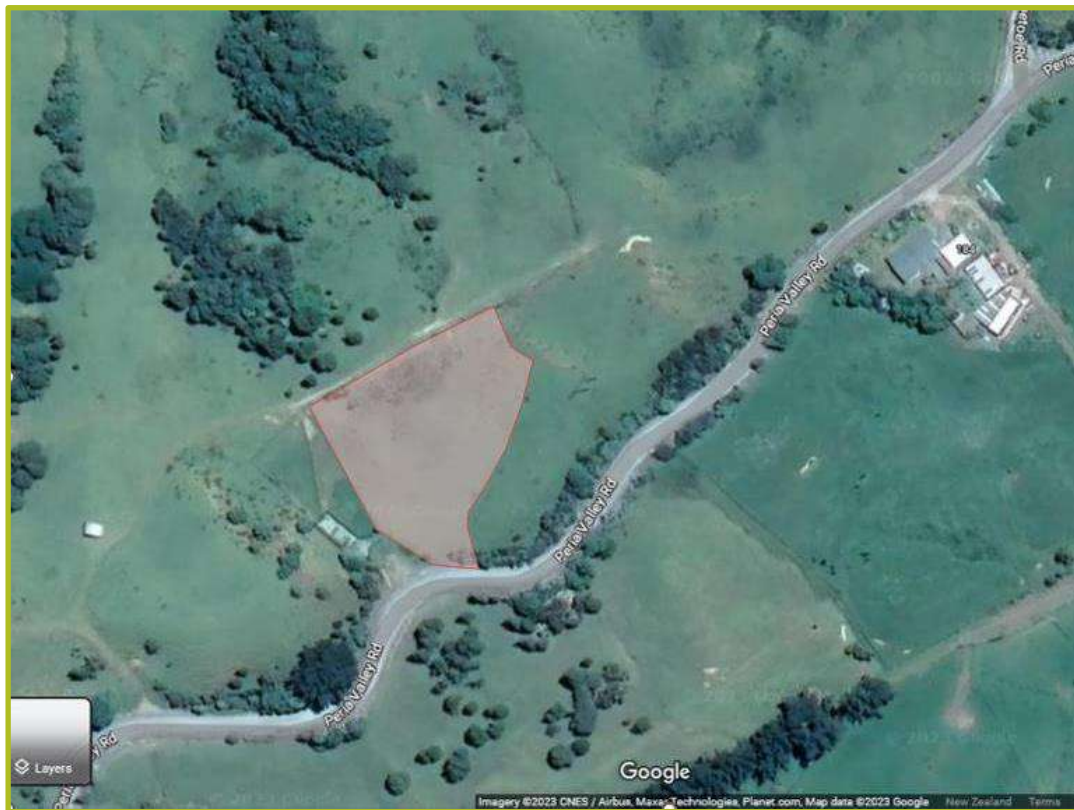
**Figure 1:** Aerial Image of Site (with red polygon indicating extent of fill area prior to start of works) (Source: GoogleMaps)

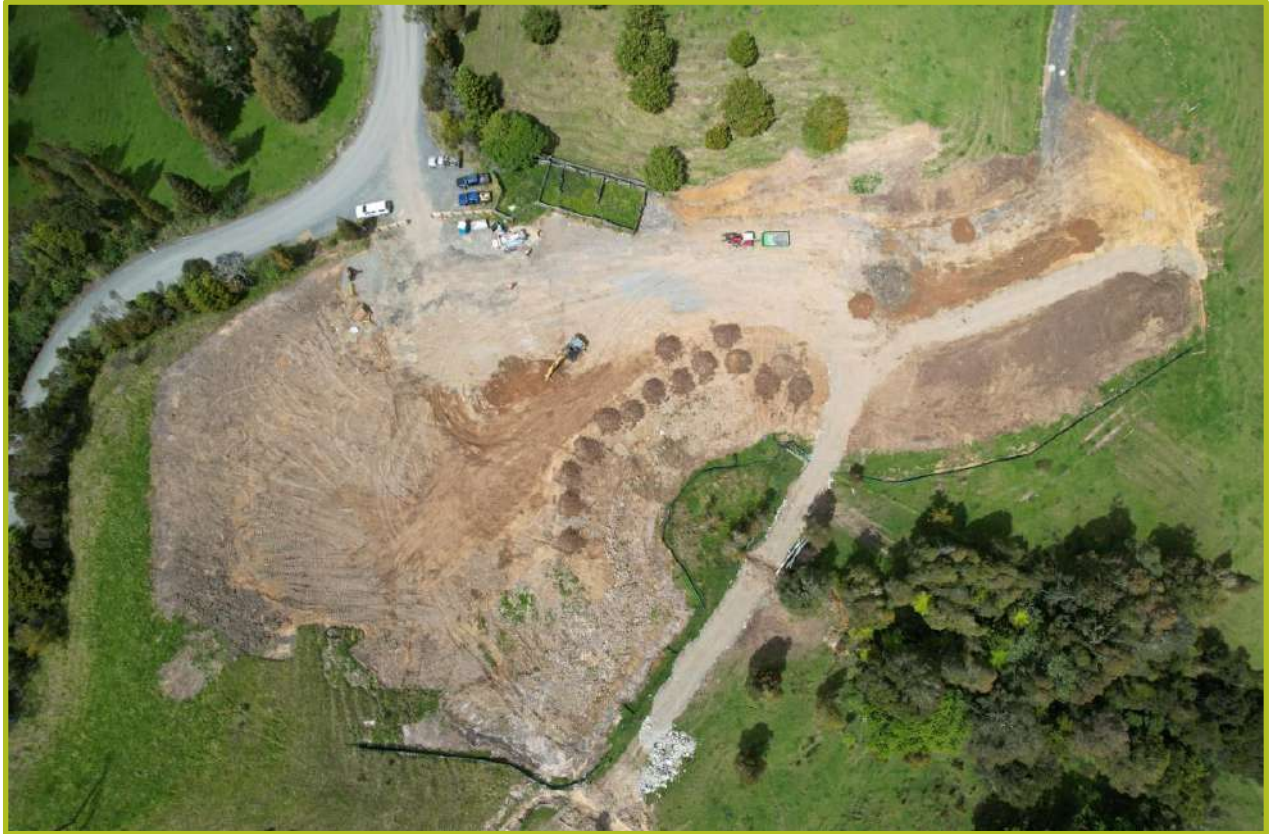
**Figure 2:** Aerial Image of Site near completion of works (Image taken 29 October 2024)

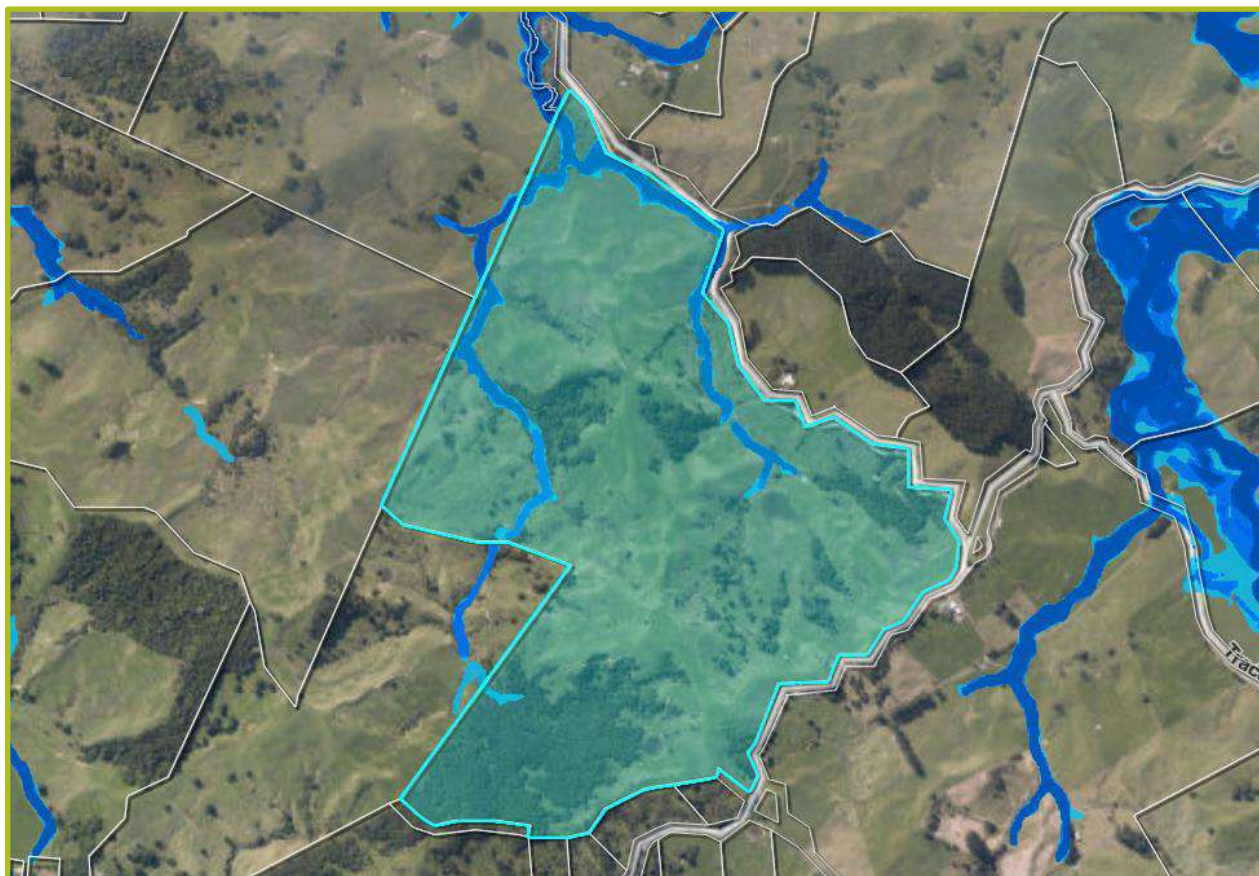
The Site is not identified as being within any natural hazard areas (refer **Figure 5**). To the north of the cleanfill area, within the same property, there are some flood susceptible areas as evident on **Figure 5**. A Hazard Summary Report is attached as **Appendix C**.

Figure 5: Flood Susceptible Areas (Source: NRC GIS Hazard Viewer – accessed 21 November 2024)

As has been identified, the area of the cleanfill was located outside of any identified natural hazard area. It is not considered the completed fill activities would create new natural hazard risks, nor alter or effect any existing natural hazard risk in the area.

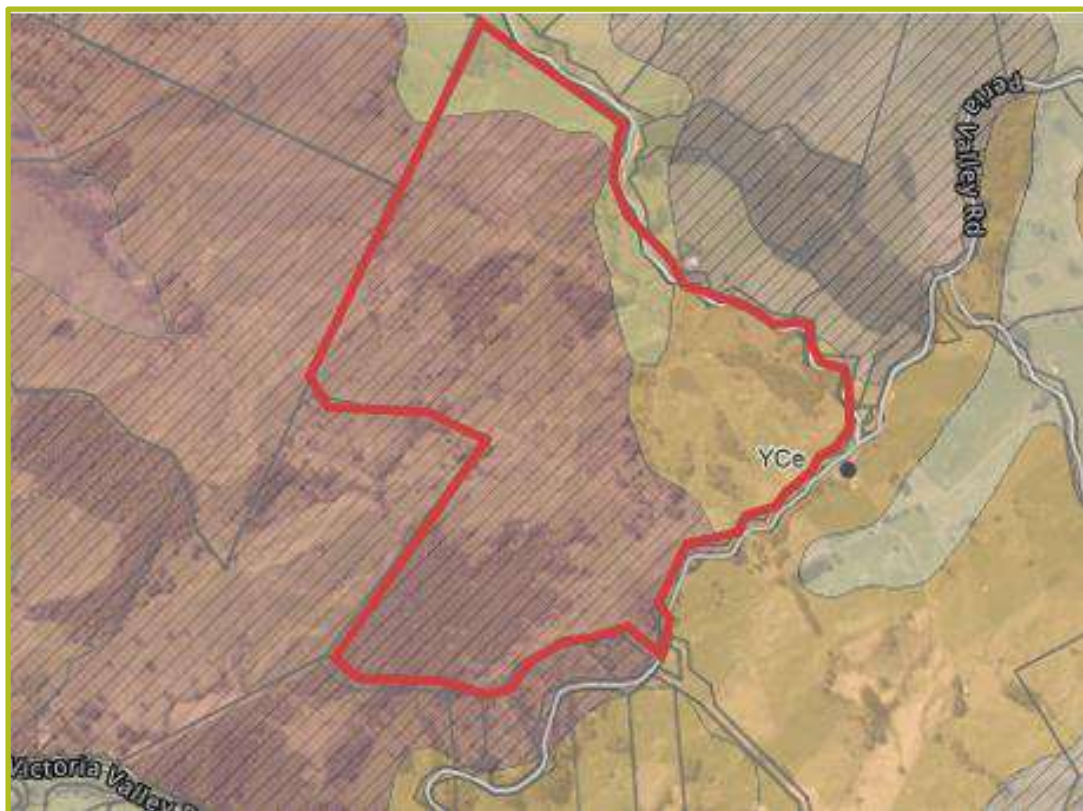
Relevant to the location within the Site where the cleanfill is located, the soil types are identified as YCe and KNH, with the cleanfill site generally being located within the soil types identified as KNH (refer **Figure 6**).

**Figure 6:** Soil Types (red thatched = KNH; Orange = YCe) (Source: NRC Managing Northland Soils factsheet viewer - accessed 5 December 2024)

KNH is identified as being Konoti clay loam. The features of this can be found in the factsheet at **Appendix D**. YCe is identified as being Waitira clay. The features of this can be found in the factsheet at **Appendix D**.

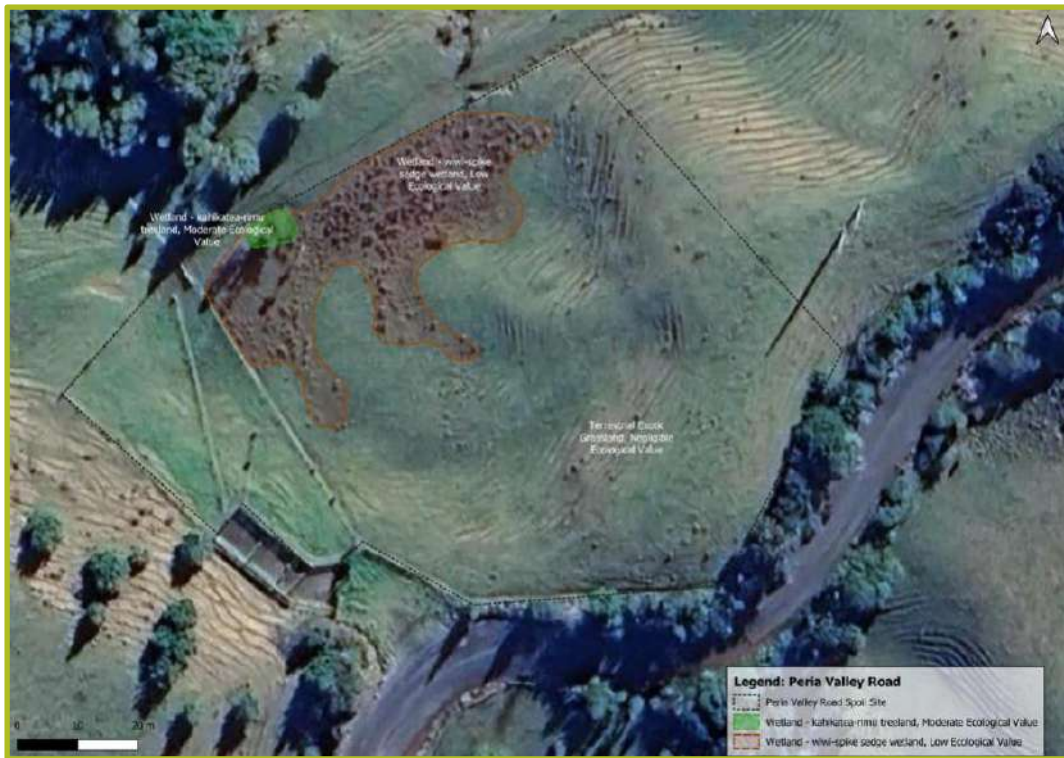
Figure 8: Wetland Areas (Source: NZEM)

As identified above, the basin feature forms a hillslope seepage, which meets the definition of a “wetland” under the RMA as it comprises “*permanently or intermittently wet areas... that support a natural ecosystem of plants and animals that are adapted to wet conditions*”. The hillslope seepage has been delineated into several wetland areas, with some of these areas being considered a “*natural inland wetland*” (refer **Figure 8**).

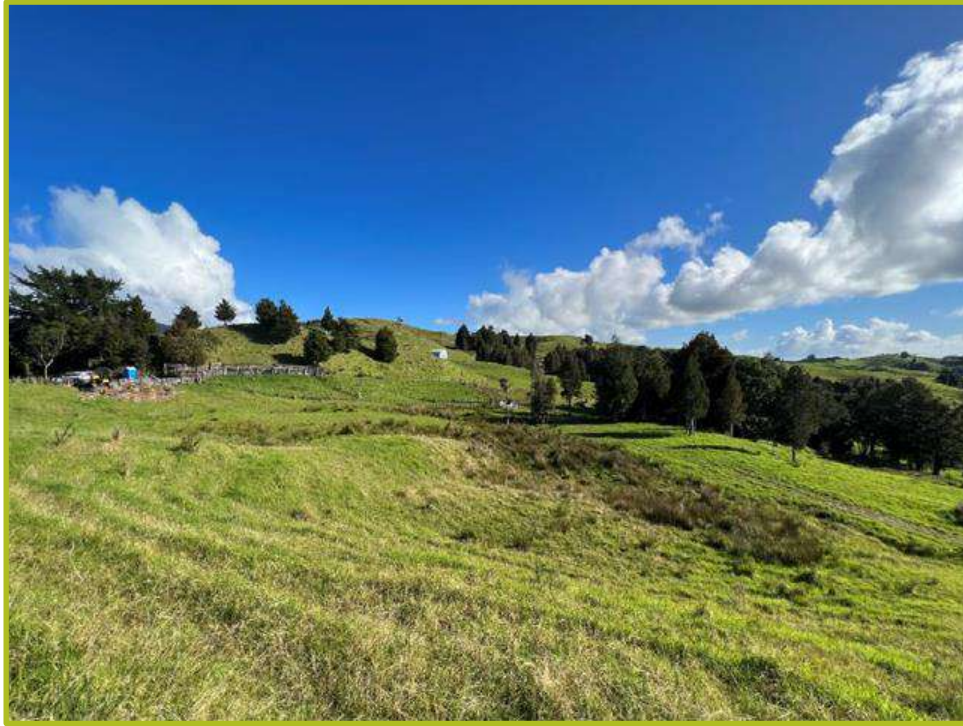
Figure 9: Exotic grassland dominant in foreground of cleanfill area (Source: NZEM)

A large proportion of the area used for the cleanfill site consists of exotic grassland, dominated by pasture species typical of rural production land. This grassland is dominated by kikuyu (*Cenchrus clandestinus*), paspalum (*Paspalum urvillei*), parsley dropwort (*Oenanthe pimpinoides*), and buttercup (*Ranunculus repens*) with occasional gorse (*Ulex europaeus*).

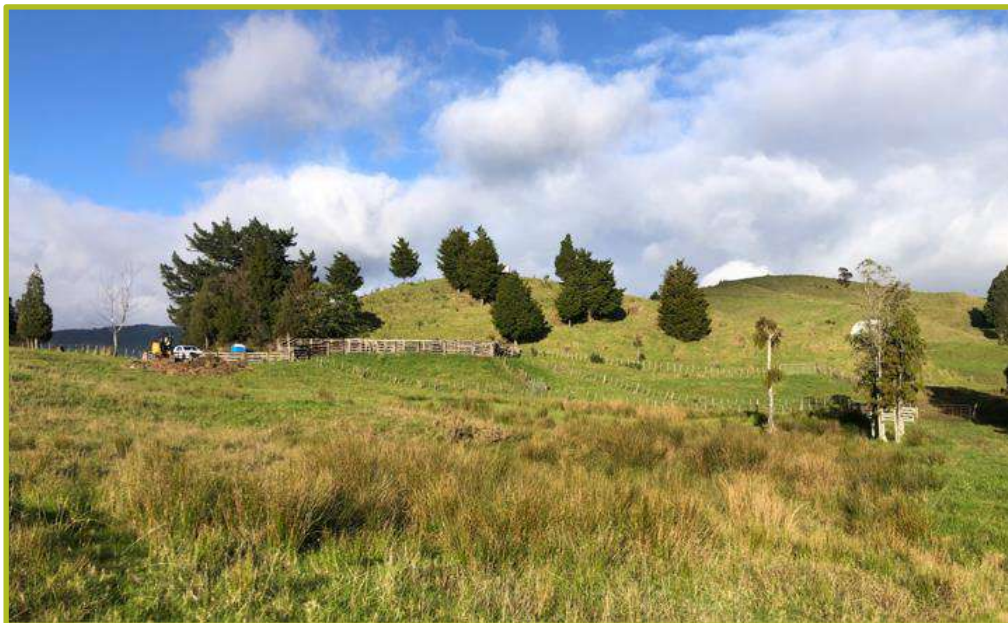
Figure 10: Wīwī-Spike Sedge Rushland

An area of the hillslope seepage is dominated by two indigenous species, wīwī (*Juncus edgariae*) and spike sedge (*Eleocharis acute*). Mercer grass (*Paspalum distichum*), and soft rush (*Juncus effusus var. effusus*) are also present, and exotic grasses are abundant towards the drier top edge of the wetland area.

The Ecological Report concludes that the hydrophytic vegetation meets the definition of an “*indigenous wetland*”. The “*indigenous wetland*” was approximately 1,365m<sup>2</sup>.

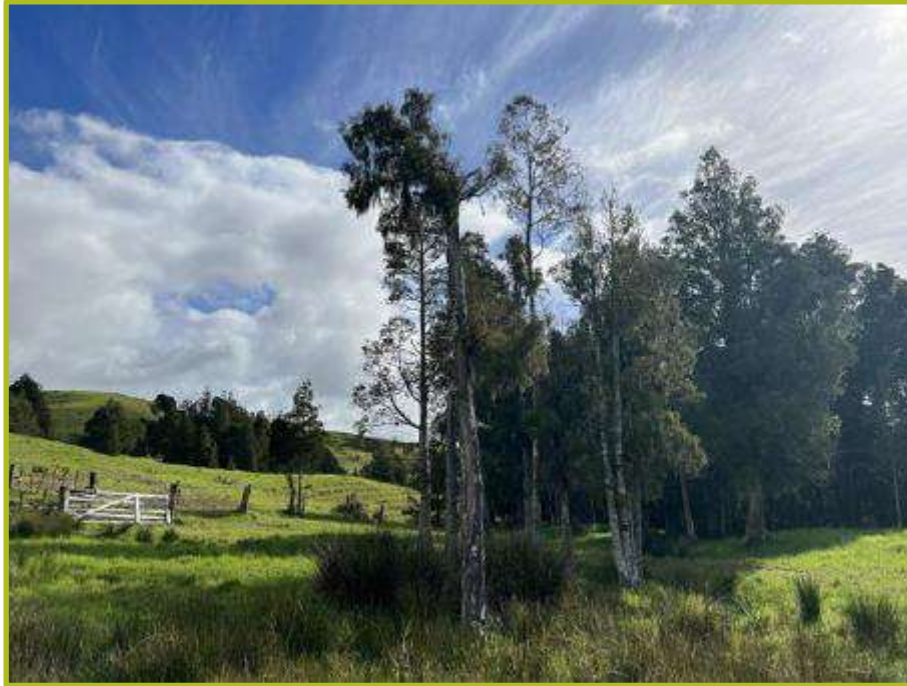
**Figure 11:** Kahikatea-Rimu Treeland (Source: NZEM)

The Ecological Report found that many of these trees exhibited late-stage symptoms of disease and/or overall stunted growth and ill-health.

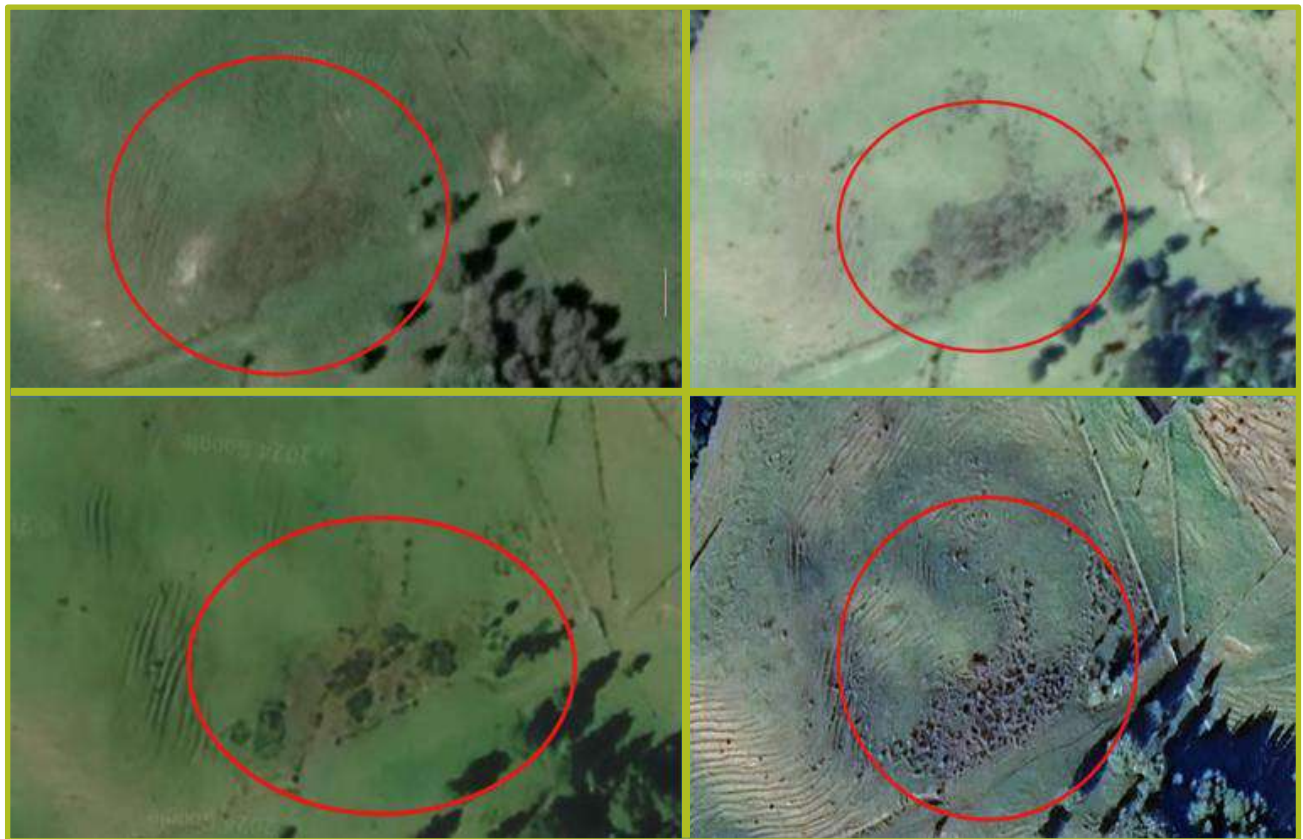
**Figure 12:** Aerial Imagery (Clockwise from top left 2016-2022) (Source: Google Earth - accessed 1 November 2024)

Aerial imagery suggests the wīwī and spike sedges within the wetland areas were less than 10 years old. As evident in **Figure 12** below, imagery from 2016 shows the sedges starting to establish, and factoring in the land use and grazing of stock, supports such a conclusion.

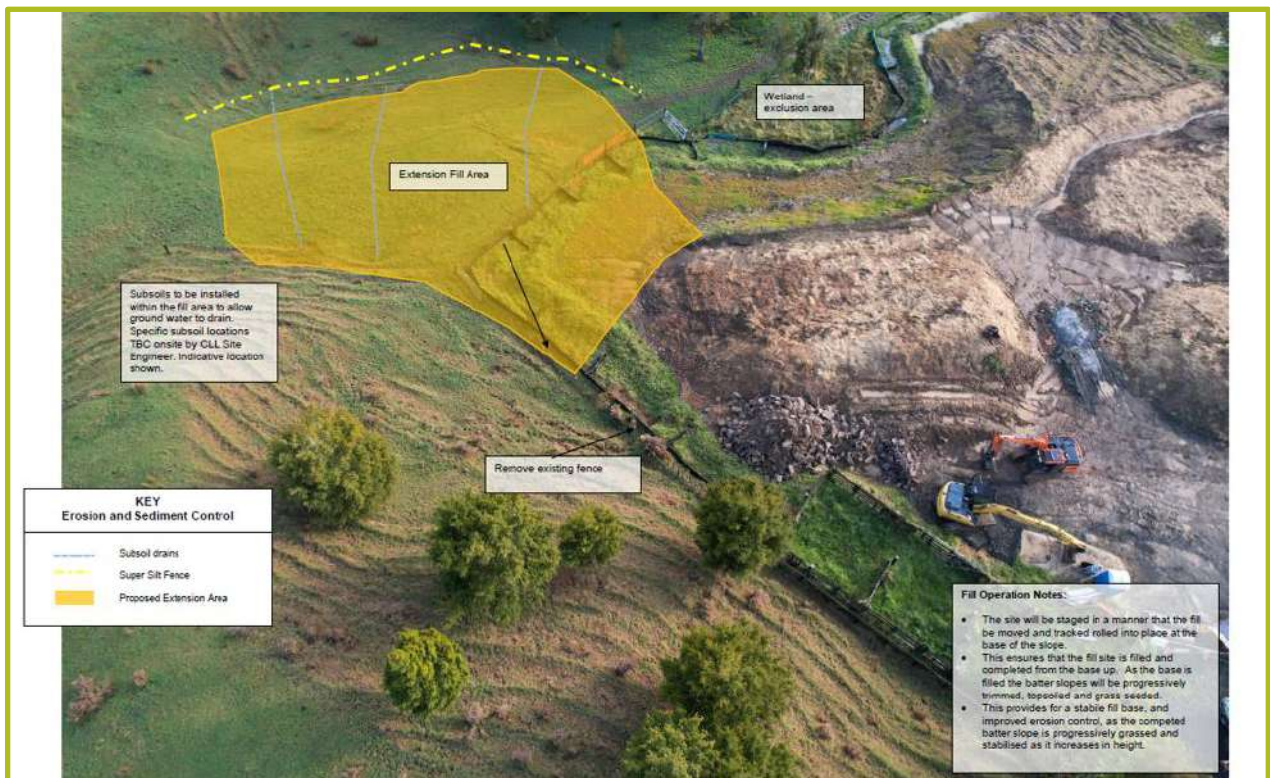
Figure 16: Snip from Erosion and Sediment Control Plan Showing Extension Fill Area, being Stage 3 (Source: Erosion and Sediment and Control Plan)

A total of 11,718m<sup>3</sup> of cleanfill was disposed of over the entirety of the cleanfill area. Cleanfill was disposed of over three stages (refer **Figure 15** and **Figure 16**) and to a depth of 4.5m. Cross sections are attached at **Appendix I**, which includes the running totals of cleanfill deposited.

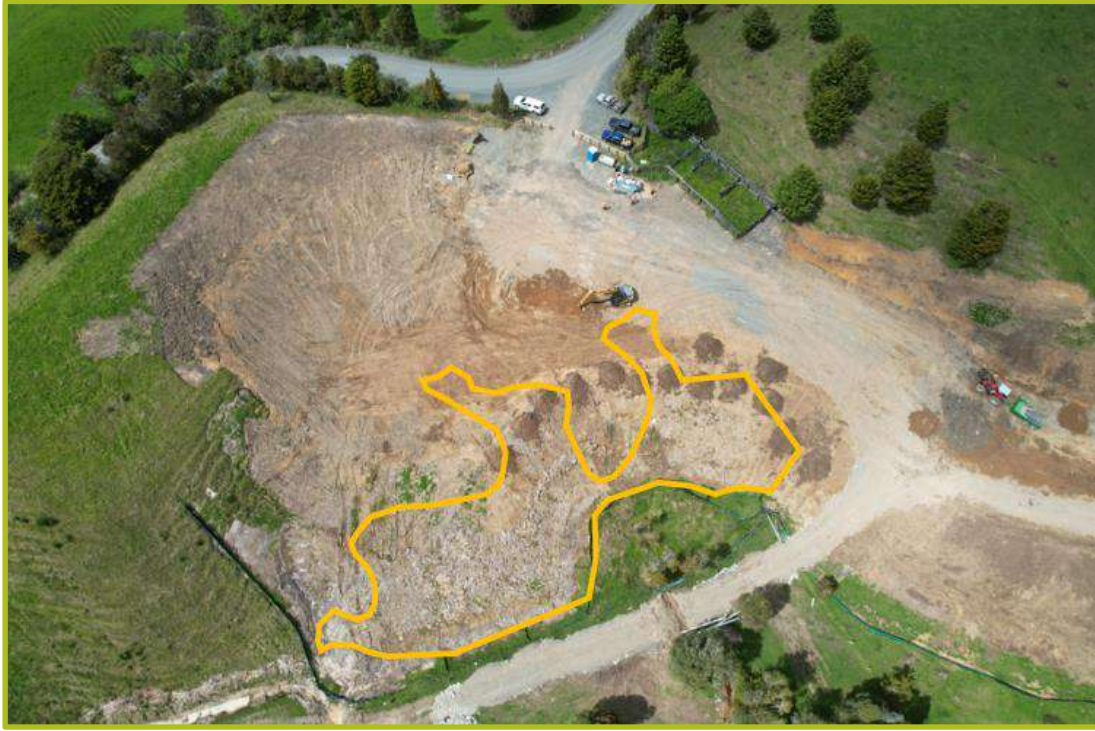
**Figure 17:** Rough approximation to indicate extent of indigenous wetland loss (orange outline)

As has been identified, the Site contained areas defined as an “*indigenous wetland*”. The area delineated as the wīwī-spike Rushland required draining and filling in order to operate the cleanfill site. This resulted in the complete and permanent loss of that area of natural inland wetland, being 1,365m<sup>2</sup> of wetland. A rough approximation to be used as a visual guide is in **Figure 17** below.

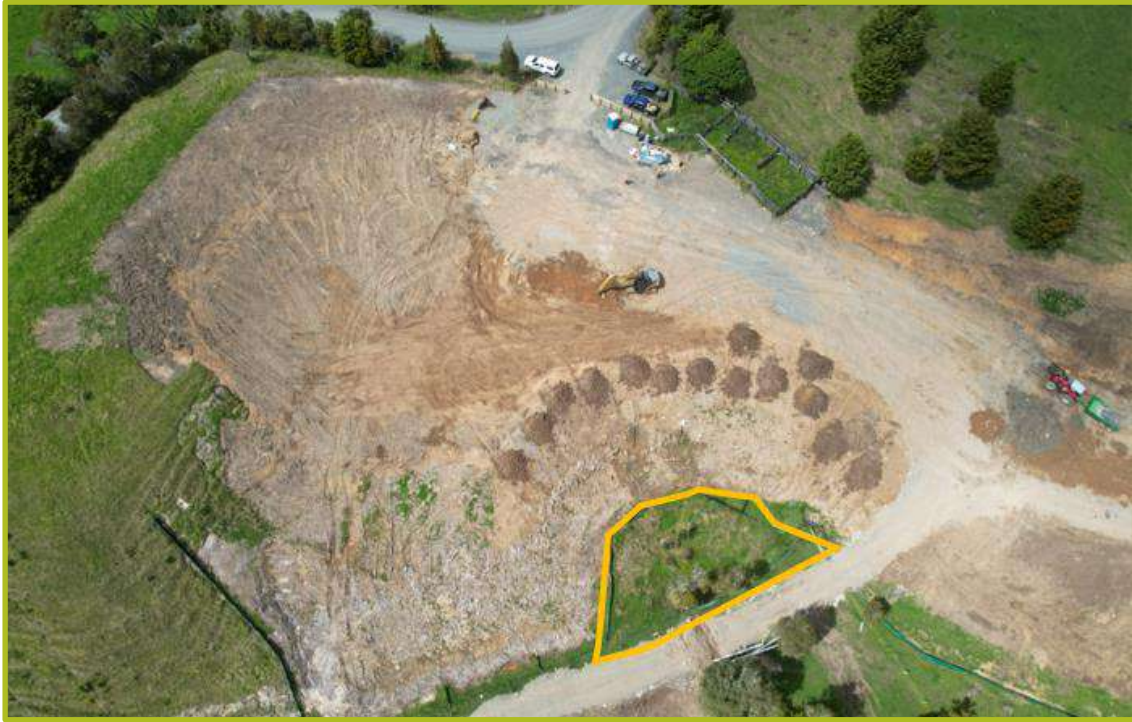
**Figure 18:** Orange Polygon indicates protected Kahikatea-rimu Treeland Natural Inland Wetland (Image taken 29 October 2024)

As the area delineated as the kahikatea-rimu treeland had mature trees and the “*At-risk Declining*” *Teloschistes flavicans* lichen, it was concluded to have moderate ecological value, therefore the area was excluded and protected from the cleanfill activities.

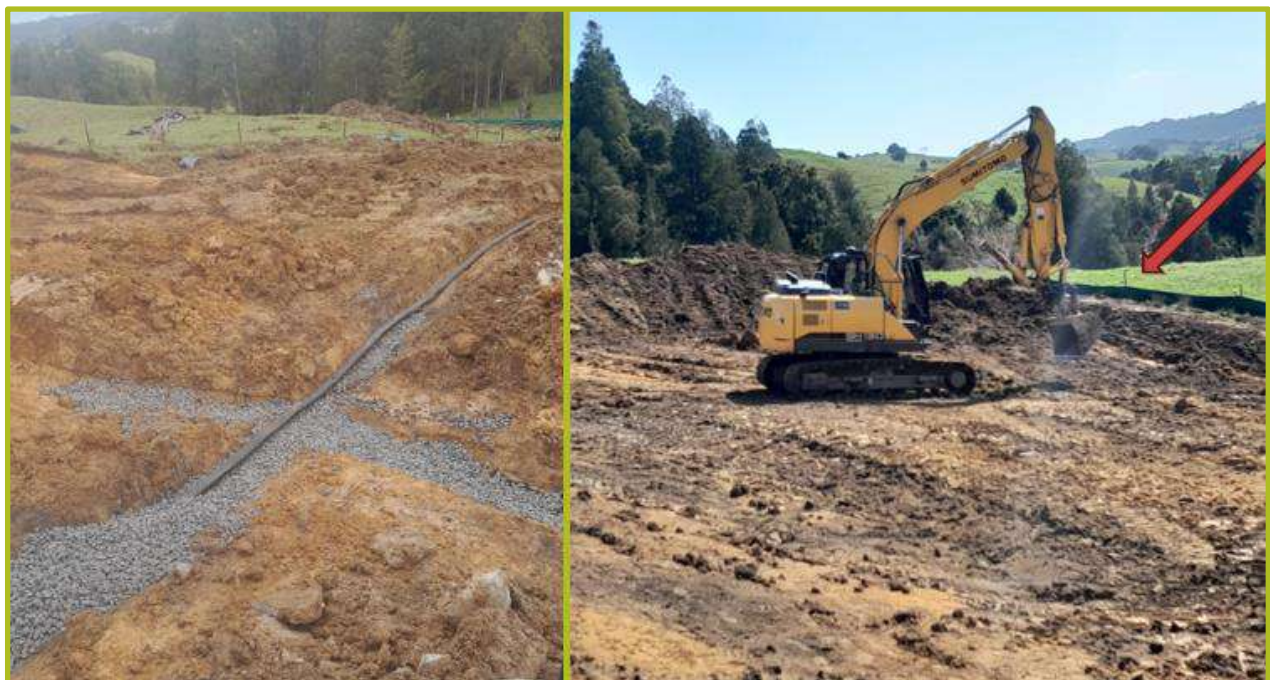
**Figure 19:** (Left) Subsoil Drainage being Installed; (Right) Silt Fence around the perimeter

Prior to beginning the fill activities on-site, Southern Skies prepared a Sediment and Erosion Control Plan (refer **Appendix F**). This was implemented on-site and included the installation of subsoil drainage and silt fencing around the perimeter of the cleanfill site.

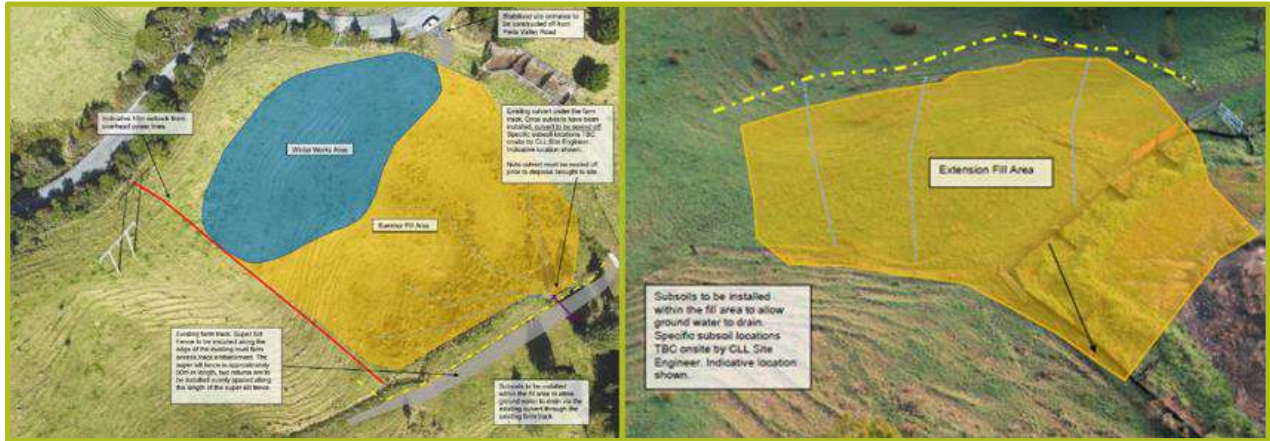
**Figure 20:** Snip from Erosion and Sediment Control Plan indicating buffer from electricity line, subsoil drainage and existing culvert

Subsoil drainage was installed that provided for the drainage of groundwater and fill material placed in the Stage 1 and 3 areas, feeding into an existing culvert beneath the farm track, adjacent to the Kahikatea/rimu wetland (refer **Figure 20**).

As there was an overhead electricity line running to the west of the cleanfill area, a 10m buffer was established and no works were undertaken within that buffer zone (refer **Figure 20**).

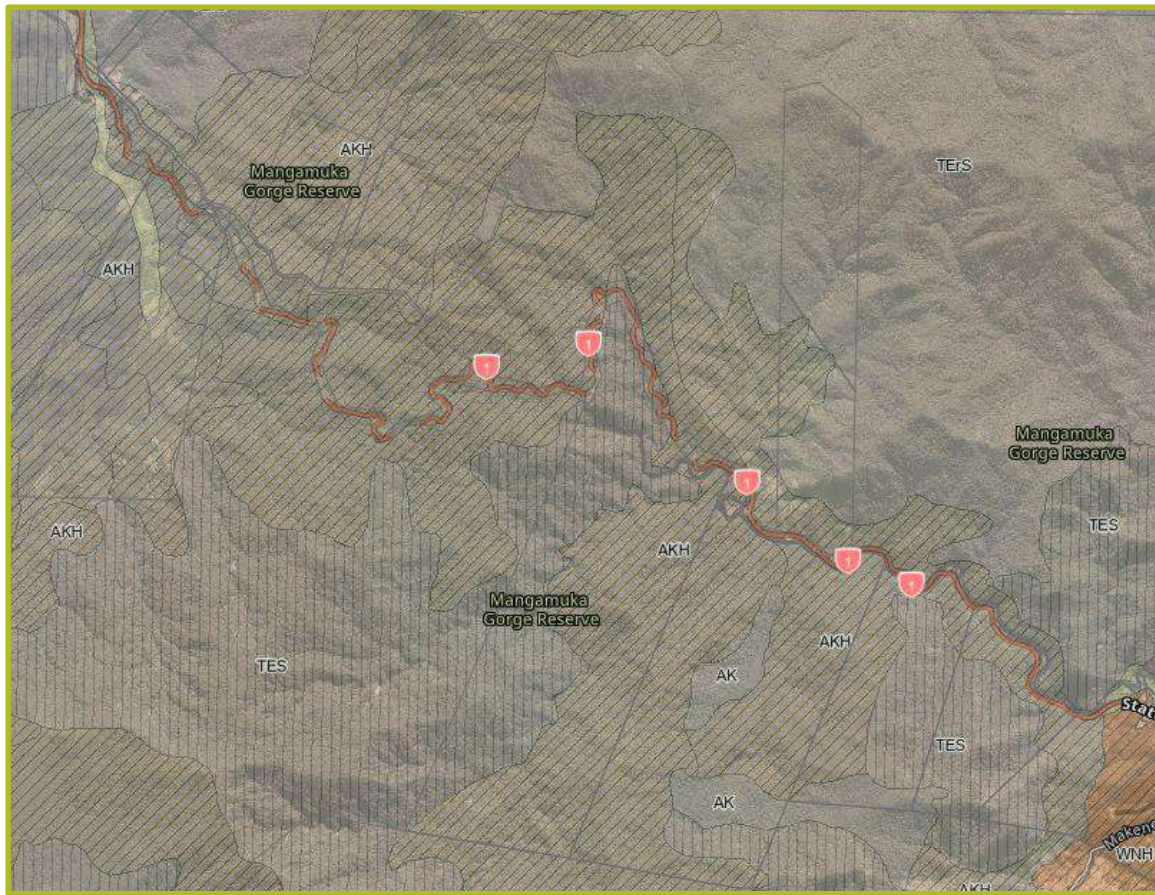
As identified in **Section 3.3.2.1**, the soil types at Peria Valley Road are KNH and YCe, whereas the soil types on the northern end of Mangamuka Gorge are identified as TES and AKH and AK (refer **Figure 23**), which are Te Kie stony clay loam stepland soils and Awapuku clay loam respectively (refer **Appendix D** for factsheets). The soils at the cleanfill site are predominantly limestone soils, whilst the soils from the Gorge are young-semi volcanic soils. This means that as a result of the cleanfill activity, soil types that differ from those on-site have been deposited. The young semi-volcanic soils, as per the factsheet, can be productive soils and good for pastoral farming, therefore their deposition within a pastoral environment would not adversely impact on the productive capacity.

**Figure 23: Soil Types of Mangamuka Gorge** (Source: NRC Managing Northland Soils factsheet viewer - accessed 5 December 2024)

When considering the properties of the soils, the limestone soils are poorly drained, and prone to becoming waterlogged (particularly in winter) which would have assisted in maintaining wetland conditions. The young semi-volcanic soils are generally well drained, therefore this would indicate that the soil types present as a result of the cleanfill activity would be less likely to create the conditions for the area to return to wetland (of which the loss of the wetland is assessed in the following sections). The end result of this is it is now considered, that as a consequence of the cleanfill activity, the area of land would now be conducive to rural production activities, such as the pastoral grazing of stock, of which the site is currently and remains to be used for.

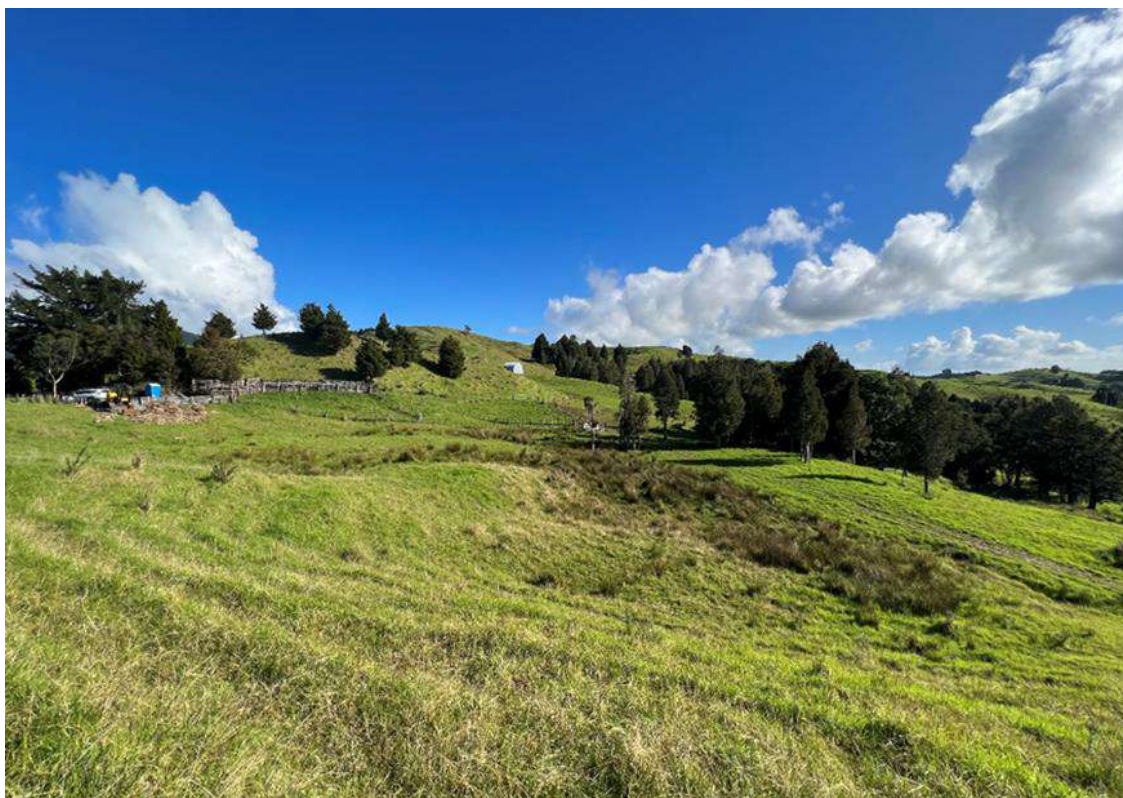
Plate 4-1: Overview of the Site, showing exotic grassland on hillslope (foreground) and hillslope seepage (right of centre).

Rapid visual assessment confirmed that most of the spoil disposal area is exotic grassland on hillslopes. This grassland is dominated by kikuyu (*Cenchrus clandestinus*), paspalum (*Paspalum urvillei*), parsley dropwort (*Oenanthe pimpellinoides*), and buttercup (*Ranunculus repens*) with occasional gorse (*Ulex europaeus*) (Plate 4-1).

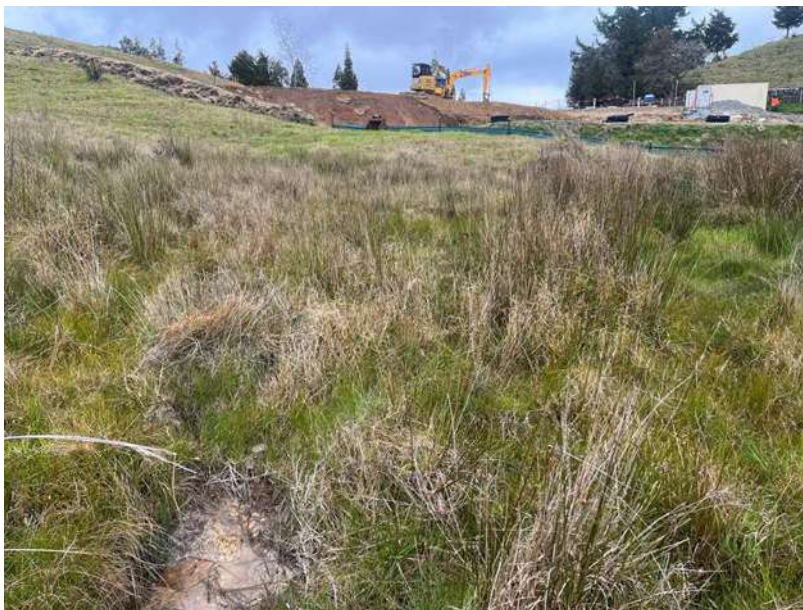
The lower hillslope within the spoil disposal site is a hillslope seepage wetland (Plate 4-2). This area meets the definition of a wetland provided in the Resource Management Act 1991, as it comprises “permanently or intermittently wet areas... that support a natural ecosystem of plants and animals that are adapted to wet conditions”. This wetland type occurs on sloping ground where the groundwater levels are close to or at the ground surface, resulting in permanently wet soils (Wildland Consultants, 2012). The hydrophytic vegetation in this seepage (Figure 4-1) meets the tests and definitions of a natural inland wetland in the NPS-FM and NES-FW. Whilst the lower edge of the wetland may have higher water levels due to the construction of an adjacent farm race, the wetland is on a sloping surface, and most of the wetland lies at a higher elevation than this race and is not there due to this artificial impoundment. Additionally, the water source does not exclude this wetland as a natural inland wetland as the site has a permanently high water table that interacts with the ground surface (vs. the alternative of only being subject to temporary rain-derived water pooling). The wetland is dominated by two indigenous species, wīwī (*Juncus edgariae* – facultative wetland species) and spike sedge (*Eleocharis acuta* – obligate wetland species) (Plate 4-2). Mercer grass (*Paspalum distichum*), and soft rush (*Juncus effusus* var. *effusus*) are also present, and exotic grasses increase in abundance towards the drier top edge of the wetland.

**Plate 4-2: Hillslope seepage wetland within the spoil disposal area. The vegetation is dominated by wīwī (*Juncus edgariae*), and spike sedge (*Eleocharis acuta*) is common.**

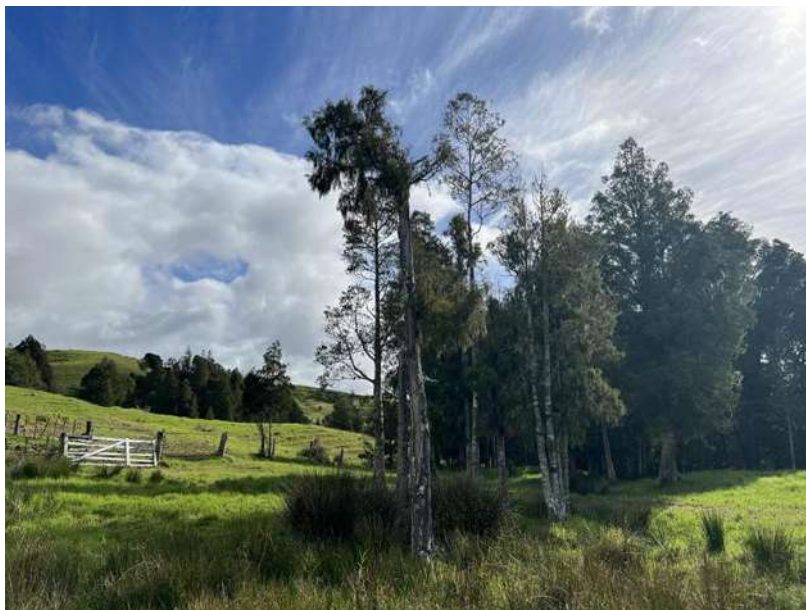
**Plate 4-3: Kahikatea-rimu treeland on the northwest edge of the hillslope seepage wetland.**

Near the northwest edge of the hillslope seepage wetland is a small area of kahikatea-rimu treeland. This treeland comprises seven kahikatea and two rimu (*Dacrydium cupressinum*) (Summer Fill Area, Figure 1-1). Many of these trees exhibited late-stage symptoms of disease and/or overall stunted growth and ill-health (Plate 4-3). Whilst small, this treeland meets the definition of an indigenous wetland in the Far North District Plan (Appendix I).

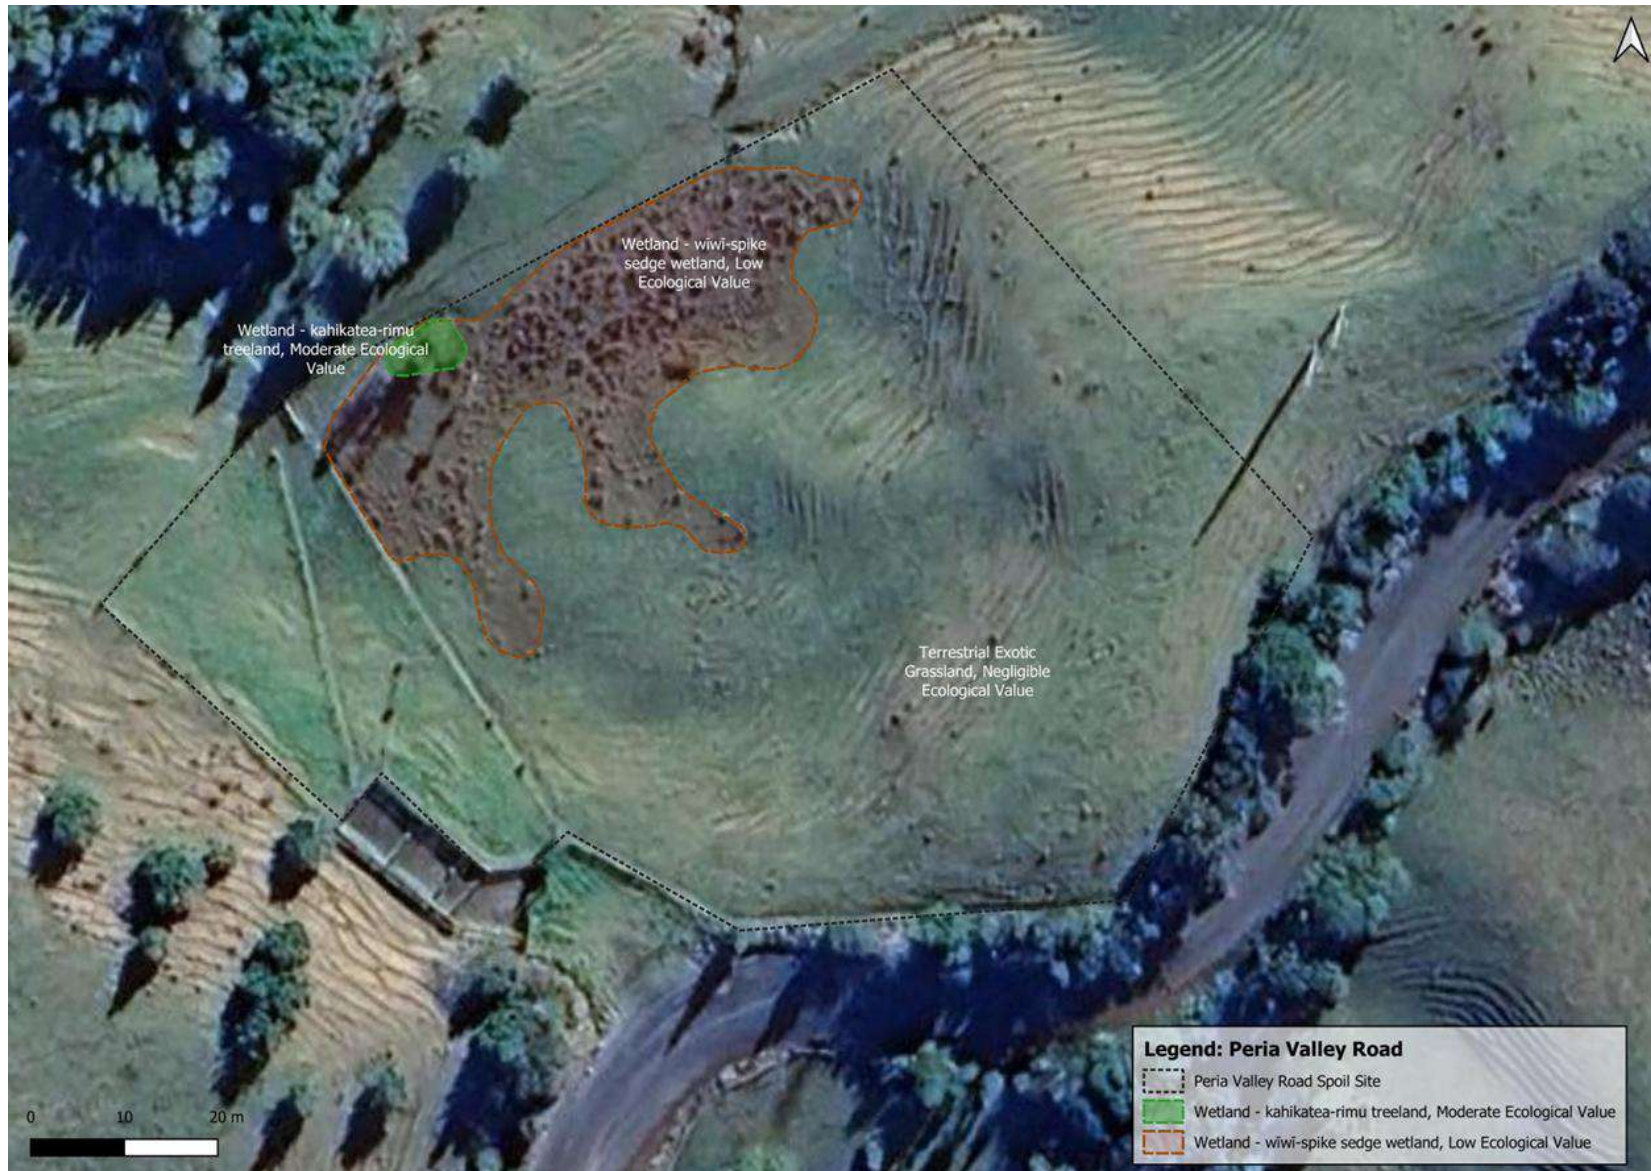
Figure 4-1: Map of vegetation and habitats at the proposed soil disposal site at 184 Peria Valley Road, Northland.

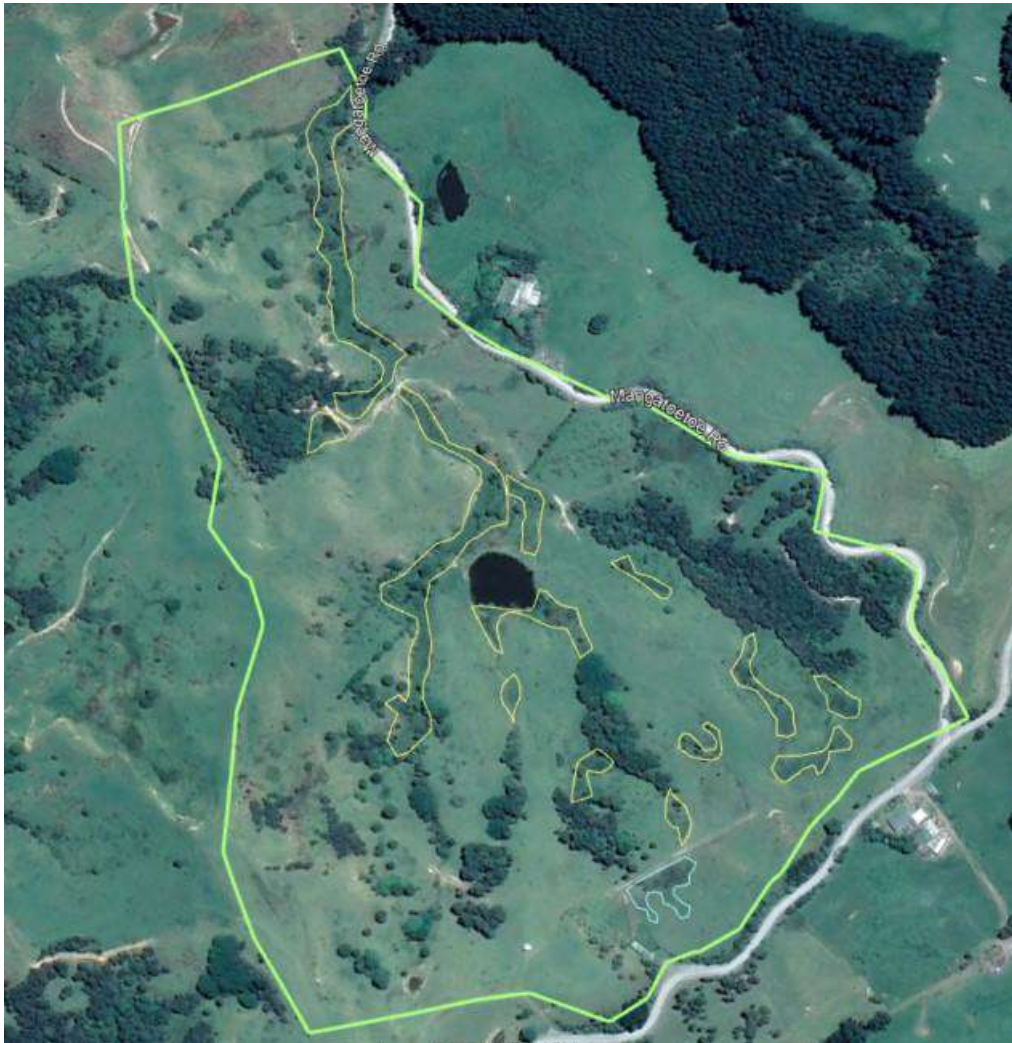
**Figure 4 1: Desktop map of wetland habitats in the catchment of the spoil site. The wetland within the spoil site is shown in blue. Additional wetland areas are likely present but concealed from view by tree canopy.**

A desktop map was produced of wetland areas in the wider catchment area, using Google Earth imagery.

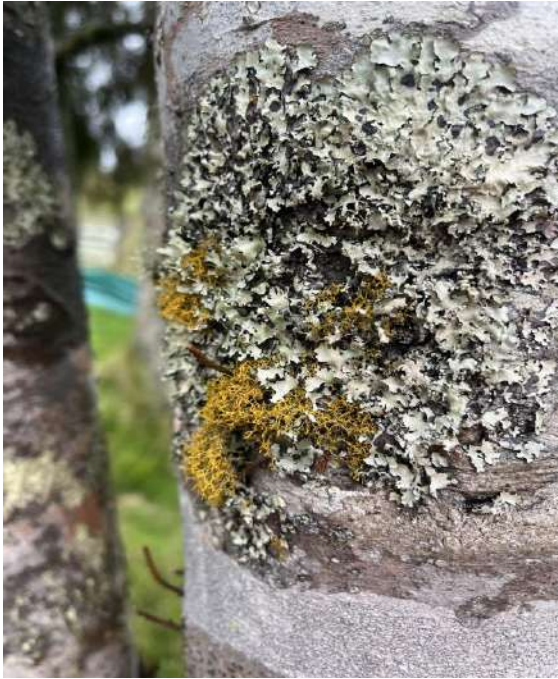
The Site is known to support one 'At Risk' species. The kahikatea in the kahikatea-rimu treeland is habitat for an epiphytic lichen, *Teloschistes flavicans*, which has a conservation status of 'At Risk-Declining' (Plate 4-4) (de Lange et al., 2018). The lower trunks of the trees supported at least 10 plants (Plate 4-5), and additional plants may be present in the upper canopy. A second survey was undertaken on 14 September 2023 to determine the size of the local *Teloschistes* population on trees on the same property. The survey found a further c. 90 individuals, spread across 16 other kahikatea within 250 m of the spoil disposal site. This is a conservative estimate of the size of the wider population, as the lichen favours canopy habitats and only trees on the edges of forest remnants could be observed.

Plate 4-4: *T. flavicans* (gold-coloured lichen) on kahikatea tree in hillslope seepage wetland within proposed spoil site.
