# Application for resource consent or fast-track resource consent

New Zealand Transport Agency Waka Kotahi (NZTA)

<b>NPSHPL</b>	National Policy Statement for Highly Productive Land 2022
<b>NRC</b>	Northland Regional Council
<b>NZCPS</b>	New Zealand Coastal Policy Statement 2010
<b>NZEM</b>	New Zealand Environmental Management Limited
<b>NZTA</b>	New Zealand Transport Agency Waka Kotahi
<b>pFNDP</b>	Proposed Far North District Plan 2024
<b>Project</b>	Establishment and operation of a cleanfill site
<b>pRPN</b>	Proposed Regional Plan for Northland 2024
<b>RMA</b>	Resource Management Act 1991
<b>RoT</b>	Record of Title
<b>RPS</b>	Regional Policy Statement for Northland
<b>SH1</b>	State Highway 1
<b>Site</b>	Lot 1 DP 35169 adjacent to 184 Peria Valley Road, Kaitaia
<b>Slip Response</b>	Mangamuka Slip Response Project 2022

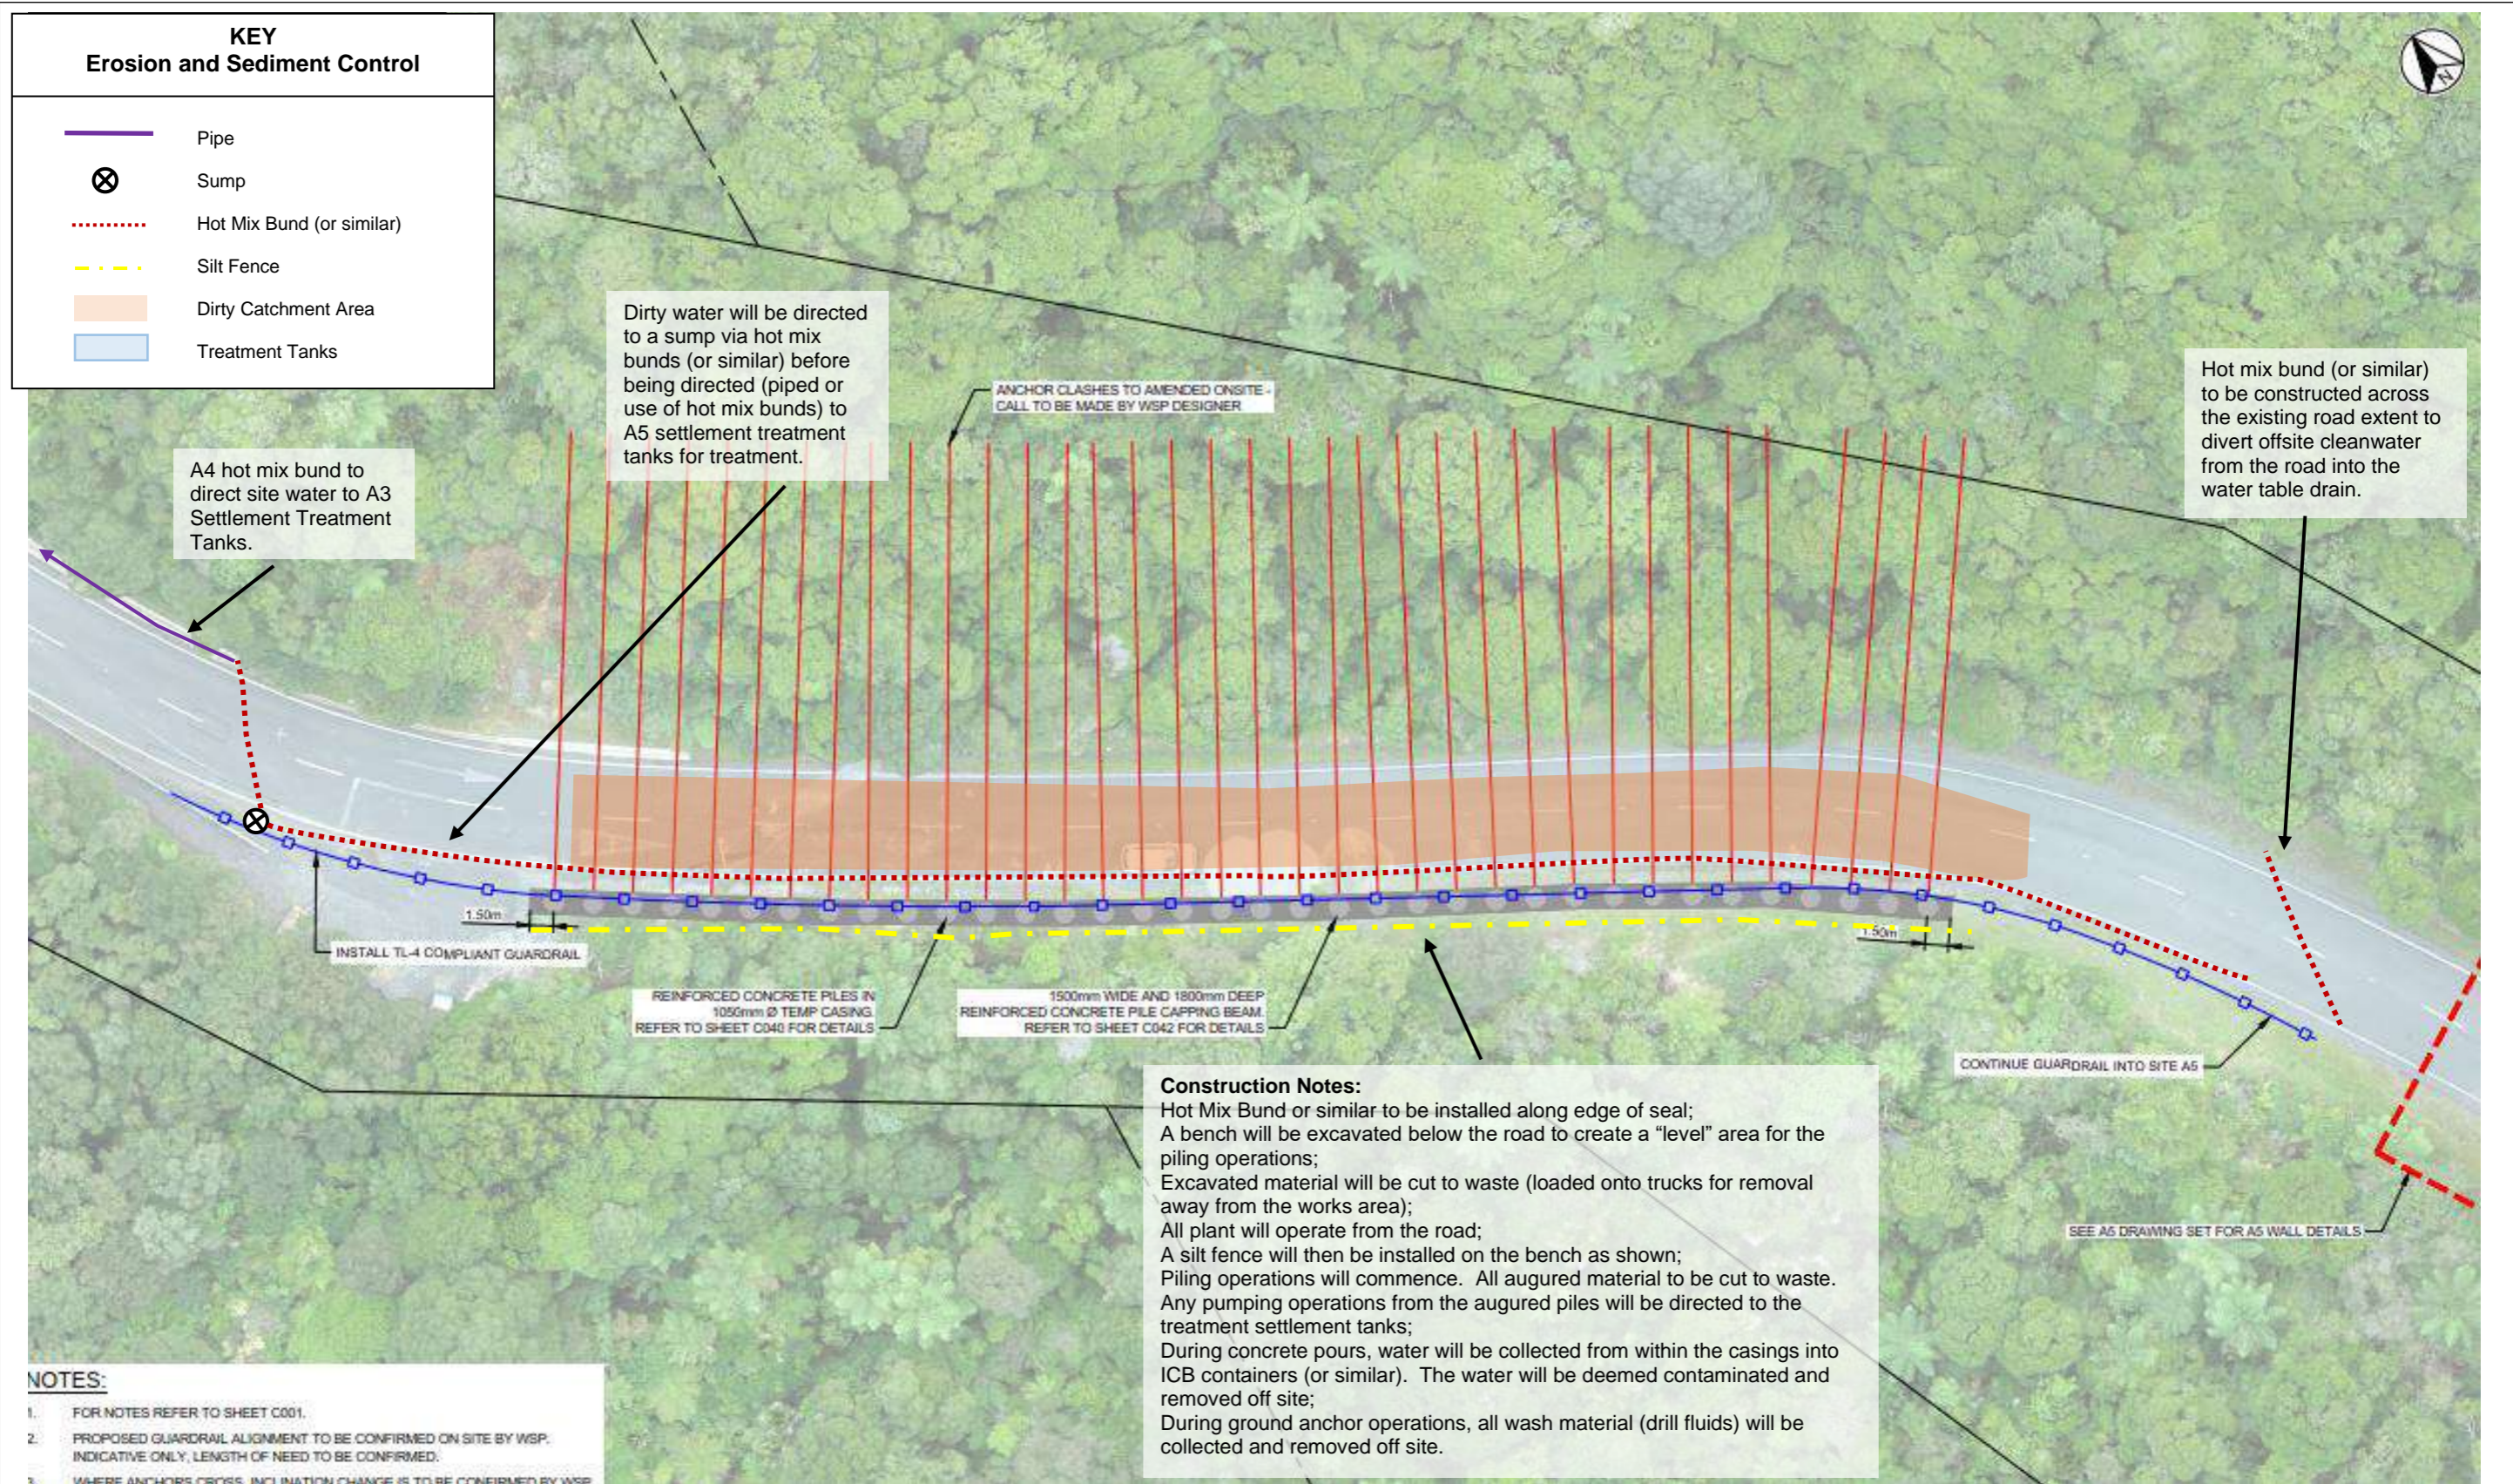
Project	<b>MANGAMUKA GORGE</b>
		Title	<b>Erosion and Sediment Control Plan – Stage A12-13 (Sheet 1 of 2)</b>
Drawn <b>MD</b>	Checked <b>CS</b>	Drawing No. <b>ESCP-001-05</b>	Sheet No. <b>05</b>

A4 hot mix bund to direct site water to A3 Settlement Treatment Tanks.

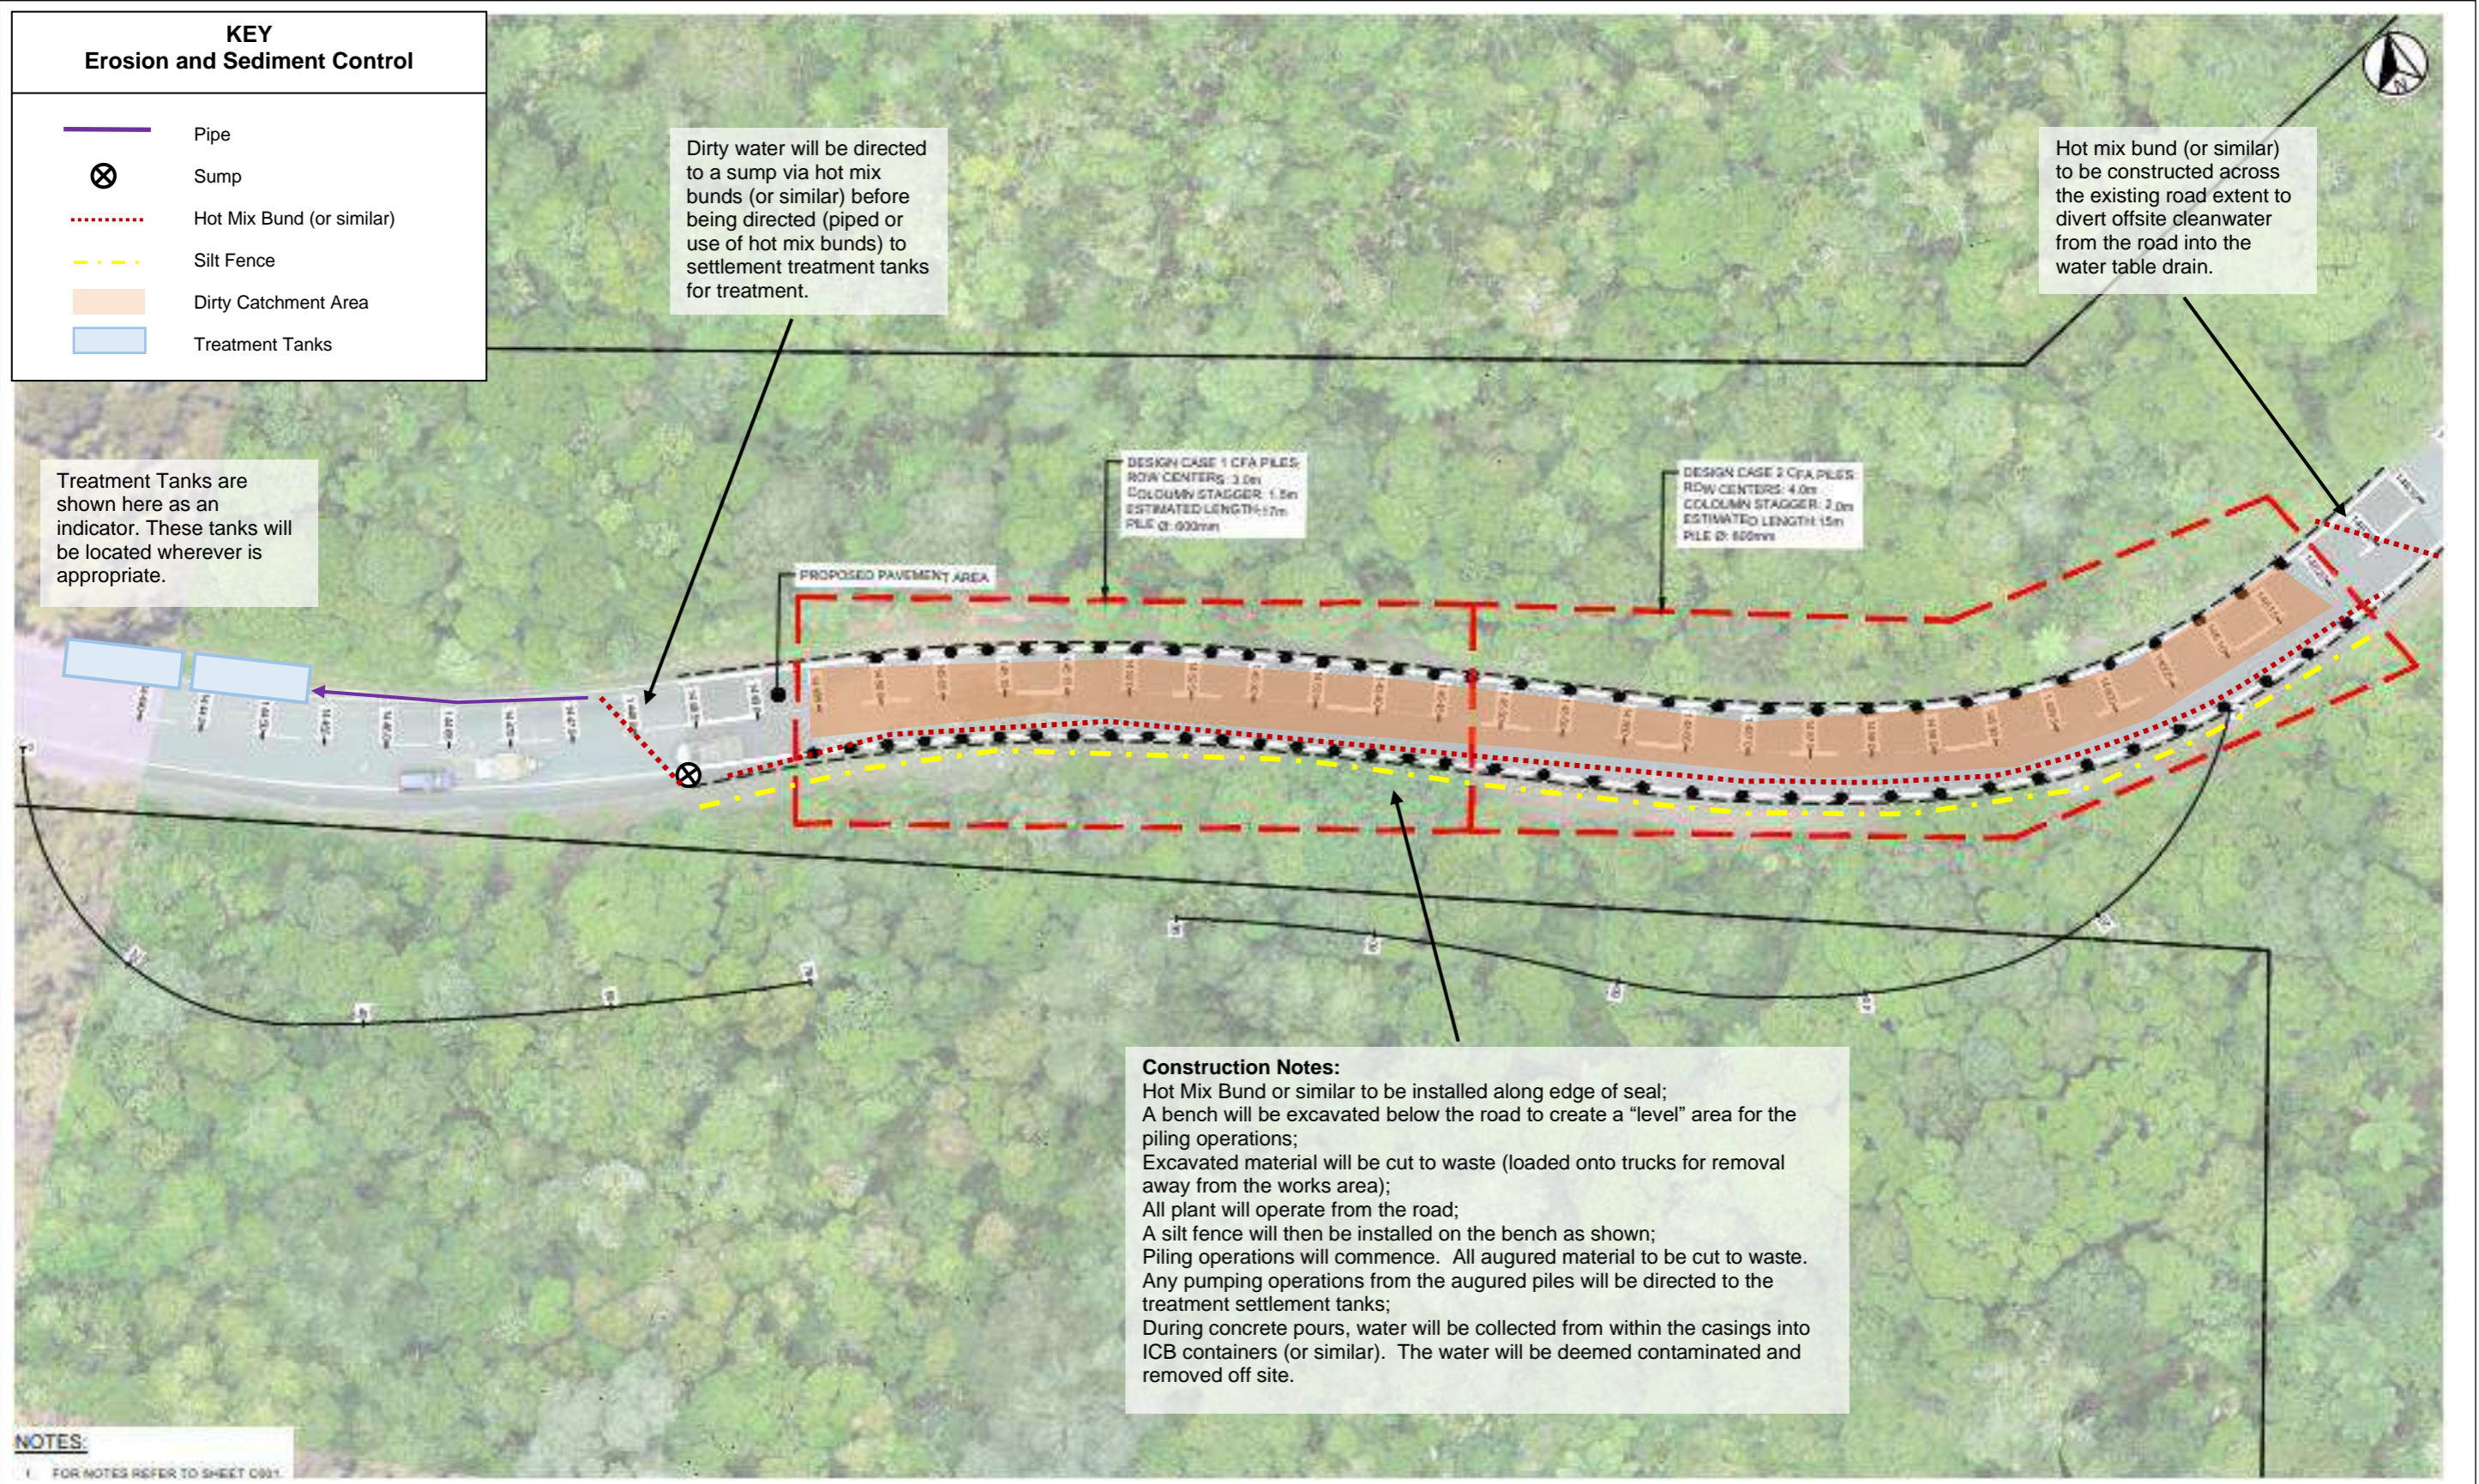
Project <b>MAUNGAMUKA GORGE</b>	Sheet No. <b>10</b>
Title <b>Erosion and Sediment Control Plan – Stage A7</b>	Drawing No. <b>ESCP-001-10</b>

Dirty water will be directed to a sump via hot mix bunds (or similar) before being directed (piped or use of hot mix bunds) to settlement treatment tanks for treatment.

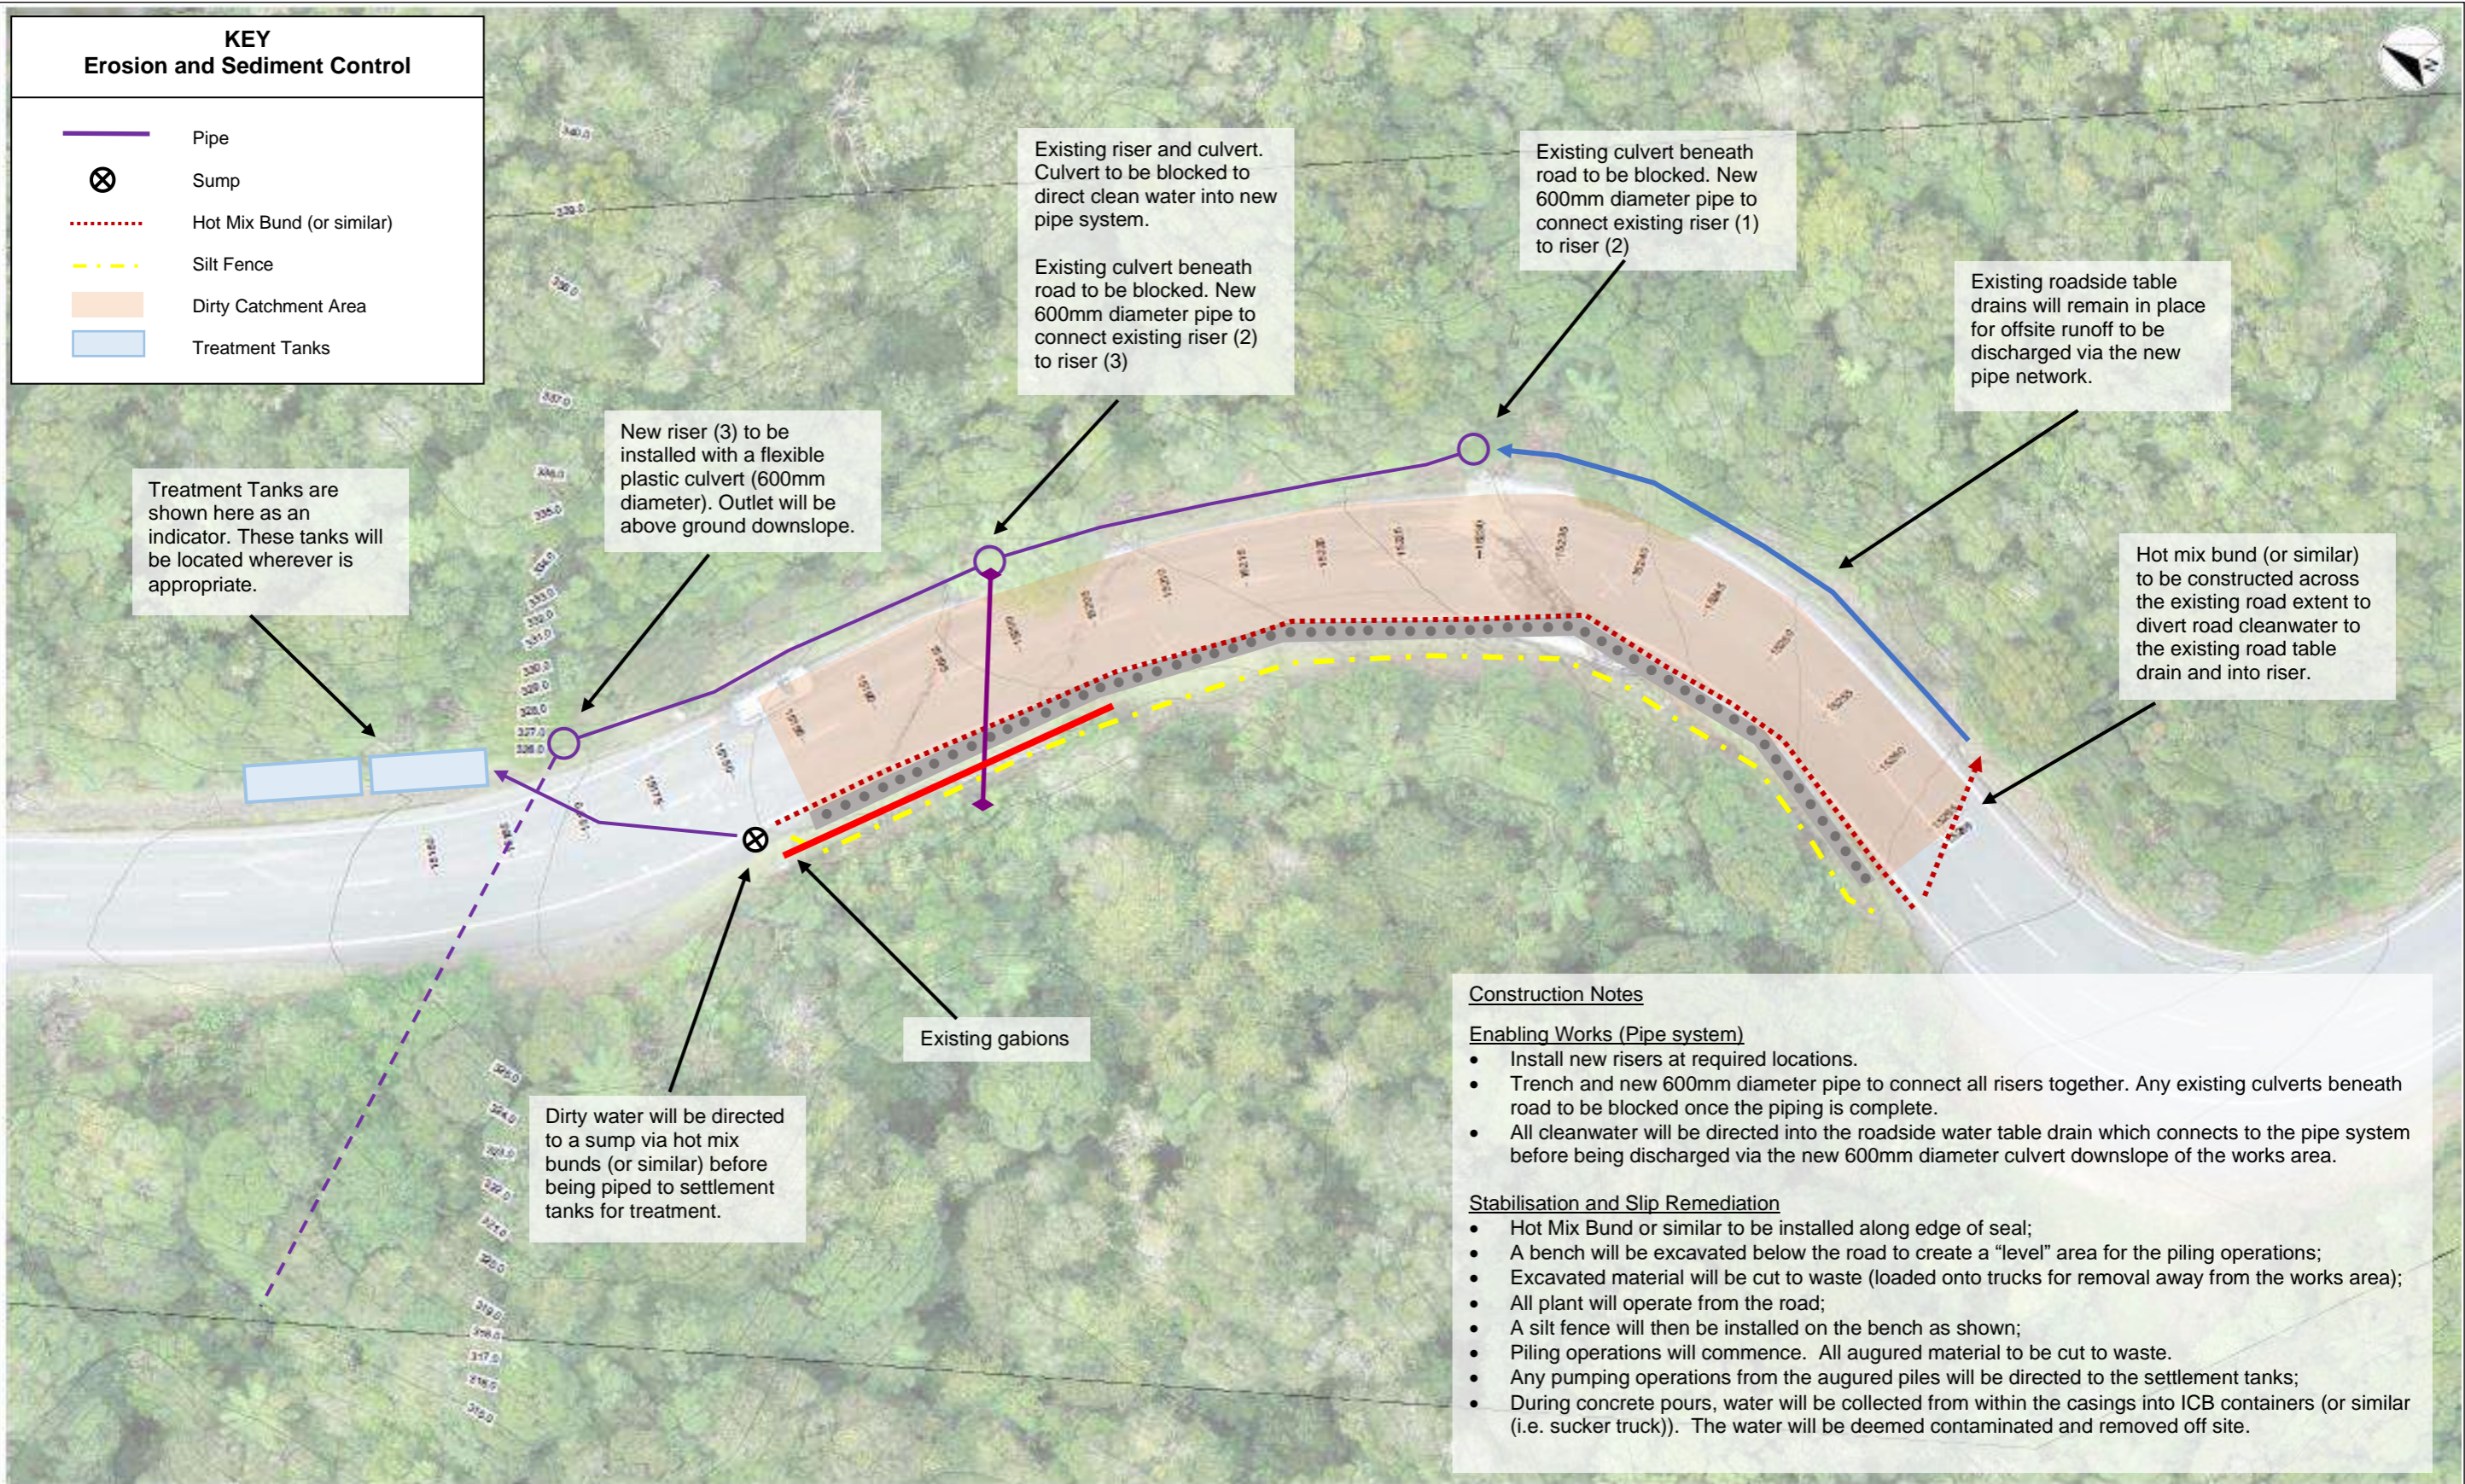
Project <b>MAUNGAMUKA GORGE</b>	Sheet No. <b>11</b>
Title <b>Erosion and Sediment Control Plan – Stage A8</b>	Drawing No. <b>ESCP-001-11</b>

Treatment Tanks are shown here as an indicator. These tanks will be located wherever is appropriate.

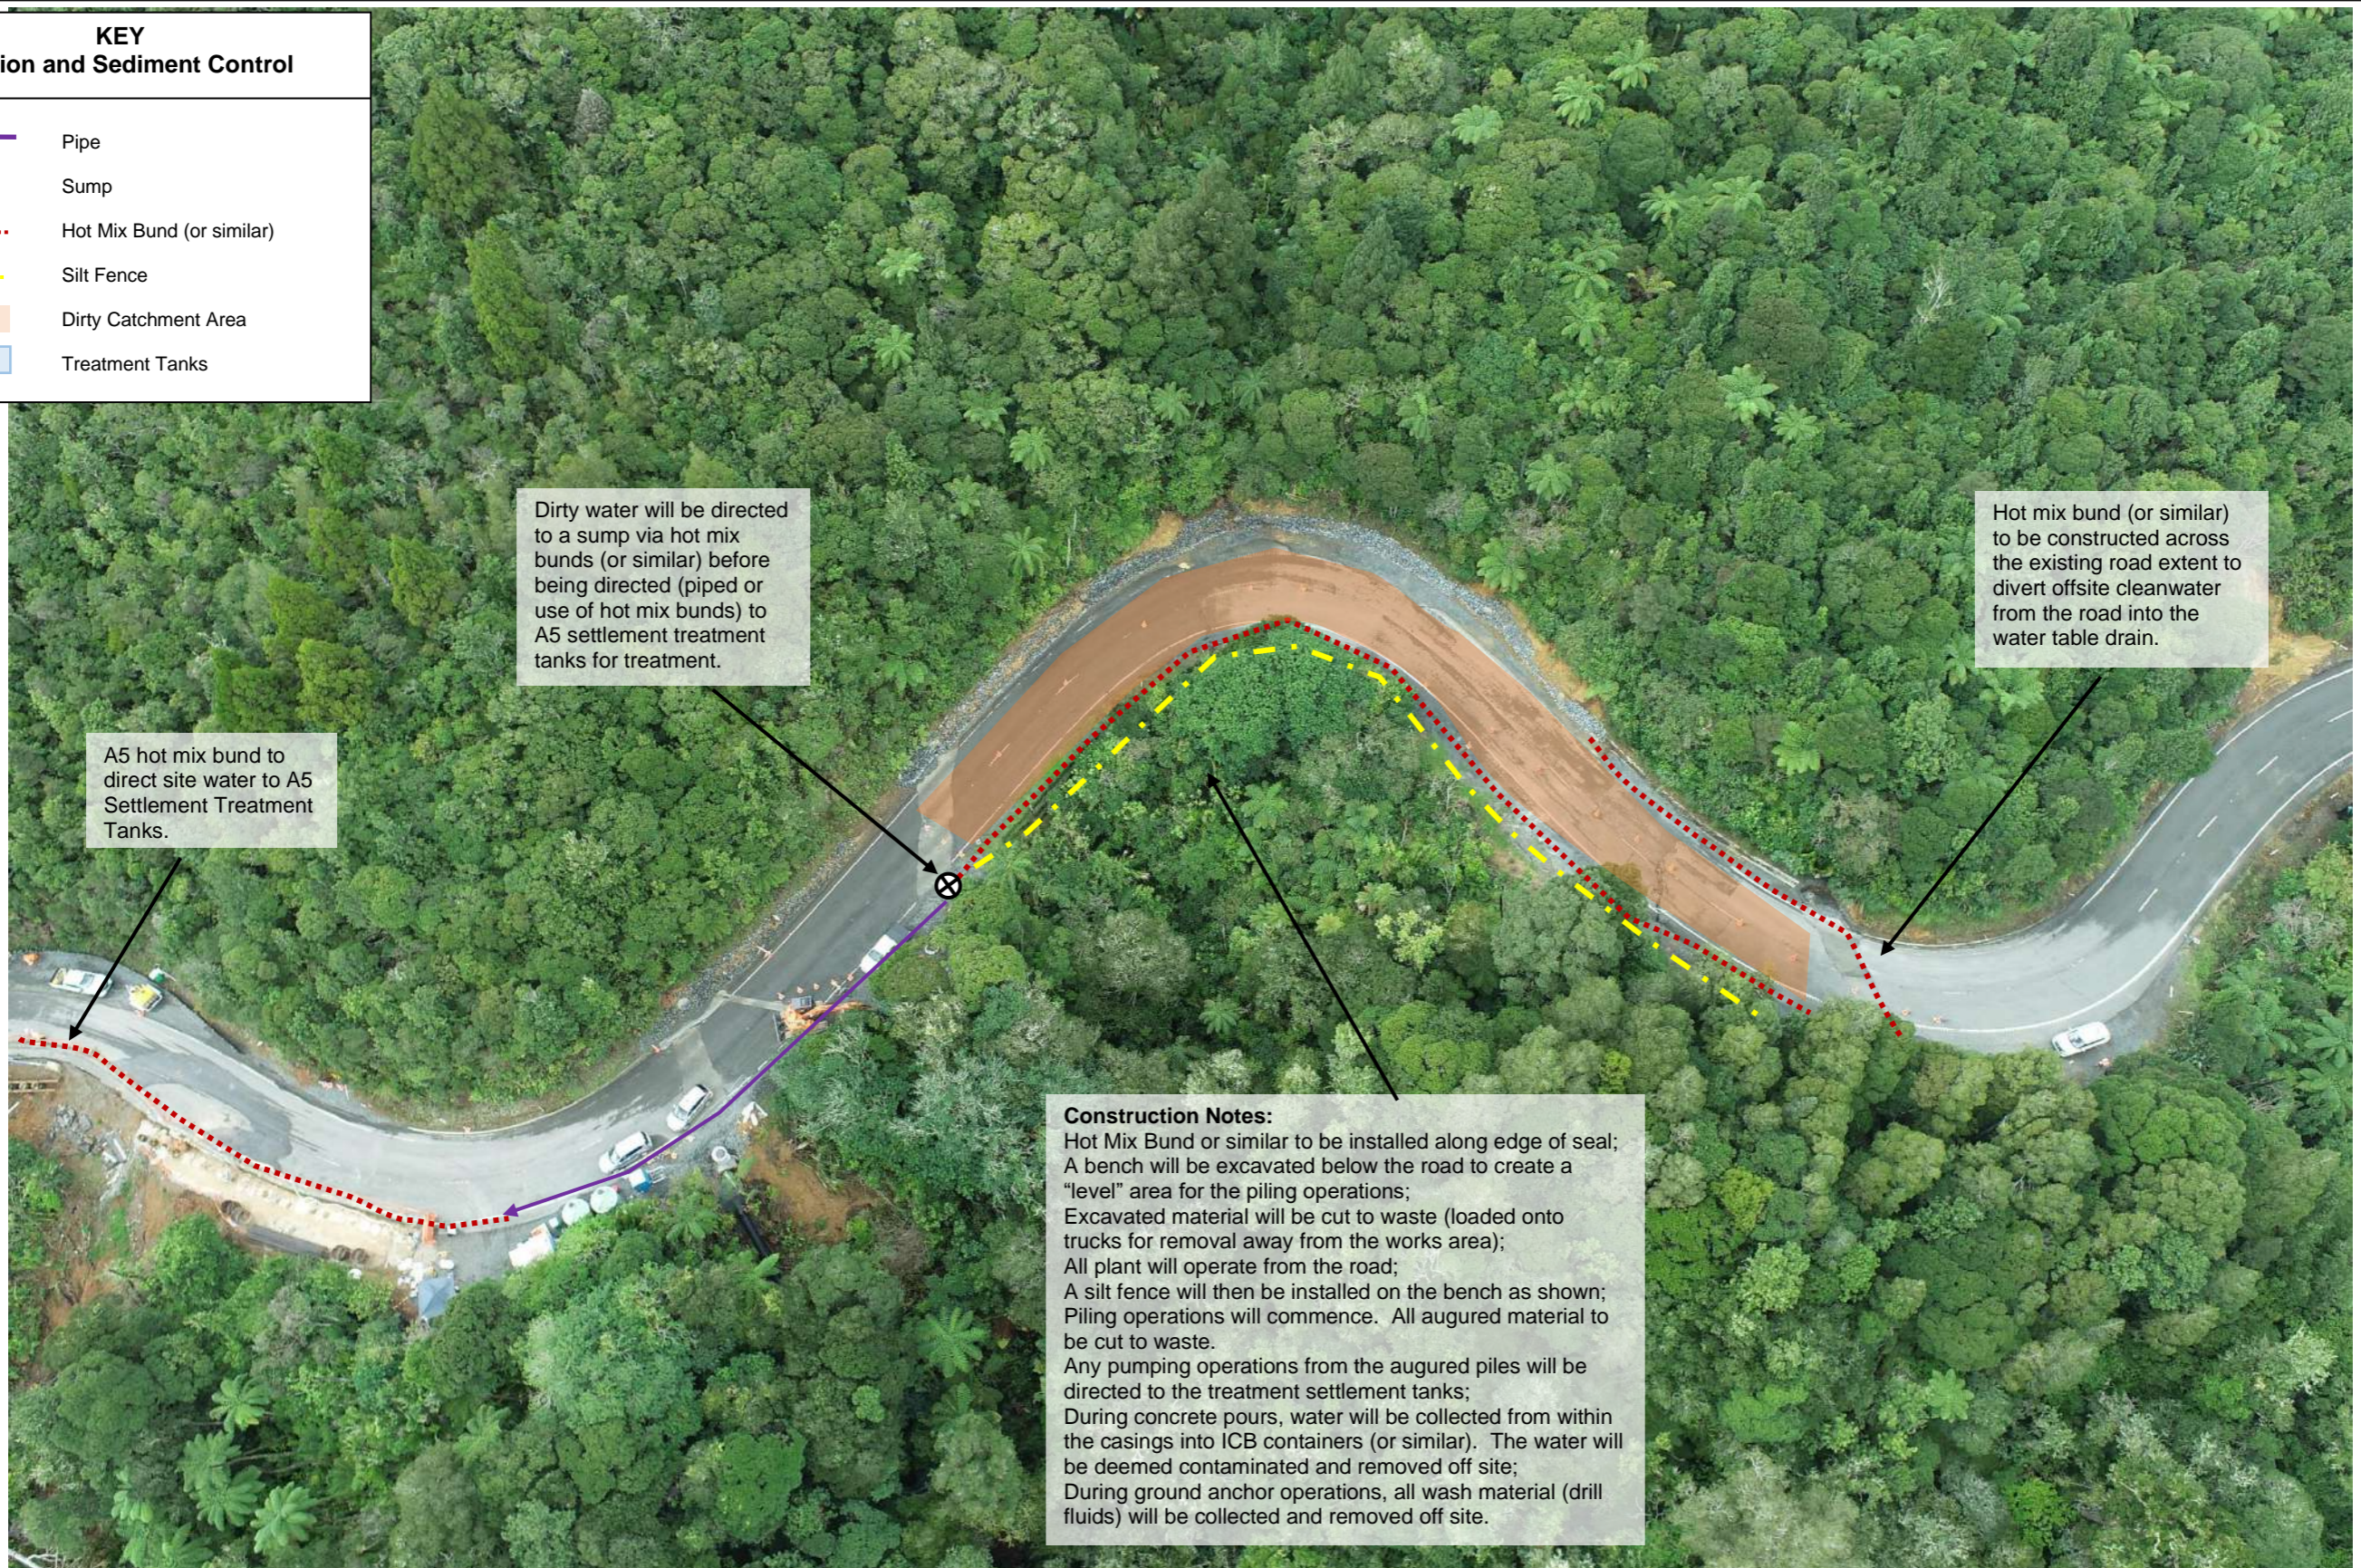
A5 hot mix bund to direct site water to A5 Settlement Treatment Tanks.

Dirty water will be directed to a sump via hot mix bunds (or similar) before being directed (piped or use of hot mix bunds) to A5 settlement treatment tanks for treatment.

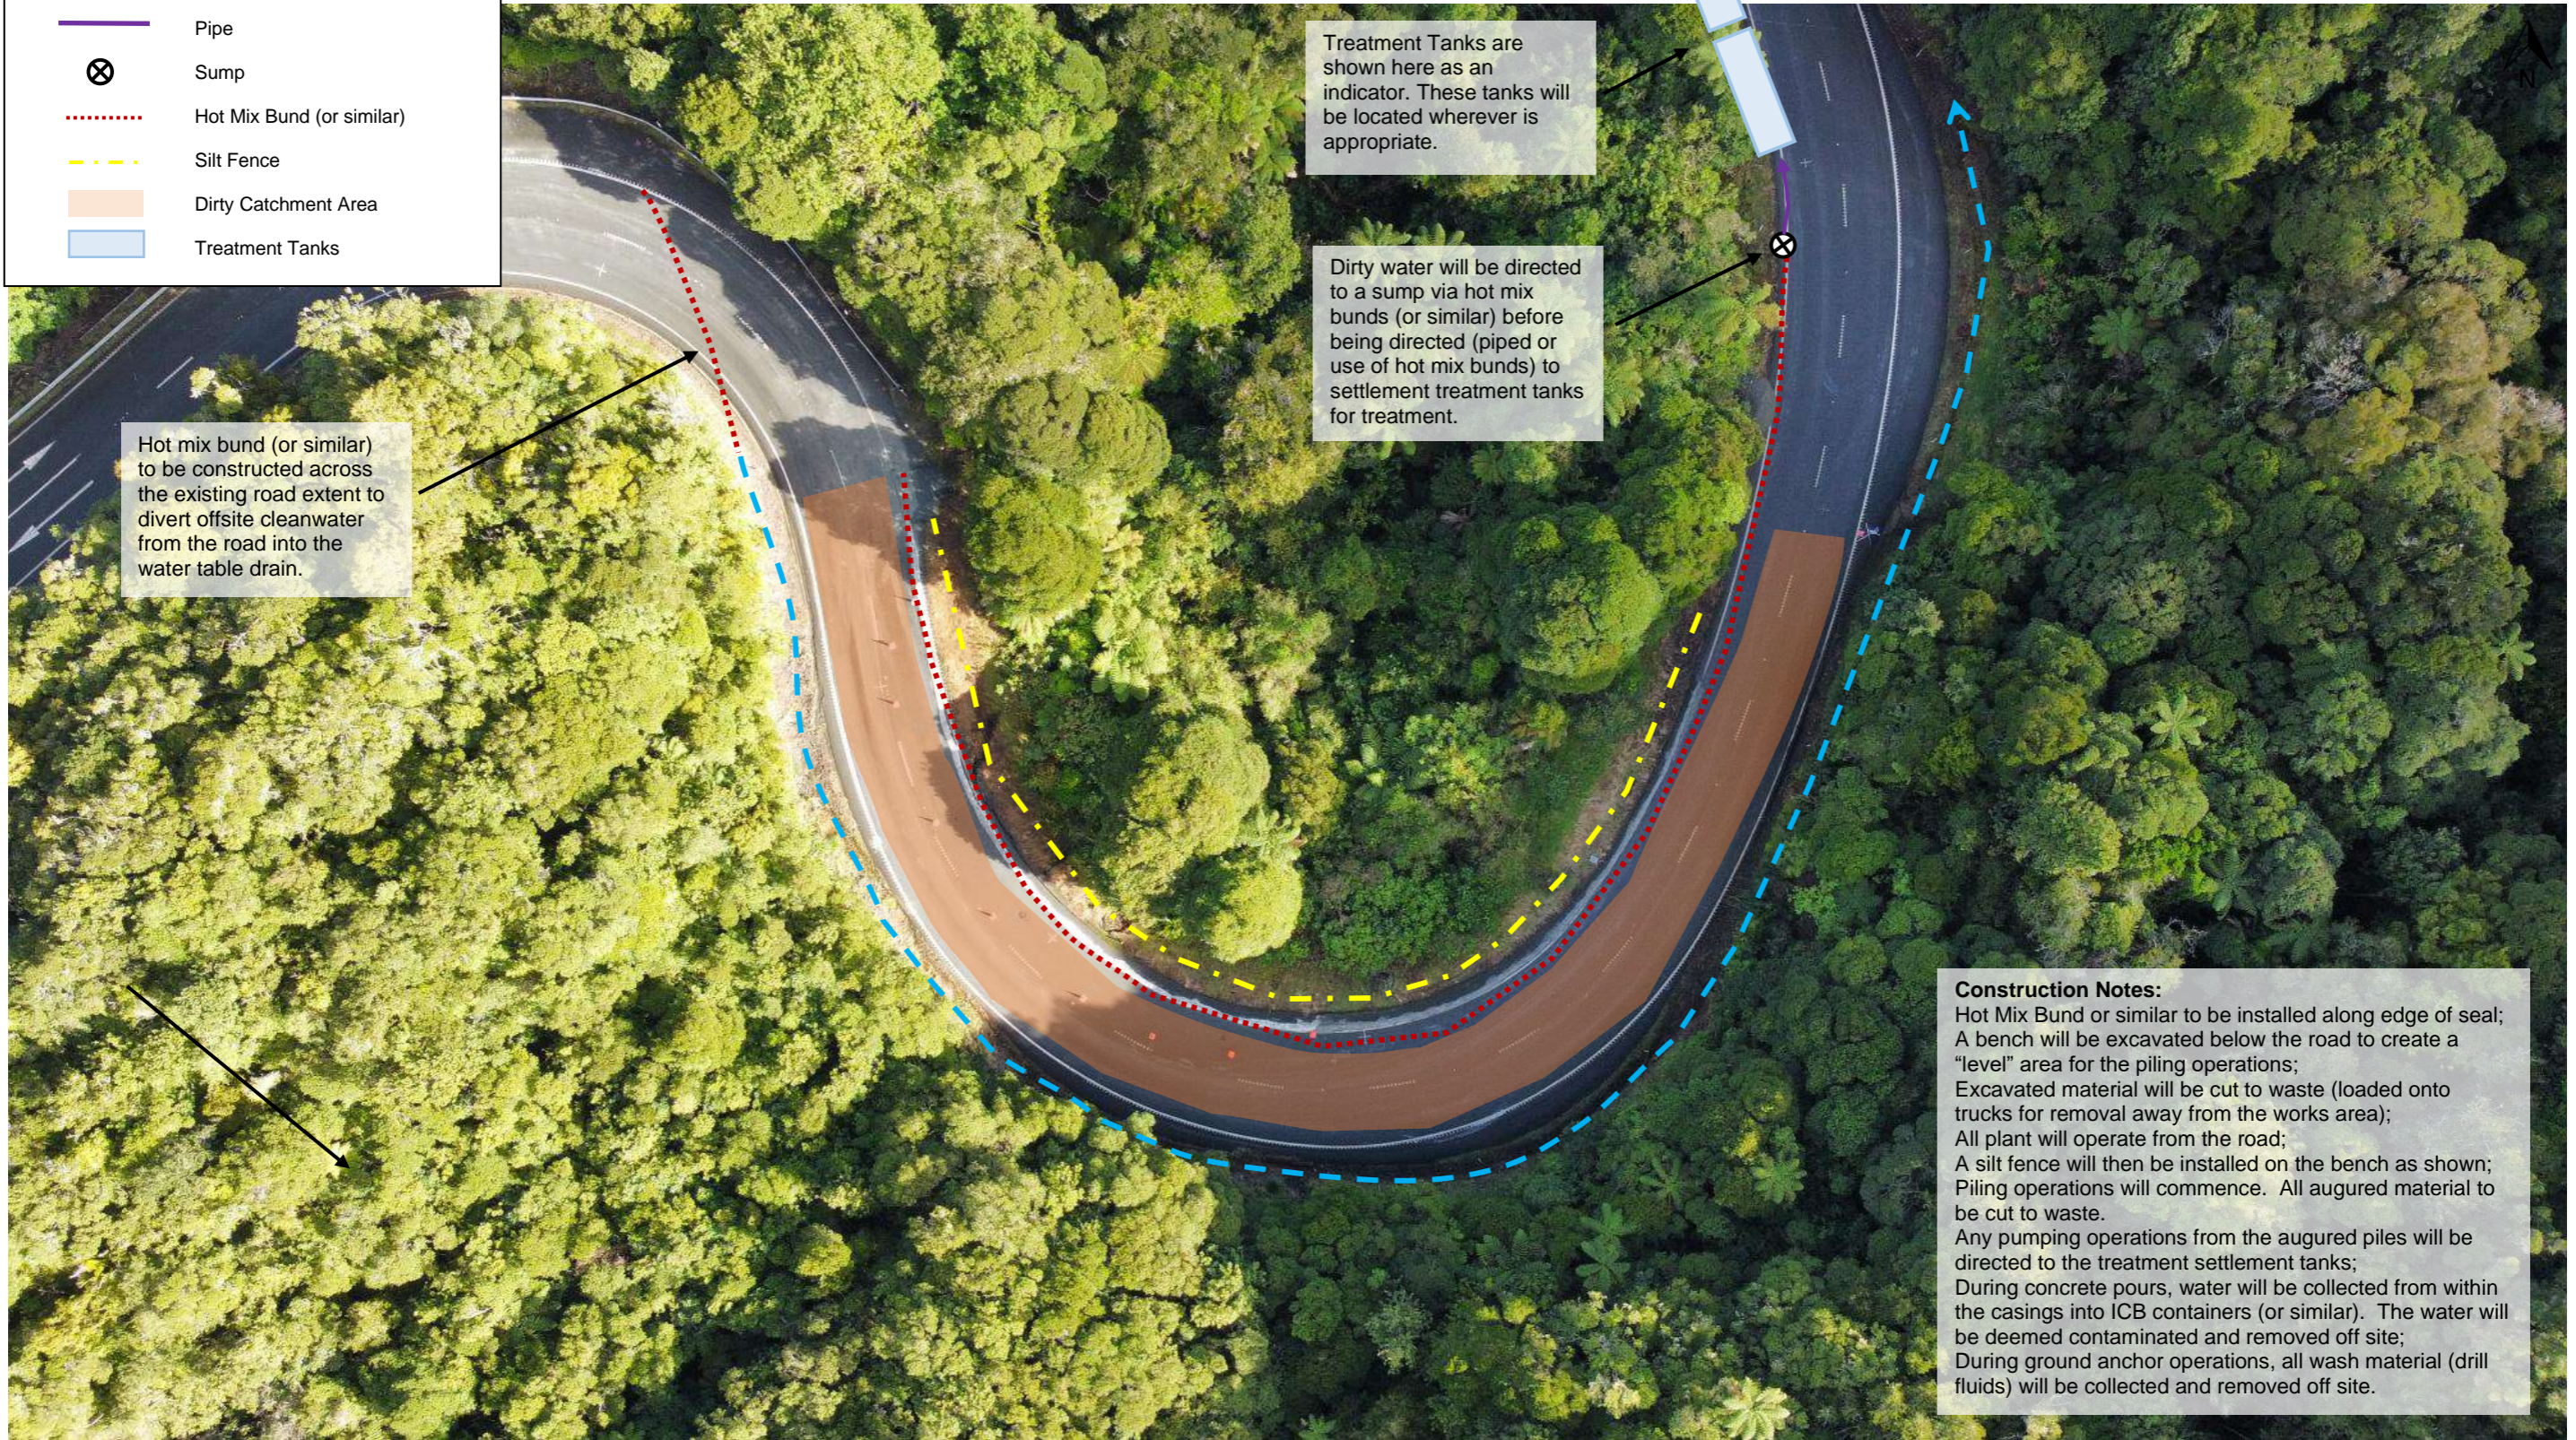
**Construction Notes:**  
 Hot Mix Bund or similar to be installed along edge of seal;  
 A bench will be excavated below the road to create a "level" area for the piling operations;  
 Excavated material will be cut to waste (loaded onto trucks for removal away from the works area);  
 All plant will operate from the road;  
 A silt fence will then be installed on the bench as shown;  
 Piling operations will commence. All augured material to be cut to waste.  
 Any pumping operations from the augured piles will be directed to the treatment settlement tanks;  
 During concrete pours, water will be collected from within the casings into ICB containers (or similar). The water will be deemed contaminated and removed off site;  
 During ground anchor operations, all wash material (drill fluids) will be collected and removed off site.

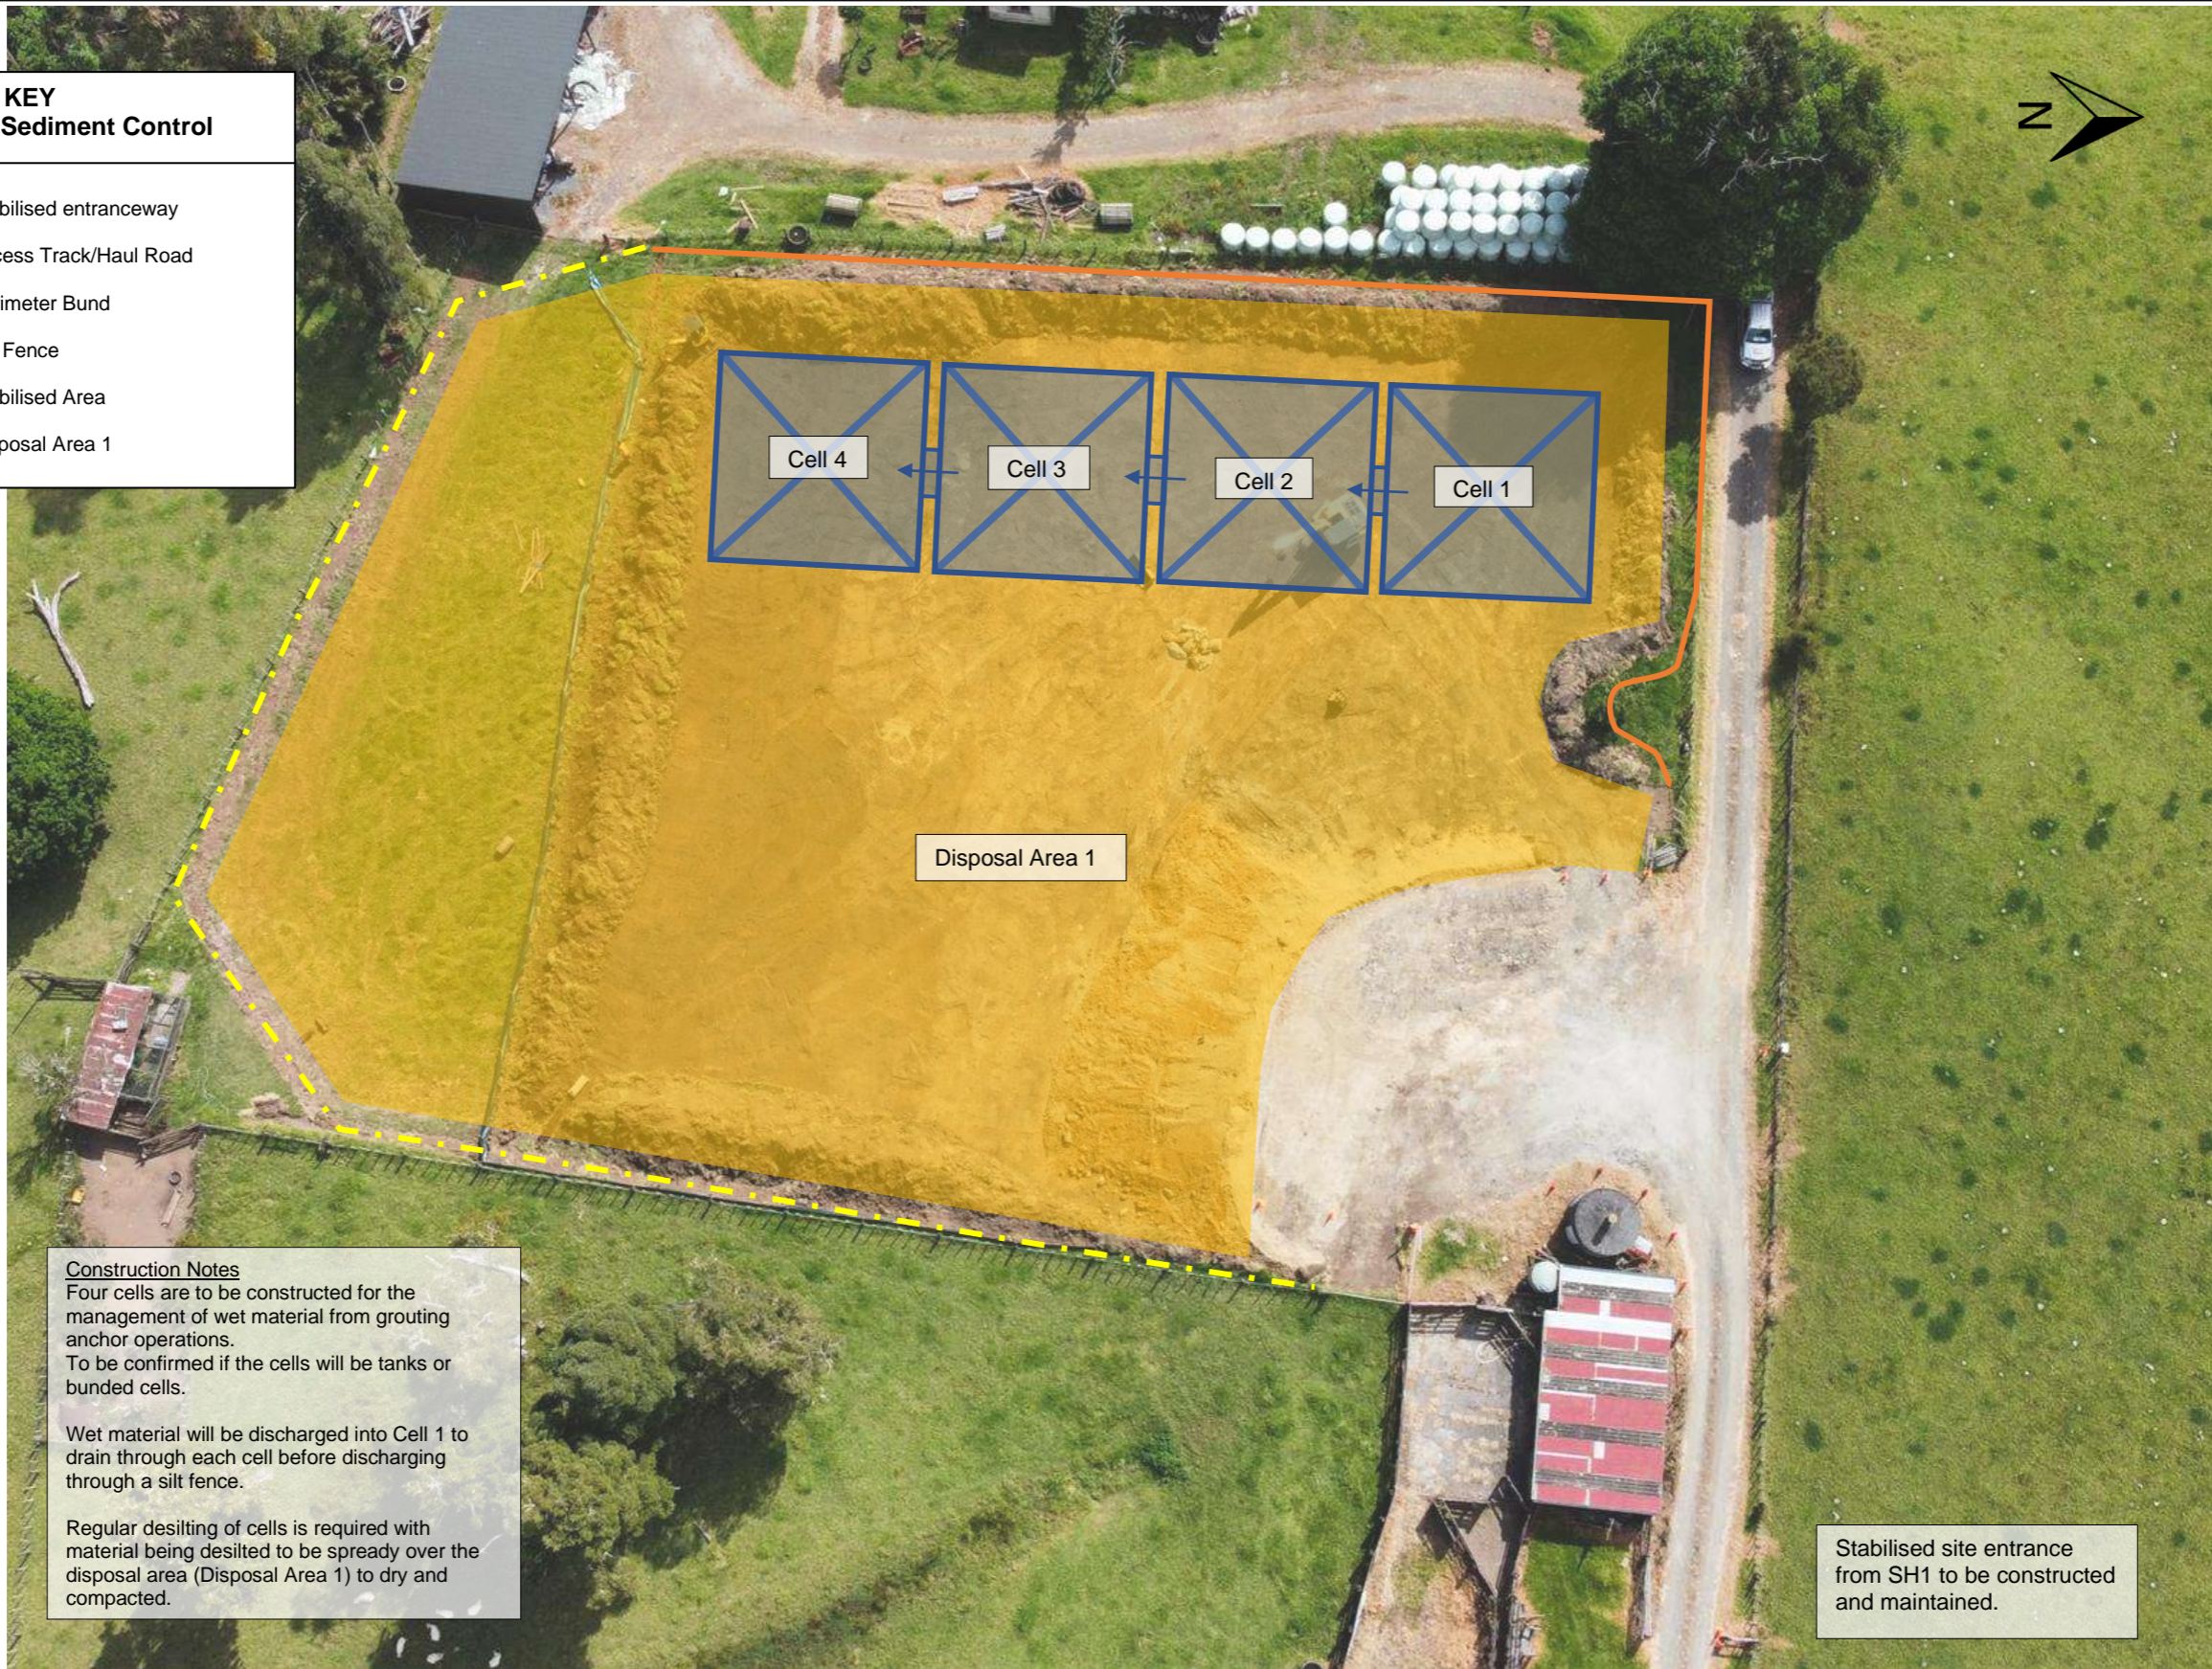
**Construction Notes**  
Four cells are to be constructed for the management of wet material from grouting anchor operations.  
To be confirmed if the cells will be tanks or banded cells.
