# Application for resource consent or fast-track resource consent

New Zealand Transport Agency Waka Kotahi (NZTA)

<b>NPSHPL</b>	National Policy Statement for Highly Productive Land 2022
<b>NRC</b>	Northland Regional Council
<b>NZCPS</b>	New Zealand Coastal Policy Statement 2010
<b>NZEM</b>	New Zealand Environmental Management Limited
<b>NZTA</b>	New Zealand Transport Agency Waka Kotahi
<b>pFNDP</b>	Proposed Far North District Plan 2024
<b>Project</b>	Establishment and operation of a cleanfill site
<b>pRPN</b>	Proposed Regional Plan for Northland 2024
<b>RMA</b>	Resource Management Act 1991
<b>RoT</b>	Record of Title
<b>RPS</b>	Regional Policy Statement for Northland
<b>SH1</b>	State Highway 1
<b>Site</b>	Lot 1 DP 35169 adjacent to 184 Peria Valley Road, Kaitaia
<b>Slip Response</b>	Mangamuka Slip Response Project 2022

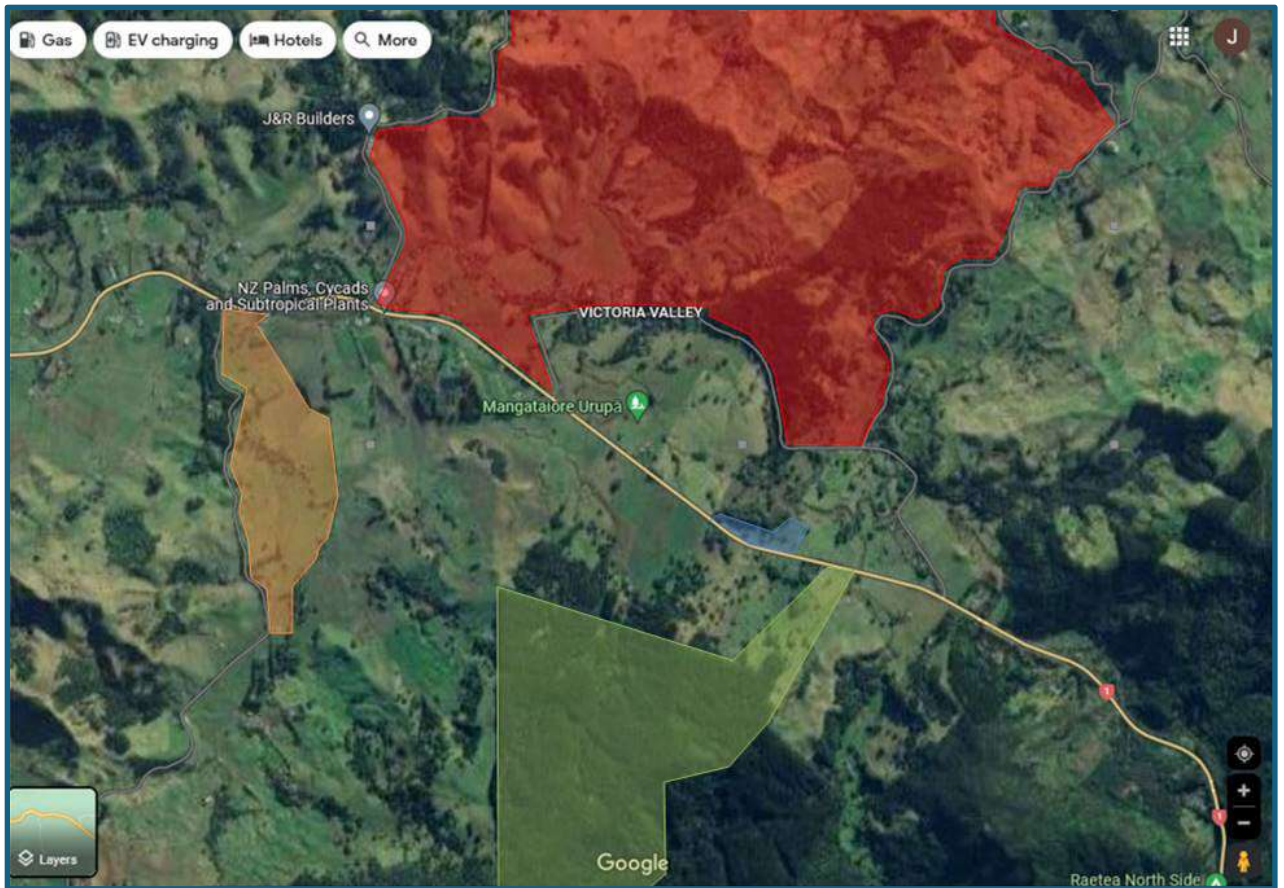
Kane Well's Farm – Most of the accessible places were in a flood hazard zone, but we managed to find a small area that wasn't. Blue colour on the above map.

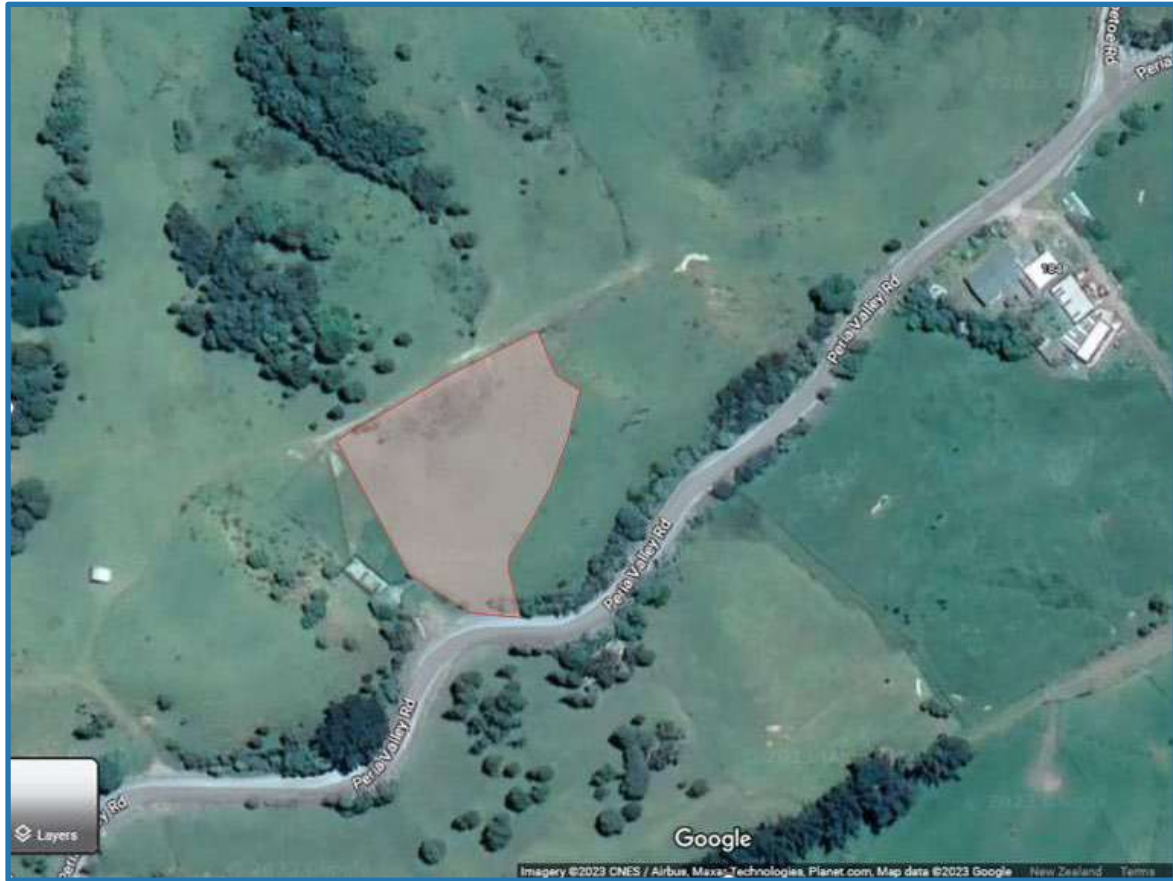
**Figure 1:** Aerial photograph of the site (2014 – 2014, NRC) showing approximate location of the fill site.

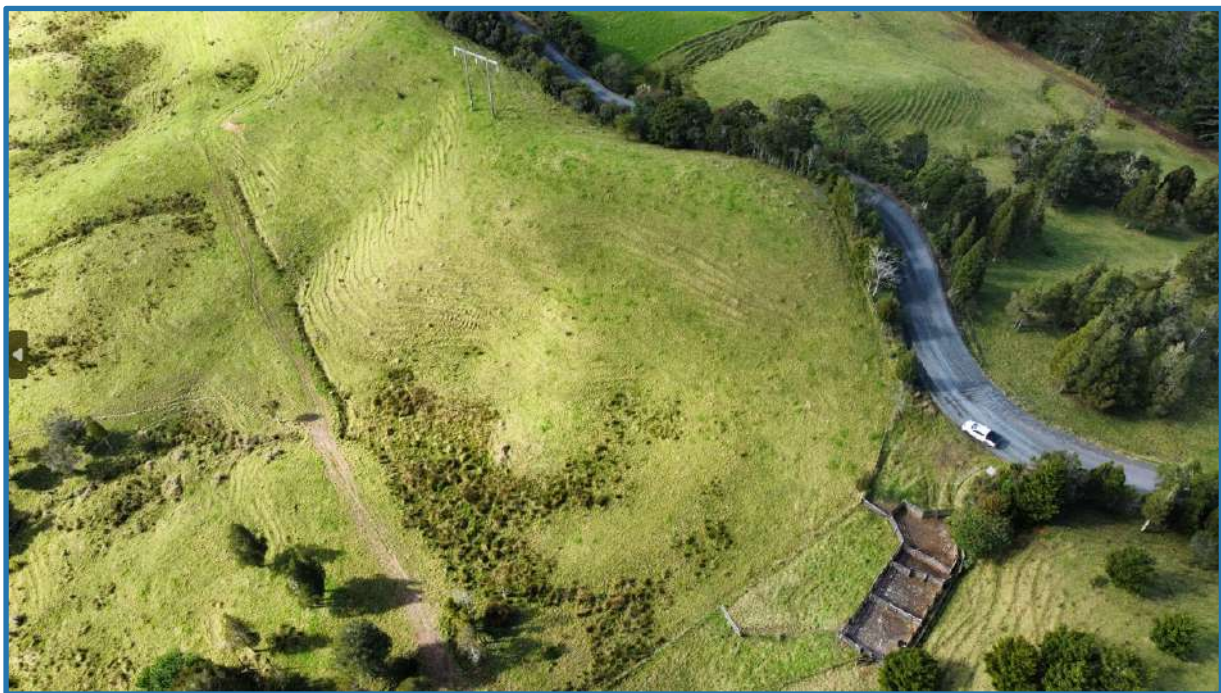
**Figure 2:** Aerial photo showing location of fill disposal site at 184 Peria Valley Road

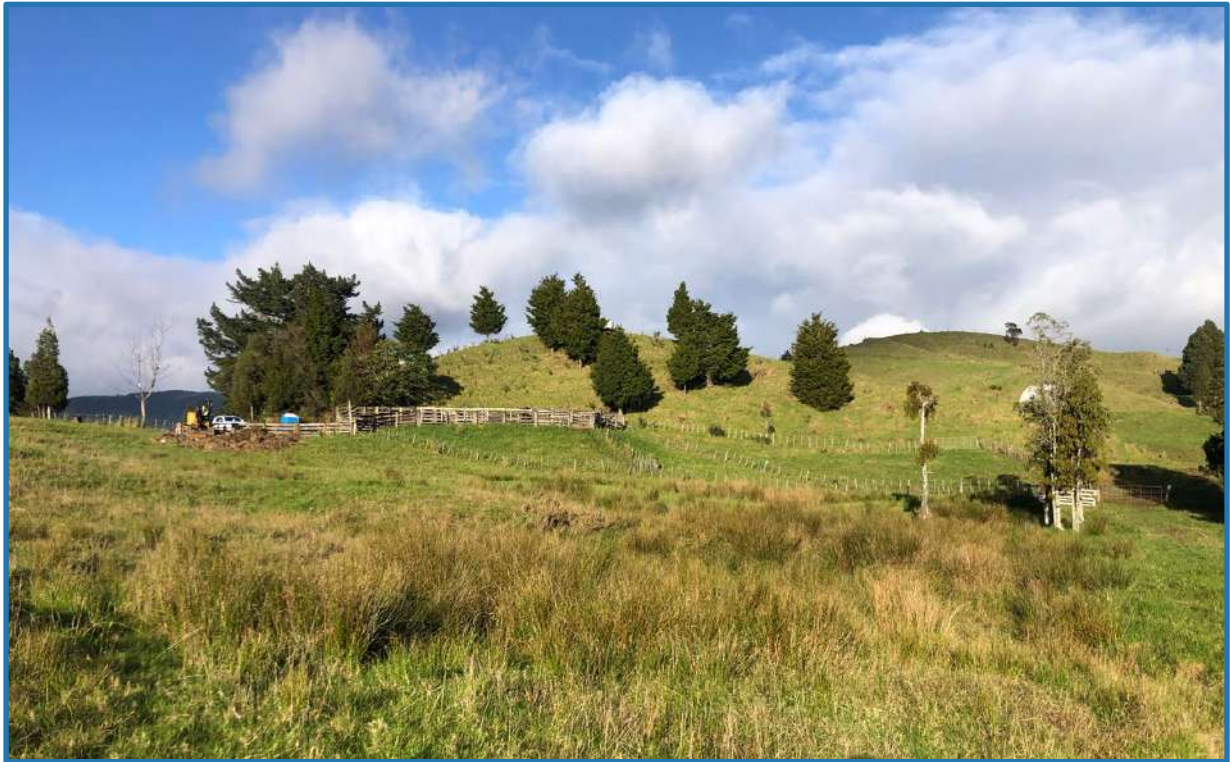
**Figure 3:** Photo of fill disposal site looking south west

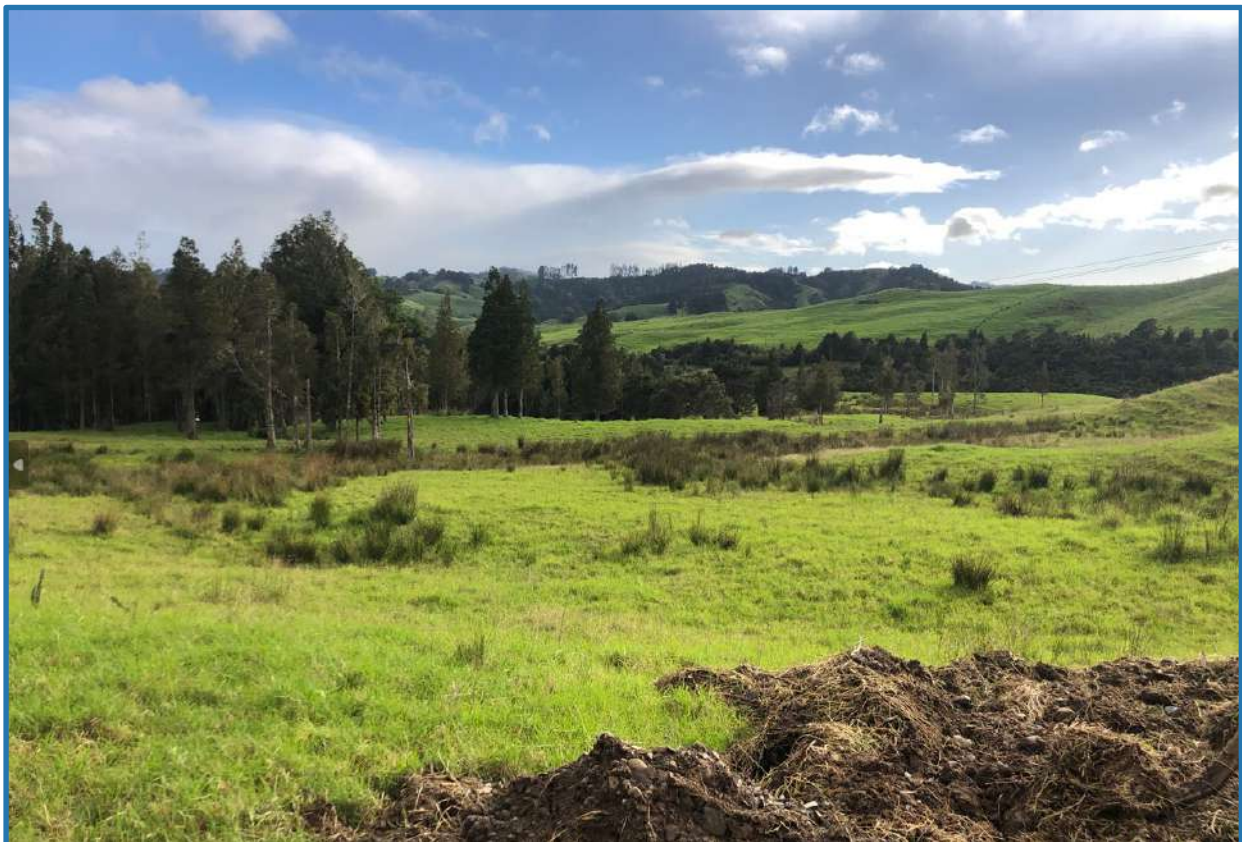
**Figure 4:** Photo of fill disposal site looking north, taken prior to works commencing.

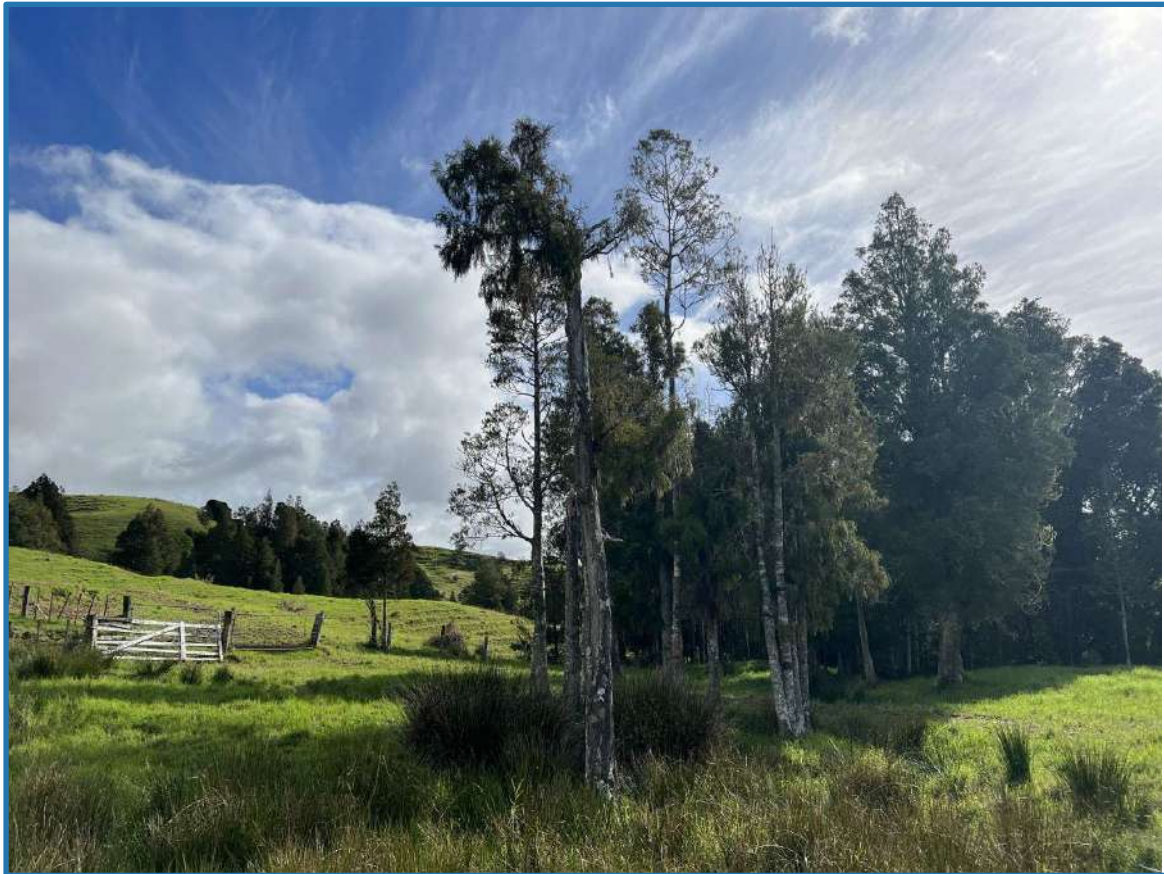
**Figure 5:** Photo of native trees and associated wetland area to be retained

Within the lower part of the wetland, there is a 35m<sup>2</sup> area containing a stand of seven kahikatea and two rimu trees. These trees have all been assessed as being in poor condition with stunted growth and ill- health, but nonetheless have higher ecological

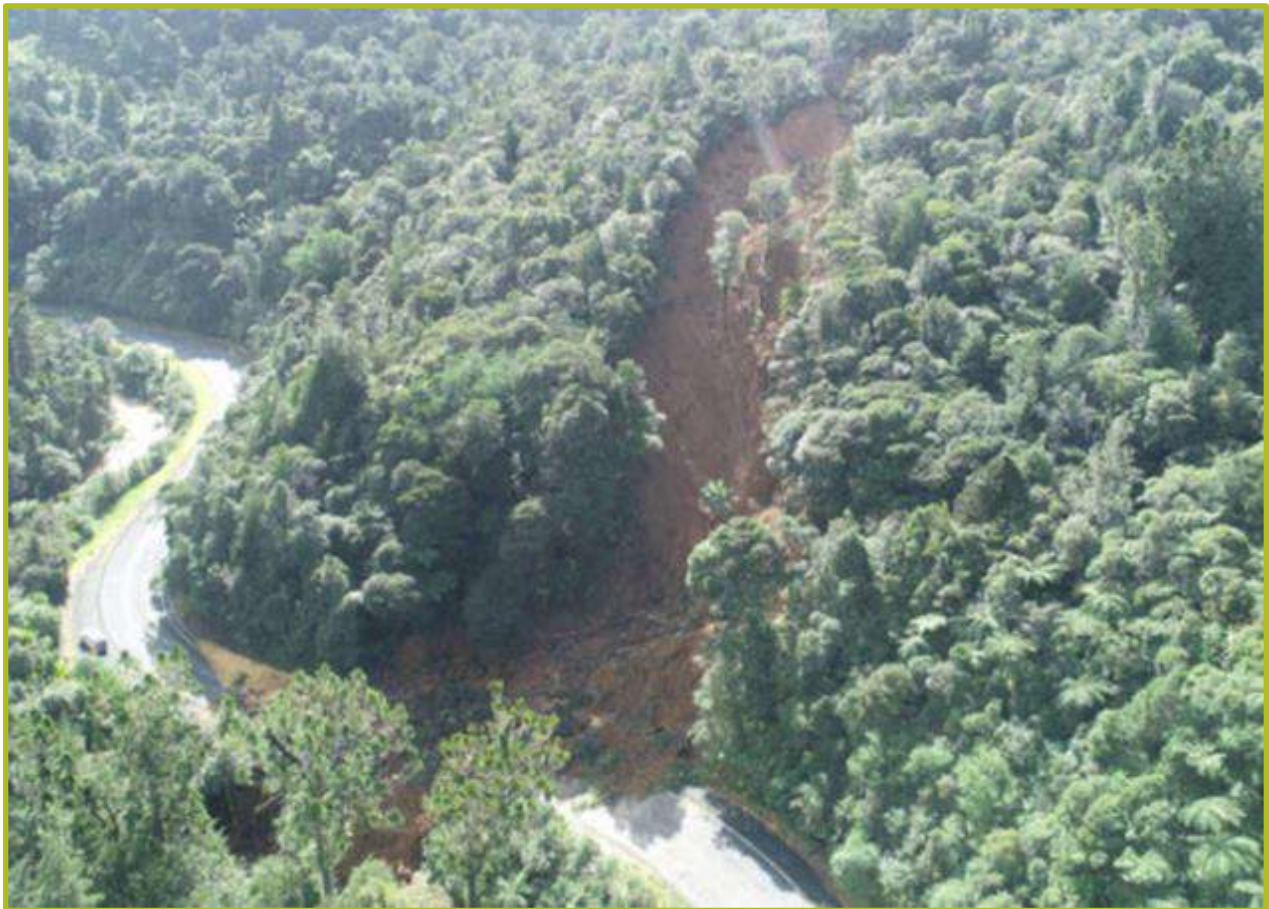
**Figure 2:** A large slip at the southern end of the Gorge in the immediate aftermath of 19 August 2022 Weather Event  
(Source: NZTA Media Release - 24 August 2022)

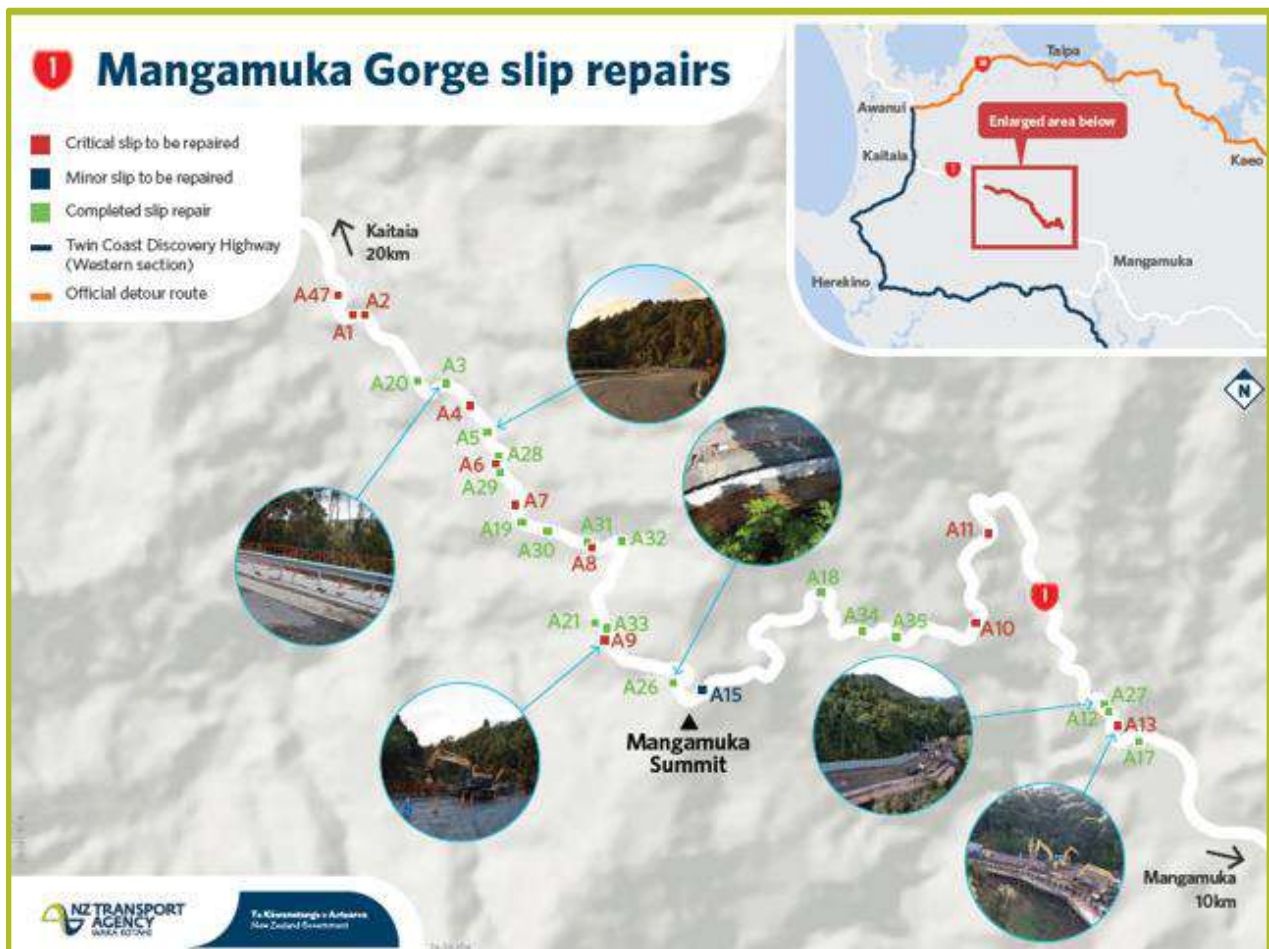
In total there are 24 “critical” slip sites, being slips posing an imminent risk of complete evacuation of the road, across the entire Gorge (refer **Figure 5**), mostly comprising underslips and several “minor” slips. Remediation works were undertaken across all the slips, including replacement and upgrade of stormwater infrastructure such as culverts.

Figure 5: Critical Slip Sites - Mangamuka Gorge

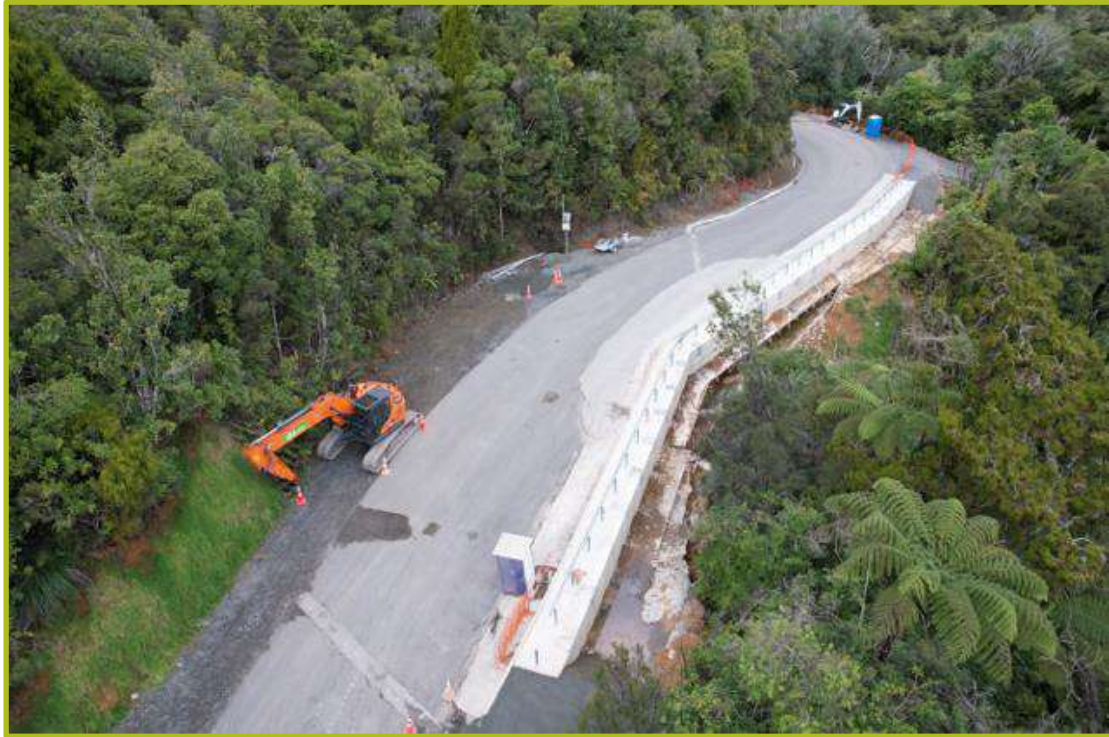
**Figure 6:** Example of Typical Slip Site (Slip A5 Near Completion of Remediation Works (Image Taken: 6 August 2024))

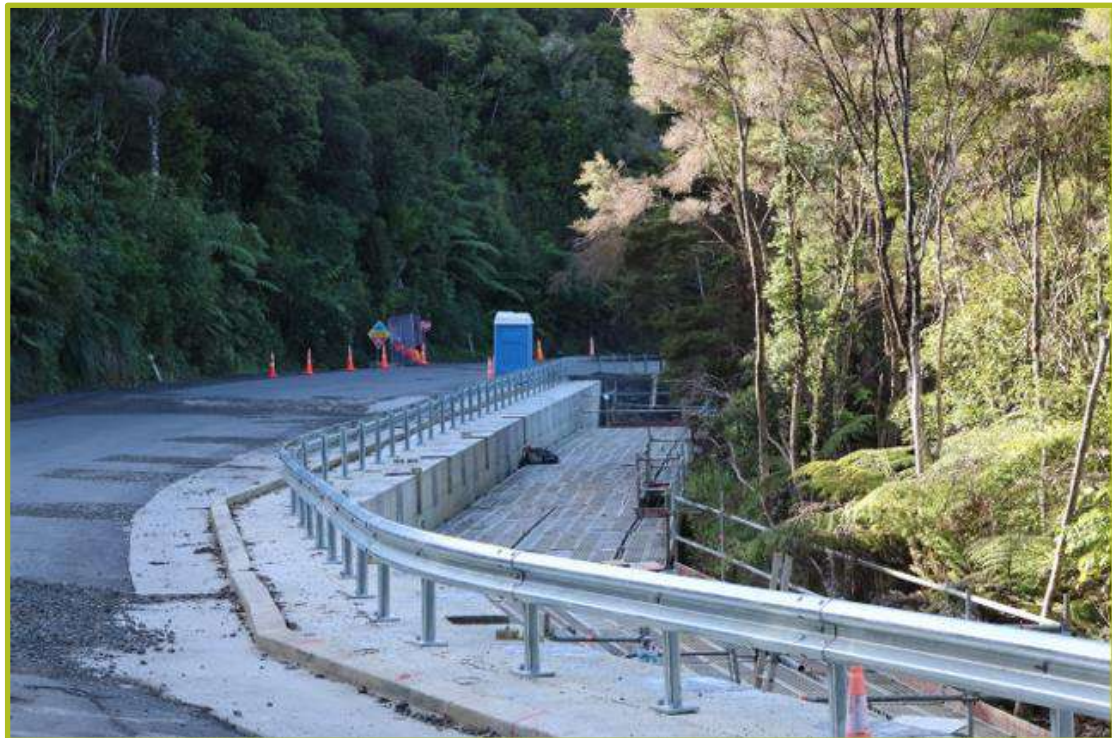
**Figure 7:** Example of Typical Slip Site (Slip A3 Near Completion of Remediation Works (Image Taken: 14 August 2024))

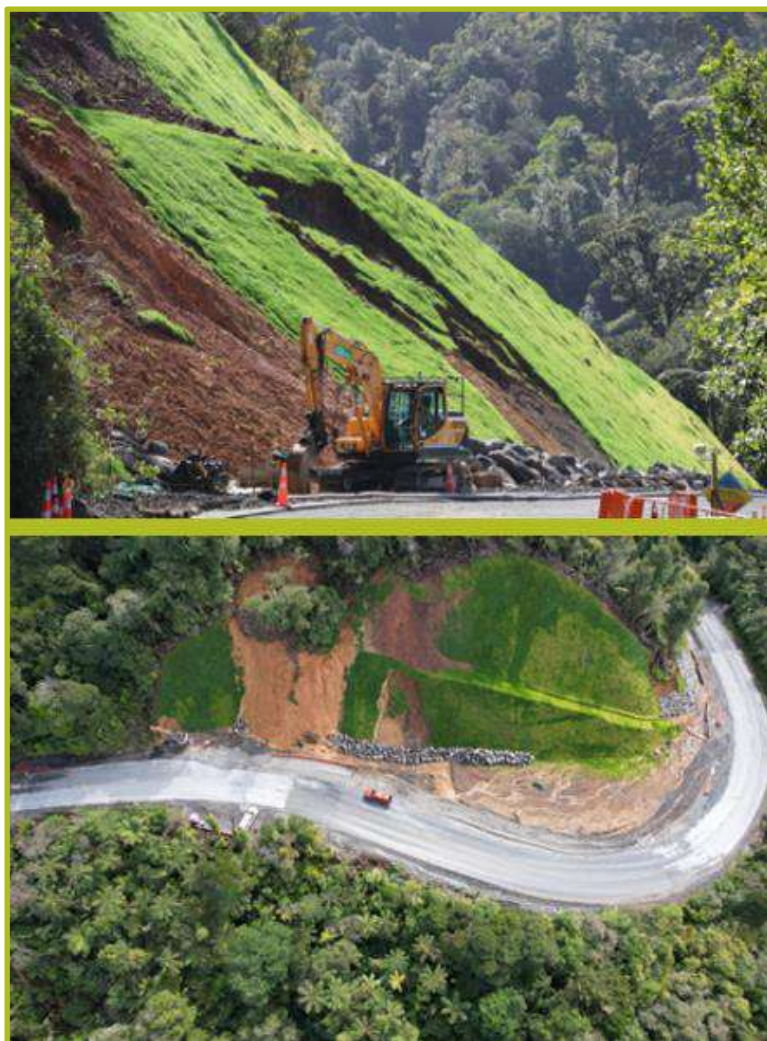
Figure 8: Slip A11 (Images taken: August 2024)

NZTA have also installed a monitoring system to monitor any future movement where the road has been reinstated. The option to build the new alignment if required in the future is still retained.

The works further involved the unavoidable requirement to clear approximately 4,283m<sup>2</sup> of native vegetation, including a number of significant old growth trees.

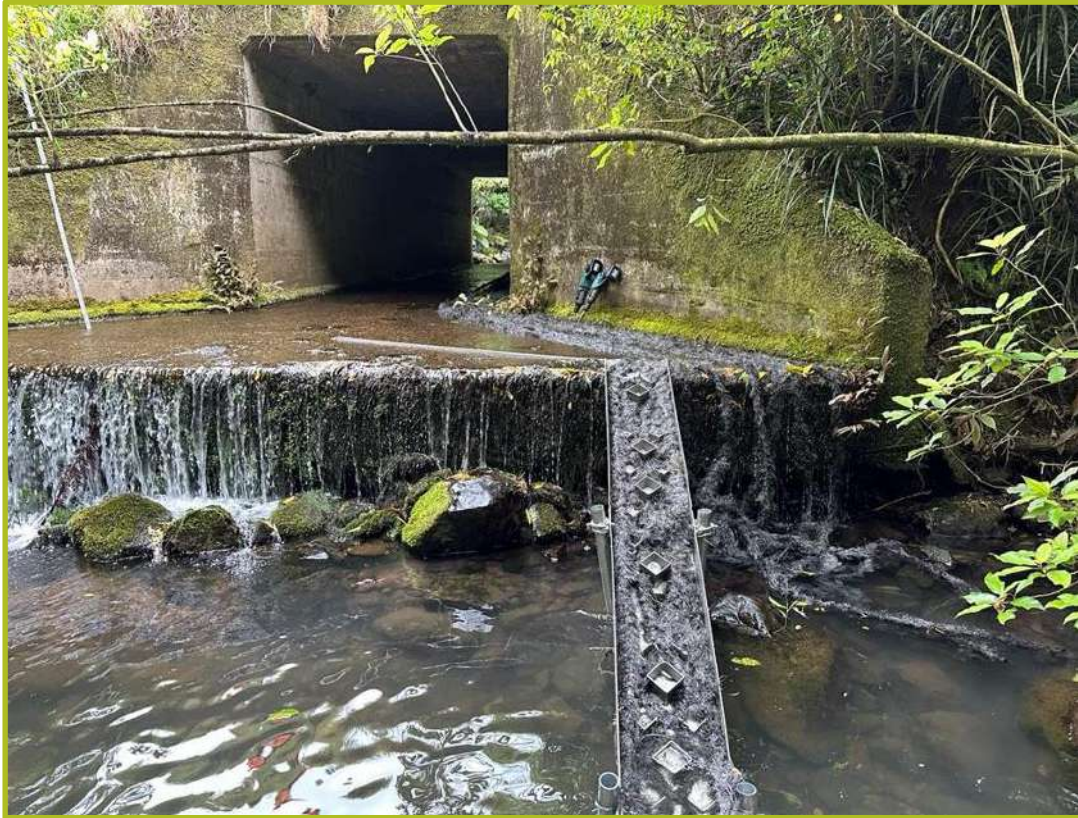
**Figure 9:** Fish Ladder installed as part of the Fish Passage Betterment across the Gorge (Image taken 5 December 2024)

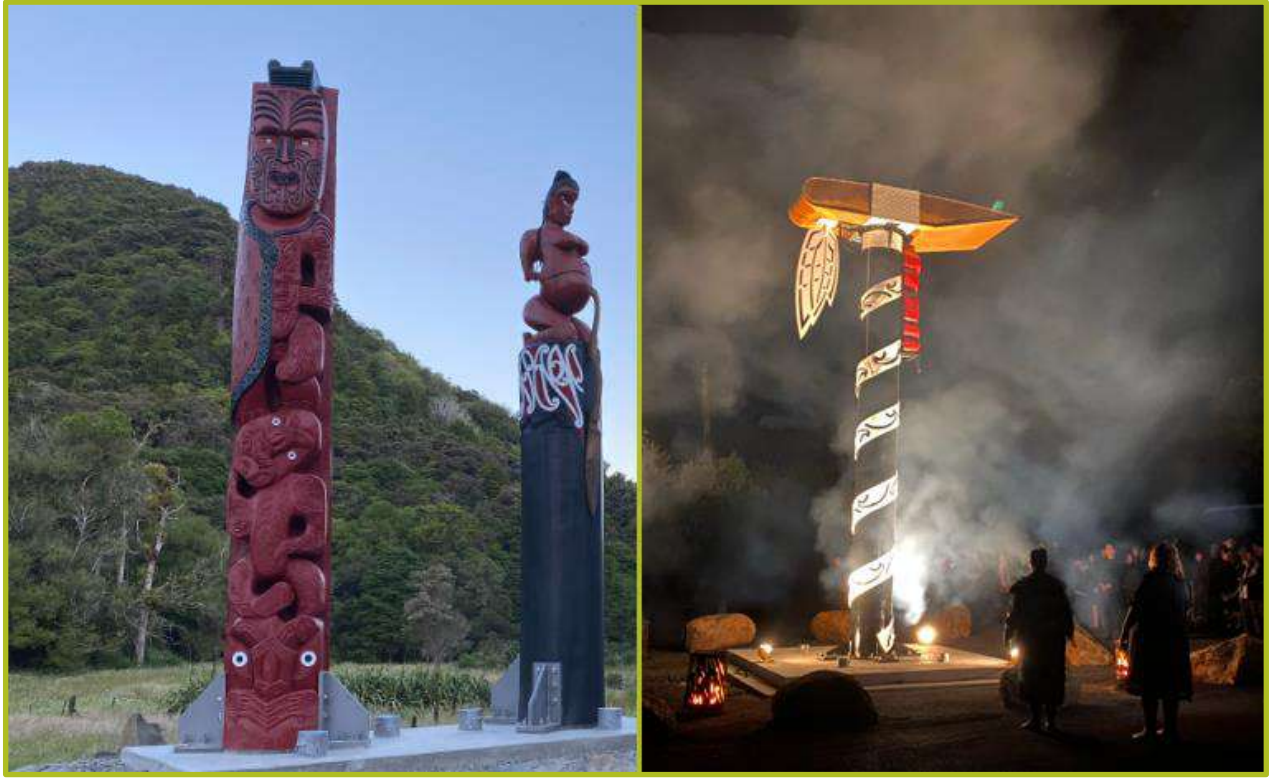
**Figure 10:** (Left) Northern Pouwhenua; (Right) Southern Pouwhenua

The Northern Pou (refer **Figure 10**) is carved from timber and is approximately 3.5m high with a 0.6m diameter.

The Southern Pou (refer **Figure 10**) is constructed out of steel is similarly approximately 3.5m high with a 0.6m diameter.

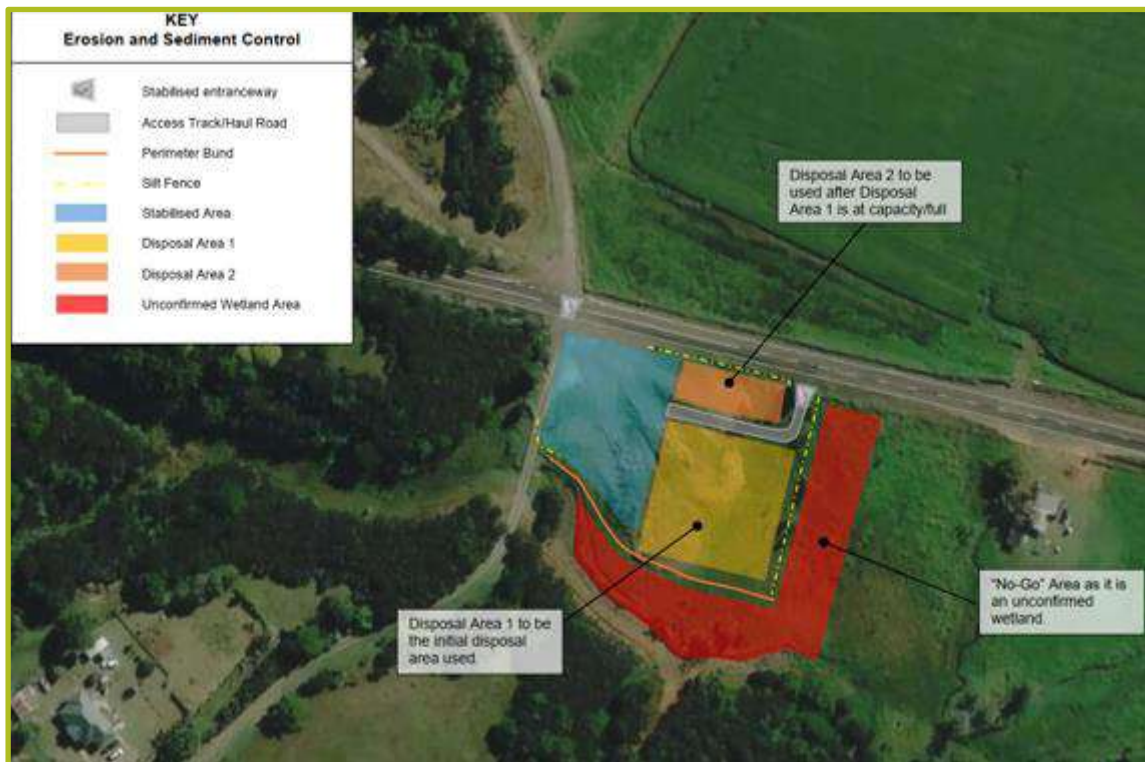
**Figure 12:** Excerpt from CLL Erosion & Sediment Control Plan, which also indicates “no go” zone in and around a natural inland wetland. *Note that fill was not disposed on the site despite the notations on the plan.* (Source: CLL Contractors)

The southern edge of the laydown yard is demarcated with a grassed bund which is set back approximately 5m from a stream, and the eastern edge has a silt fence beyond which is a natural inland wetland. A “no go” zone was established (refer **Figure 12**) that ensured the works and utilisation of the Southern laydown site did not encroach within the natural inland wetland area, and the utilisation of the site was confined to the areas that were already established as a laydown area, prior to its use as one for the Slip Response.

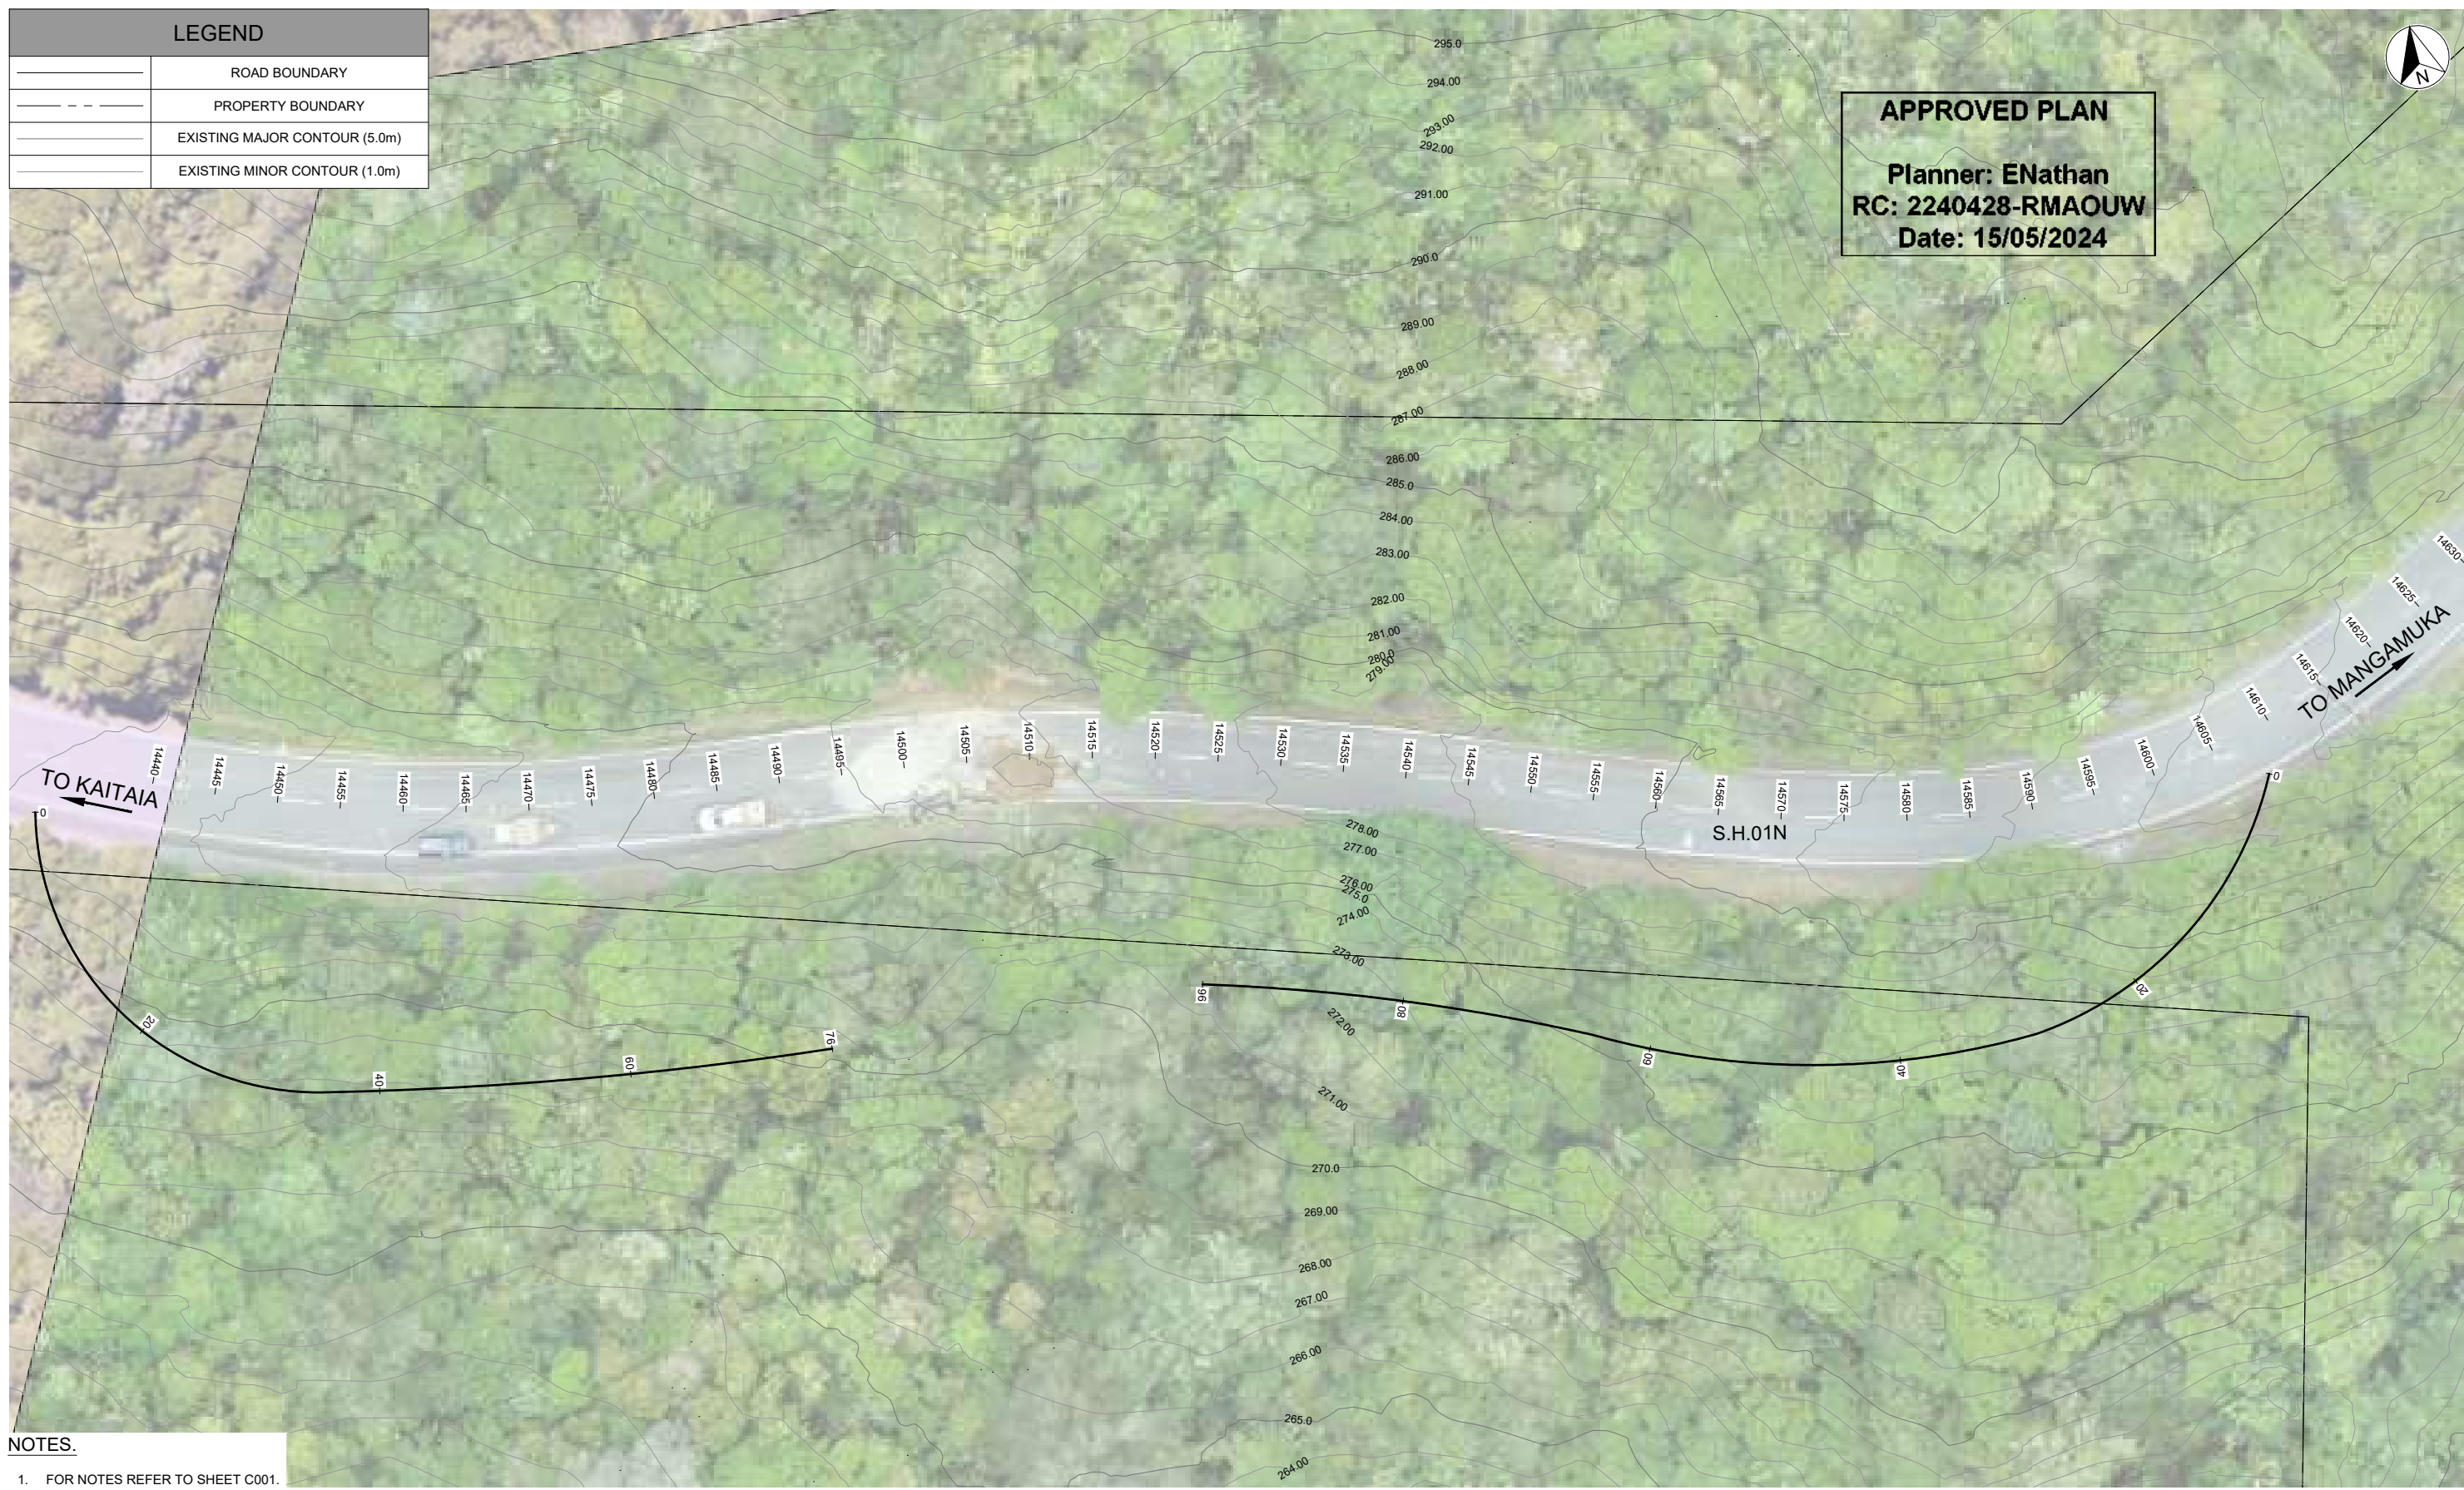
PROJECT	TITLE	SHEET NO.	REVISION
WAKA KOTAHI NEW ZEALAND TRANSPORT AGENCY S.H. 01N R.S. 119 R.P. 14.030 - 14.110, MANGAMUKA, NORTHLAND A7 NZTA EMERGENCY WORKS 2022	PLAN PAVEMENT EXTENTS	C021(A7)	2
WSP PROJECT NO. (SUB-PROJECT) 1-11241.13

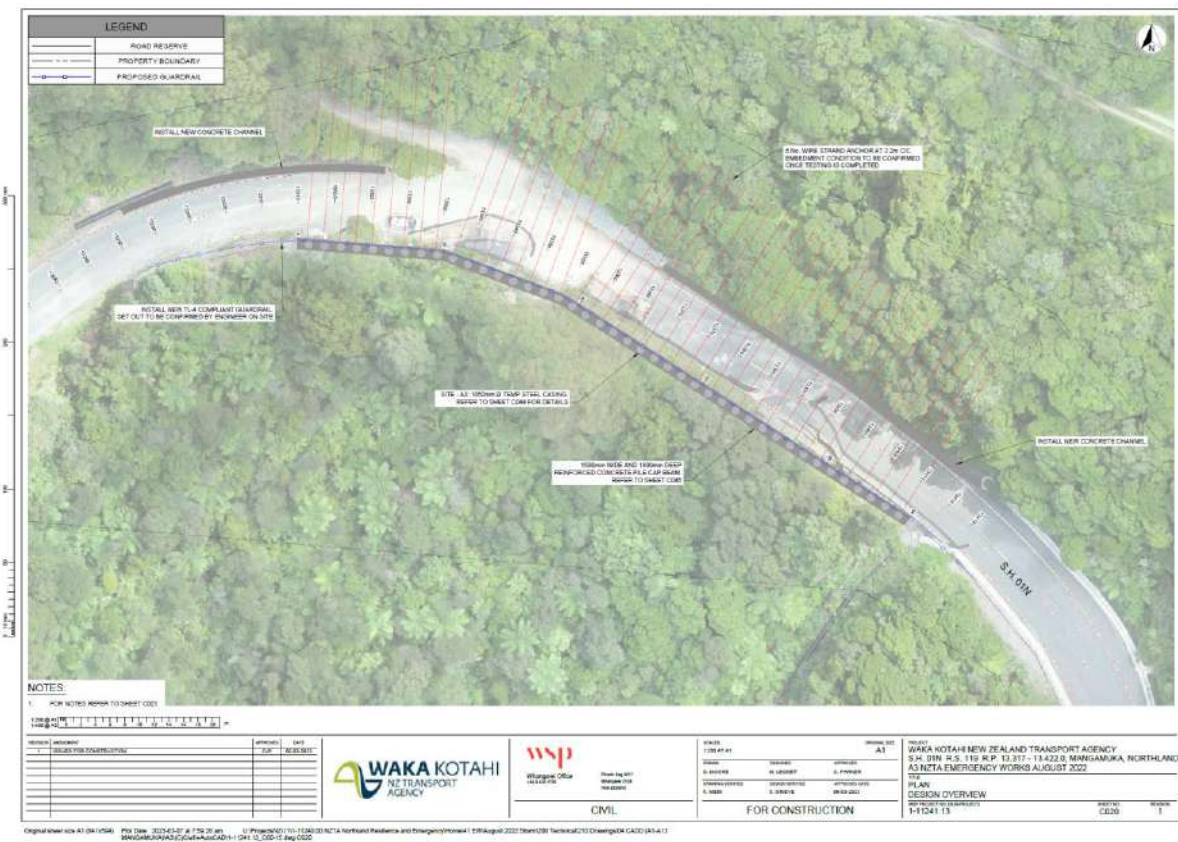
Figure 3: Slip A3, plan of concrete cap and pile retaining and new channelling.

Arrays of bored subsurface drains will take water from the upslope side of the slips to central manholes and then dispose of it via the existing stormwater system. Concrete channels and minor road widening will also be undertaken. Plans for works at slip A3 near the Raetea campground are provided below as an example of the typical treatment (Figure 2- Figure 5), along with typical cross sections for concrete piles and drains (Figure 6-Figure 7), and similar plans for all the slips have been provided and considered, along with associated/enabling works.

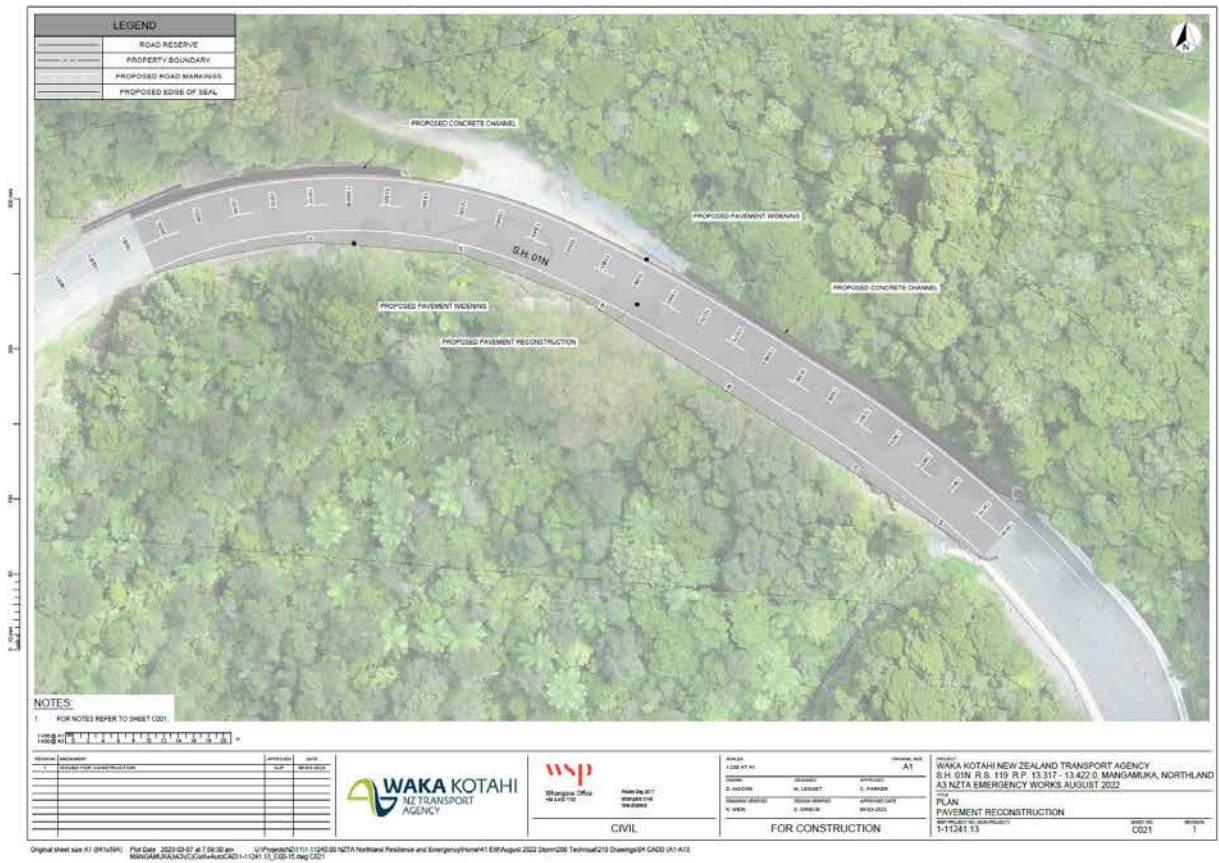
Figure 4: Slip A3, plan of pavement reconstruction.

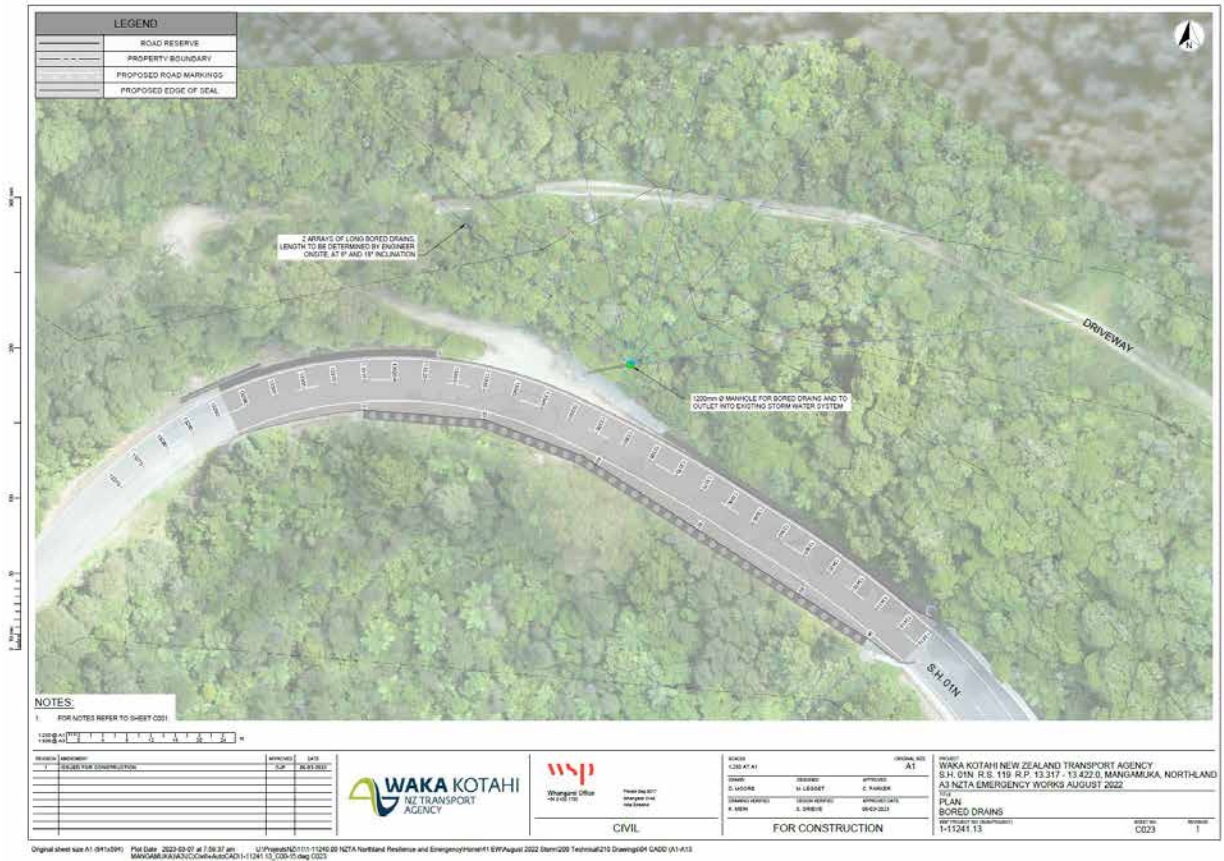
Figure 5: Slip A3, plan of bored drains.
