# Application for resource consent or fast-track resource consent

New Zealand Transport Agency Waka Kotahi (NZTA)

<b>NPSHPL</b>	National Policy Statement for Highly Productive Land 2022
<b>NRC</b>	Northland Regional Council
<b>NZCPS</b>	New Zealand Coastal Policy Statement 2010
<b>NZEM</b>	New Zealand Environmental Management Limited
<b>NZTA</b>	New Zealand Transport Agency Waka Kotahi
<b>pFNDP</b>	Proposed Far North District Plan 2024
<b>Project</b>	Establishment and operation of a cleanfill site
<b>pRPN</b>	Proposed Regional Plan for Northland 2024
<b>RMA</b>	Resource Management Act 1991
<b>RoT</b>	Record of Title
<b>RPS</b>	Regional Policy Statement for Northland
<b>SH1</b>	State Highway 1
<b>Site</b>	Lot 1 DP 35169 adjacent to 184 Peria Valley Road, Kaitaia
<b>Slip Response</b>	Mangamuka Slip Response Project 2022

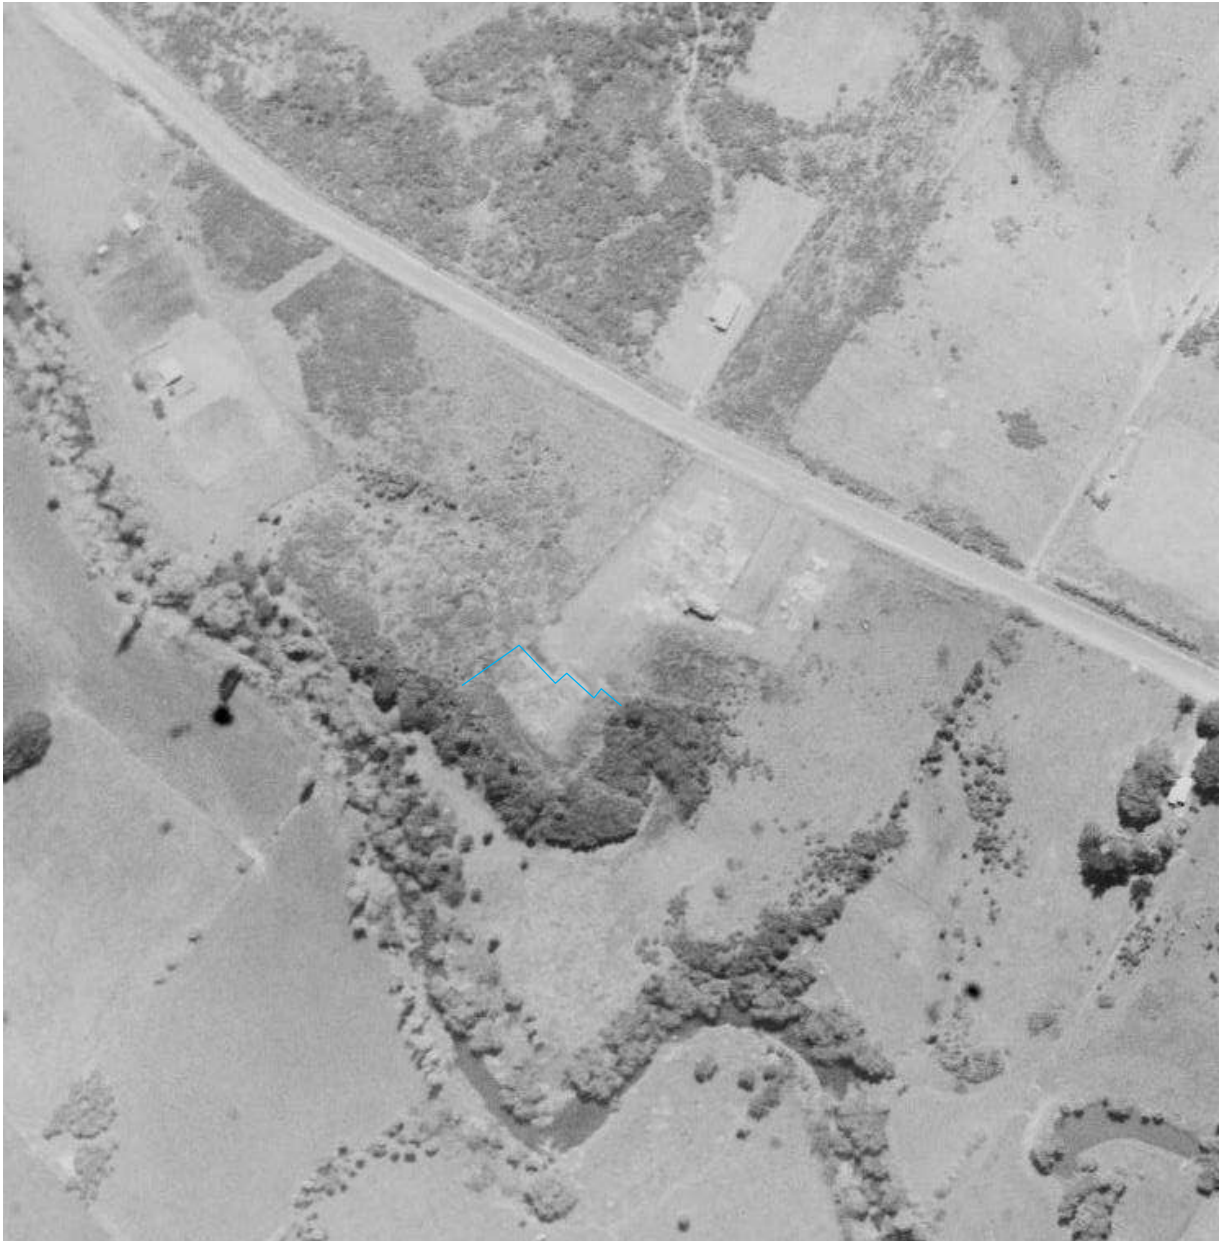
Figure 77: Detail from aerial image SN 350 1365/16 (1950) showing clearest image of possible defensive ditch with gun-fighting flanking angles at rear of urupa (in blue).

Both modern and historic aerial imagery (Figure 77 - Figure 80) show the remains of what appears to be a defensive earthwork with multiple flanking angles suggestive of gun-fighting adaptation on the northern face, most obvious in the 1950 aerial. A western return of the ditch back towards the river is most visible in the 1973 aerial.

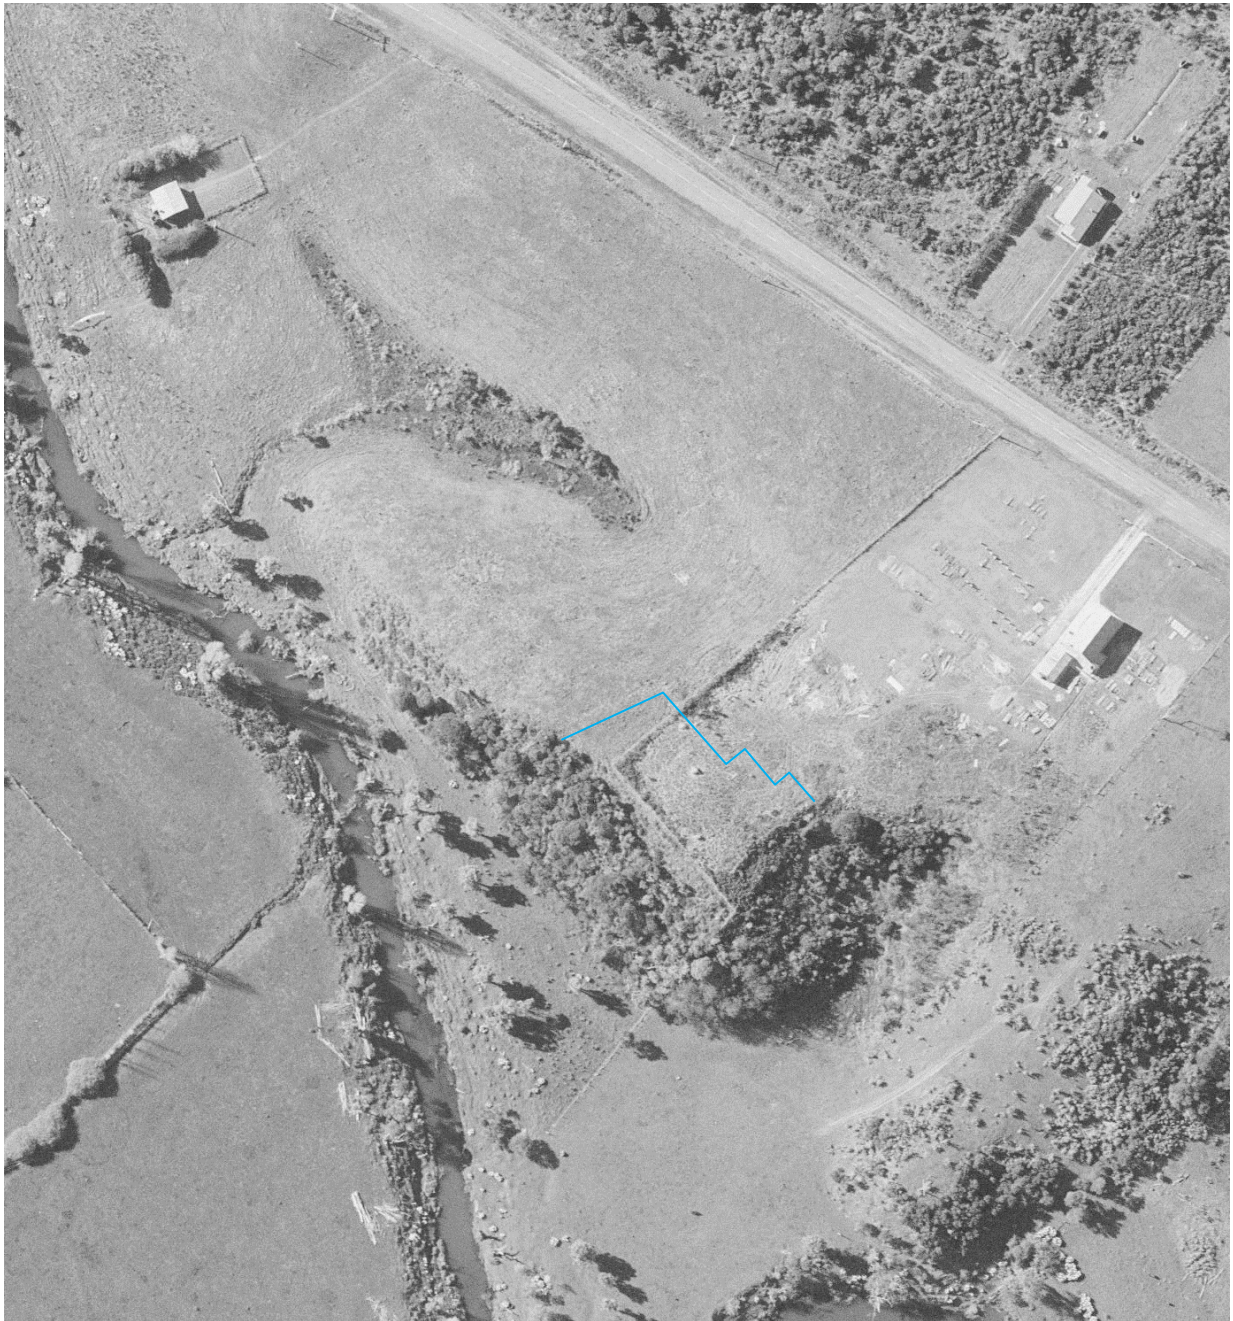
Figure 78: Detail from SN 1417 B/12 (1961) showing possible defensive ditch with gun-fighting features at rear of urupa.

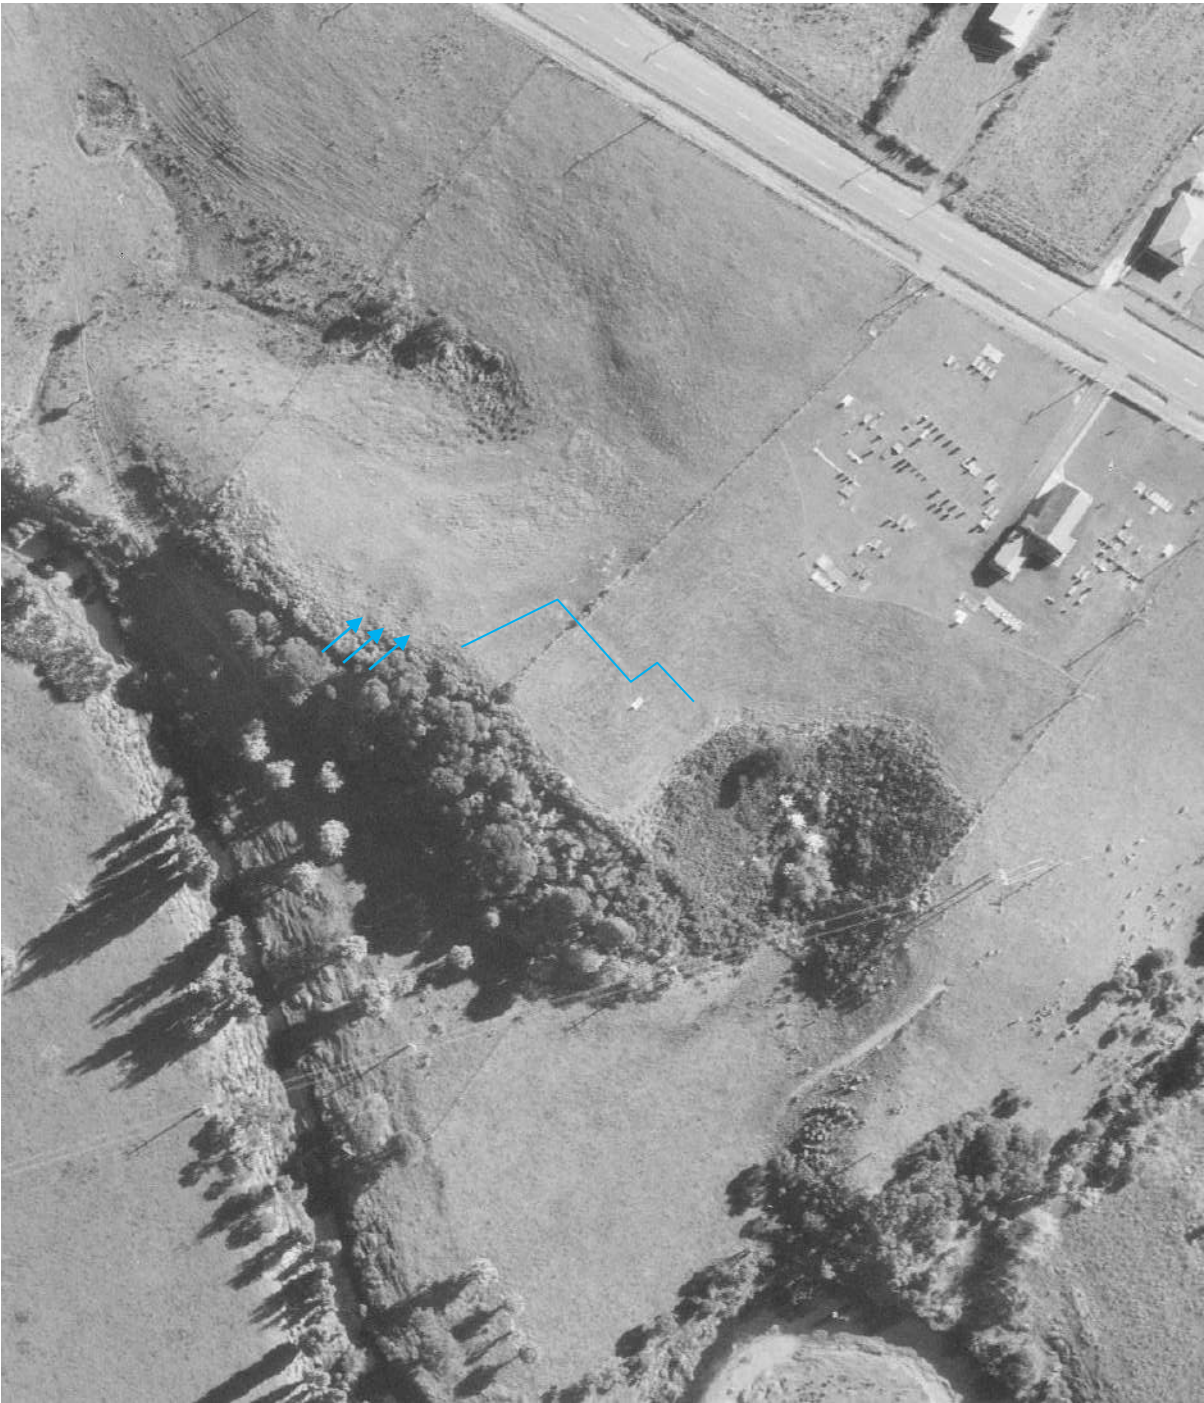
Figure 79: Detail from aerial image SN 3675 C/3 (1973) with defensive ditch and possible terraces.

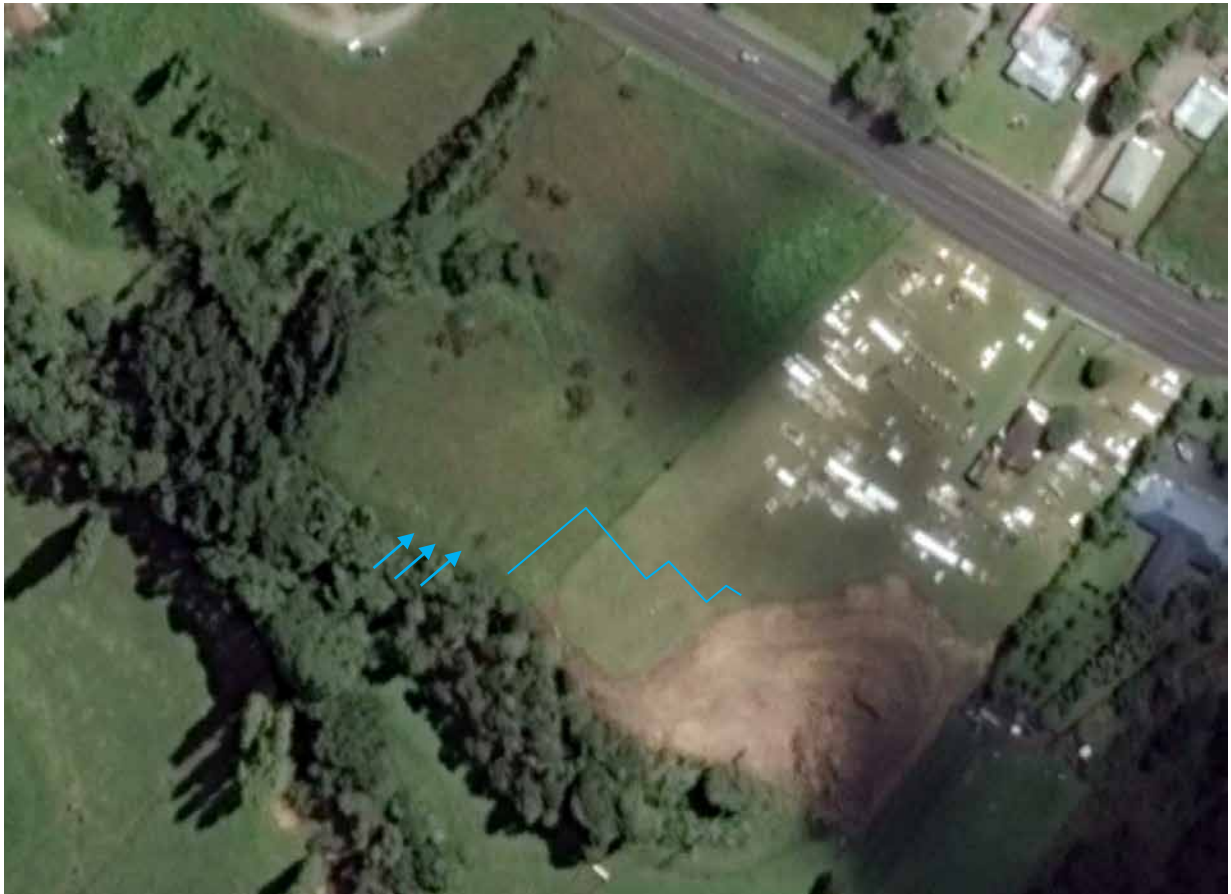
Figure 80: Detail from 2016 aerial showing possible terraces, and defensive ditch (Google Earth).

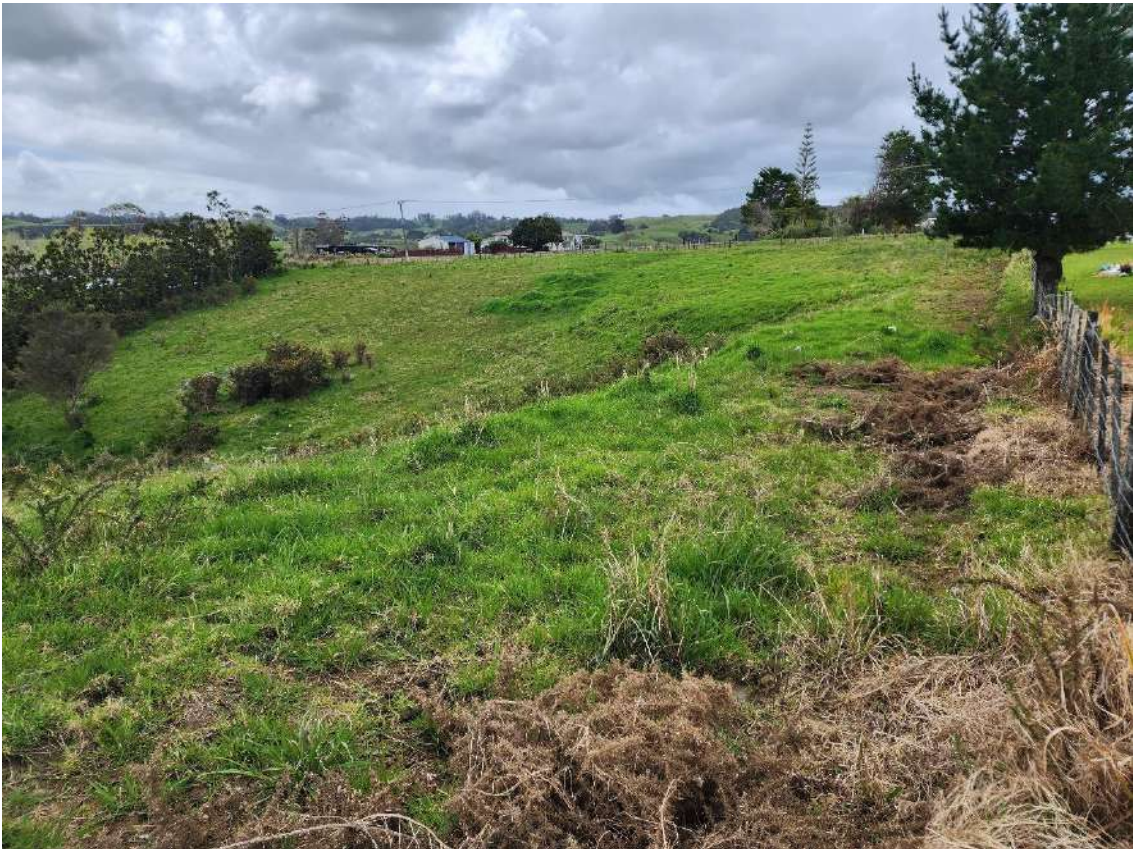
Figure 86: Looking north towards proposed spoil dump site.

The proposed spoil dump site (Figure 86) was visited for an hour on 9 September 2023, in the company of T. Latimer, R. Gabel, and G. Latimer. The possible infilled defensive ditch in the urupa was visible as a slightly darker line of vegetation and shallow swale running across the rear of the urupa under closely mowed grass, but was not visible beneath the rank grass on the western side of the internal fence (Figure 87).

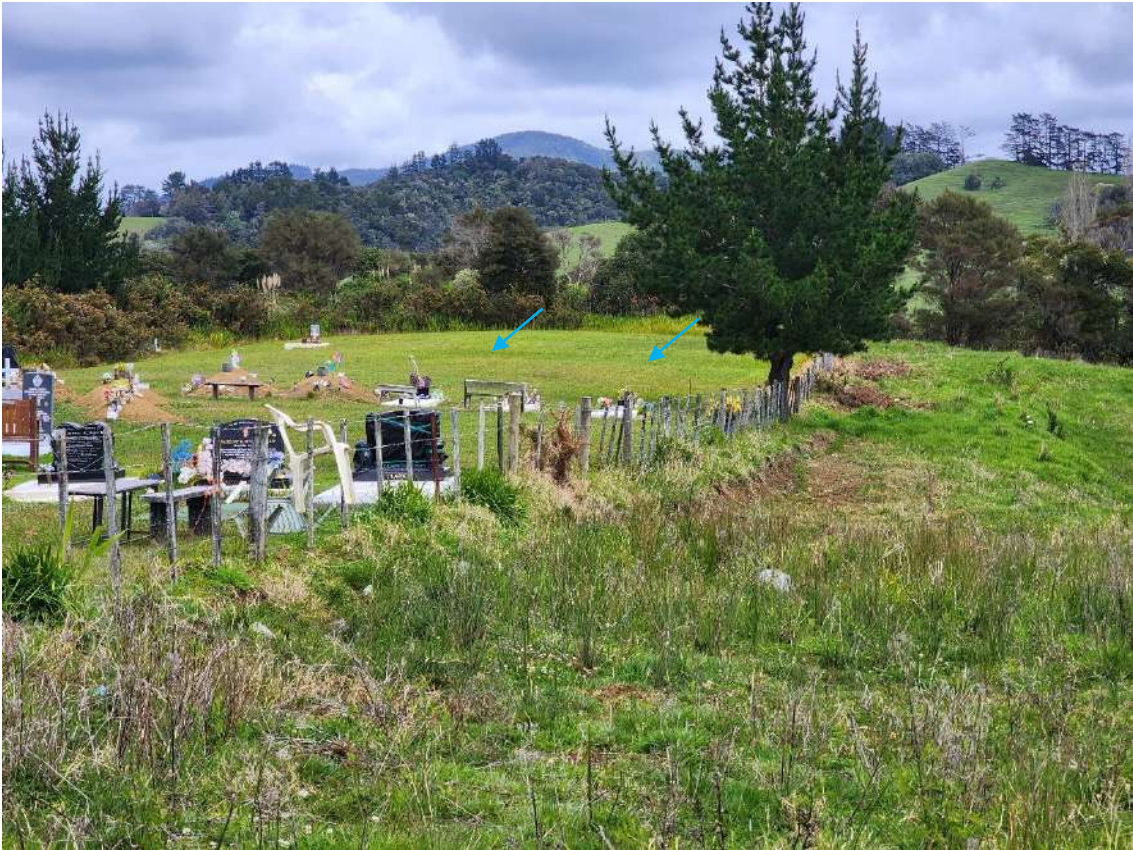
Figure 87: Looking south over rear of urupa with possible infilled ditch.

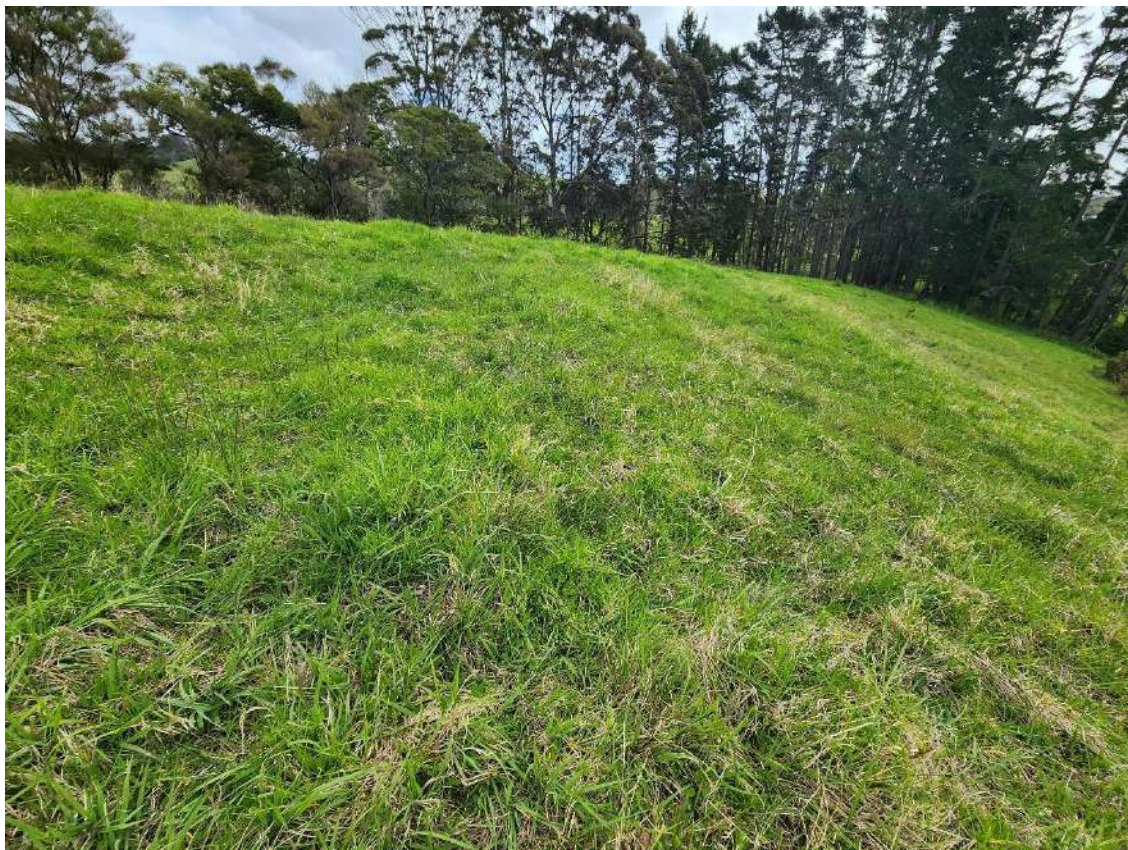
Figure 88: Possible terraces down western ridgeline.

A number of possible terraces were observed on the southern descending spur to the west of the fence. There were larger transverse terraces on the spur which were 10-15 x 10 x 0.3m in size, and smaller lateral terraces around the head of the gully which are more likely to be erosional features. However they were all relatively indistinct and while they looked like they started as erosion features, have probably been modified by occupation and/or gardening (Figure 88).

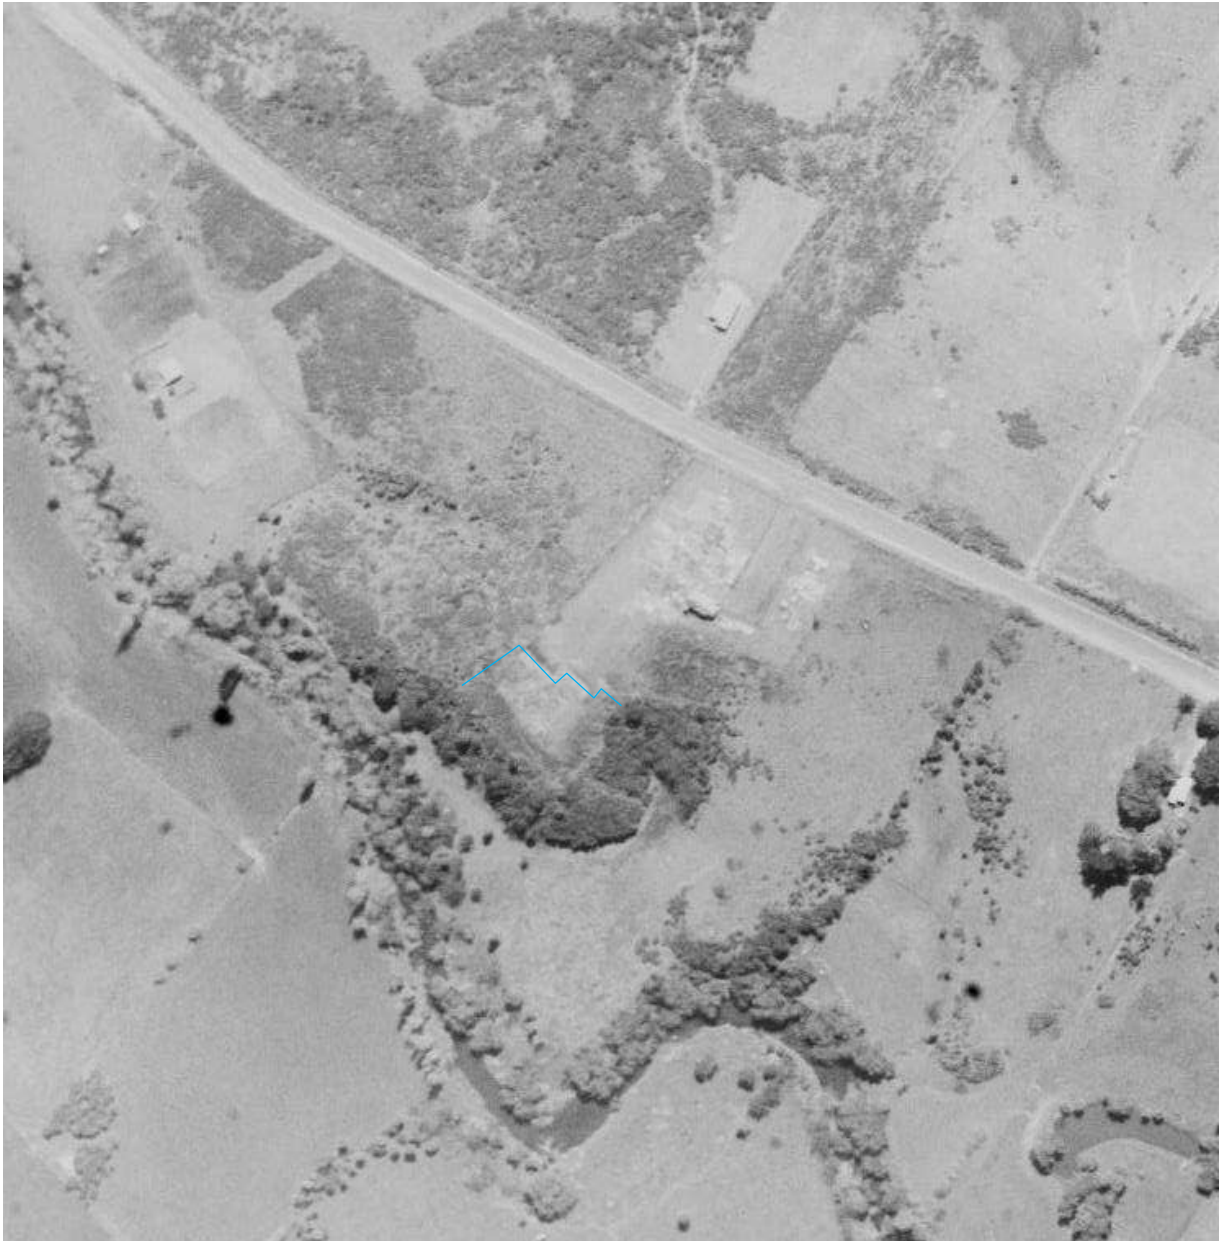
Figure 77: Detail from aerial image SN 350 1365/16 (1950) showing clearest image of possible defensive ditch with gun-fighting flanking angles at rear of urupa (in blue).

Both modern and historic aerial imagery (Figure 77 - Figure 80) show the remains of what appears to be a defensive earthwork with multiple flanking angles suggestive of gun-fighting adaptation on the northern face, most obvious in the 1950 aerial. A western return of the ditch back towards the river is most visible in the 1973 aerial.

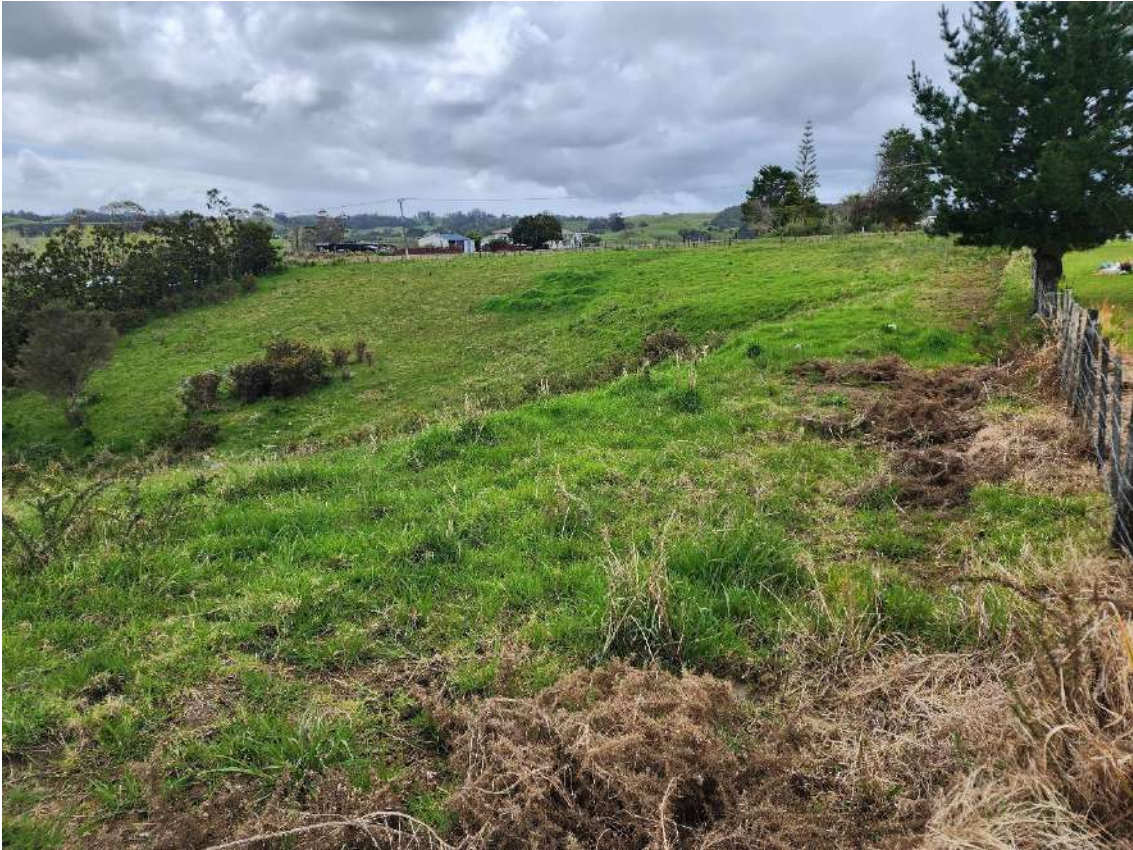
Figure 86: Looking north towards proposed spoil dump site.
