# **Application for resource consent or fast-track resource consent**

To aid in the Slip Response, the Northern Laydown Area was established at 6770 State Highway 1 for the purpose of storage of materials and for the fabrication of mesh for the pile foundations (the Project).

# MANGAMUKA SLIP RESPONSE PROJECT 2022

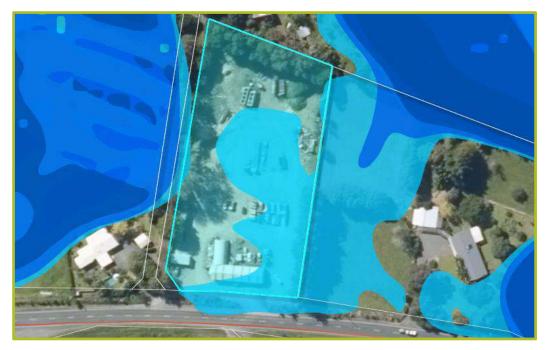
The Site is identified on Northland Regional Council's Hazard Property Viewer as being within a "*one-in-100-year flood extent (plus climate change*)" (refer **Figure 4**). A Hazard Summary Report is attached as **Appendix C** and indicates that 38.7% of the Site is within the flood extent.

Figure 4: Flood Hazard Extent (Source: NRC GIS Hazard Property Viewer - accessed 25 November 2024)

The entire Site is identified on FNDC's Operative District ePlan as being within the "*NRC flood susceptible land*" (refer **Figure 5** below). It is, however, considered that this out of date, and the extent shown in **Figure 4** (above) is more up-to-date and accurate.

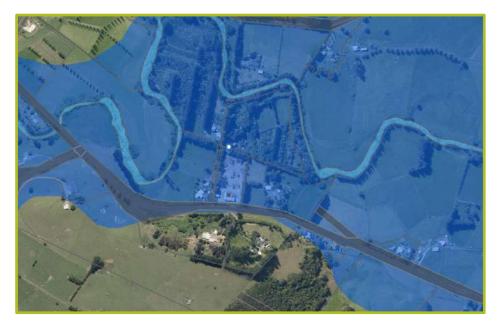
Figure 5: NRC Flood Susceptible Land over the Site (blue marker pin) (Source: FNDC Operative District ePlan - accessed 25 November 2024)

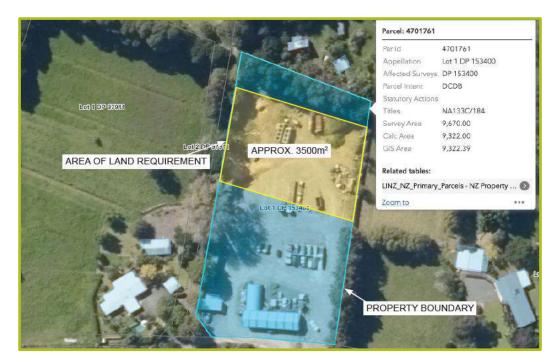
In order to establish and operate the Northern Laydown Area, an area of approximately 3,500m<sup>2</sup> within the existing industrial yard at 6770 SH1 was required (refer **Figure 9** and **Appendix E**).

Figure 9: Area of 6770 SH1 Required (Source: Hoskins Civil Land Requirement Plan)

This Laydown Area at 6770 SH1 was established in February 2023 to support the Phase 1 slip remediation works on the northern section of the Gorge. The Laydown Area is maintained in a coarse, open graded granular aggregate surface and occupies approximately 3,500m<sup>2</sup> of flat, low-lying land at the rear of an existing industrial yard. Whilst the Site contained aggregate prior to its use by NZTA, further aggregate was deposited, which resulted in more than 20% of the Site being covered in it, being the permitted activity threshold under the Far North District Plan.

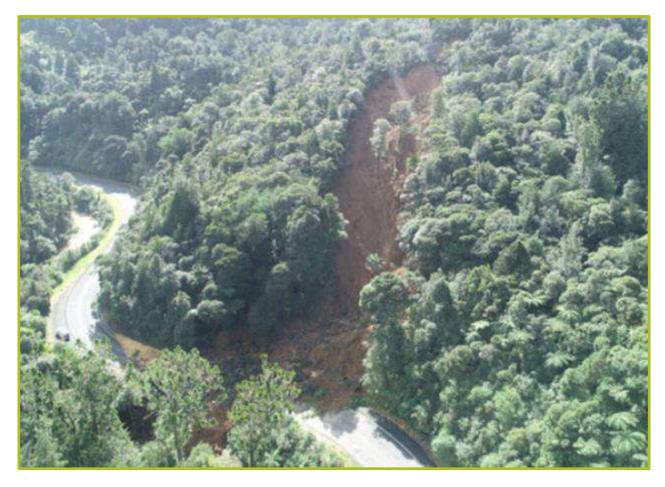
Figure 2: A large slip at the southern end of the Gorge in the immediate aftermath of 19 August 2022 Weather Event (Source: NZTA Media Release - 24 August 2022)

The Maungataniwha Ranges are a volcanic mountain range over which SH1 is constructed. During 2022, particularly in between June and August, the Maungataniwha Ranges and SH1 through the Gorge were subjected to significant rainfall, which resulted in the soils within the Ranges becoming completely saturated. On 19 August 2022, Te Tai Tokerau/ Northland was hit with a Severe Weather Event, including strong wind gusts and significant rainfall, which caused widespread damage and flooding across the Region, and resulted in a large number of landslides through the Gorge, making it impassable. For contractors to access and assess the Gorge a temporary track had to be cut through a large slip at the southern end of the Gorge.

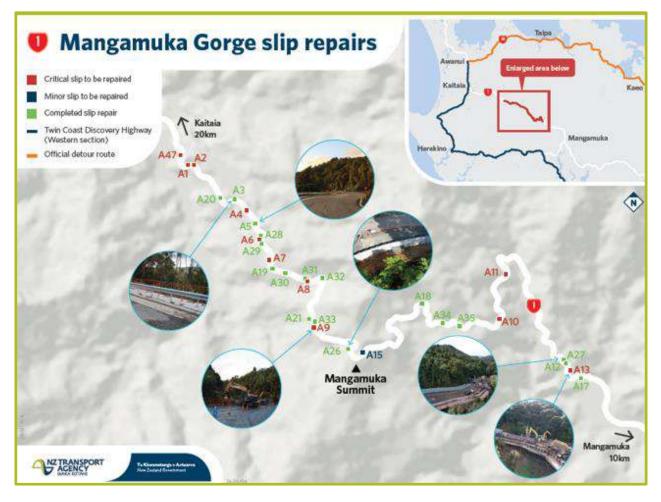
In total there are 24 "*critical*" slip sites, being slips posing an imminent risk of complete evacuation of the road, across the entire Gorge (refer **Figure 5**), mostly comprising underslips and several "*minor*" slips. Remediation works were undertaken across all the slips, including replacement and upgrade of stormwater infrastructure such as culverts.

Figure 5: Critical Slip Sites - Mangamuka Gorge

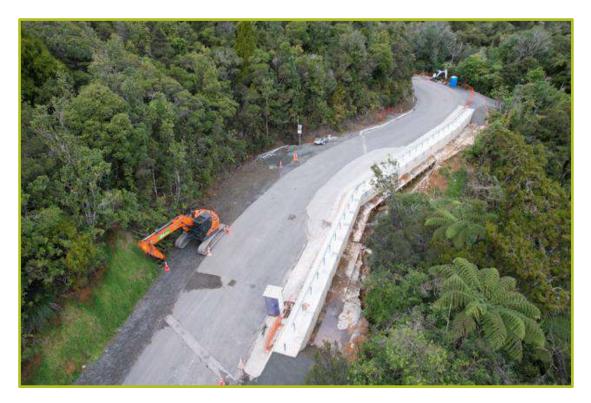
Figure 6: Example of Typical Slip Site (Slip A5 Near Completion of Remediation Works (Image Taken: 6 August 2024))

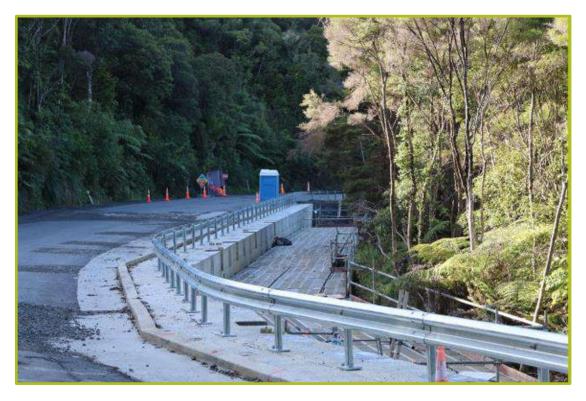
Figure 7: Example of Typical Slip Site (Slip A3 Near Completion of Remediation Works (Image Taken: 14 August 2024))

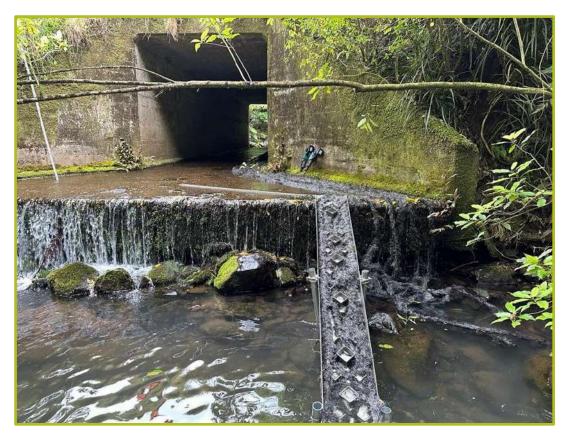
Figure 9: Fish Ladder installed as part of the Fish Passage Betterment across the Gorge (Image taken 5 December 2024)

Fish passage structures were installed in several culverts based on a priority approach, which saw fish passage improved and/or restored to the four main permanent streams throughout the Gorge.

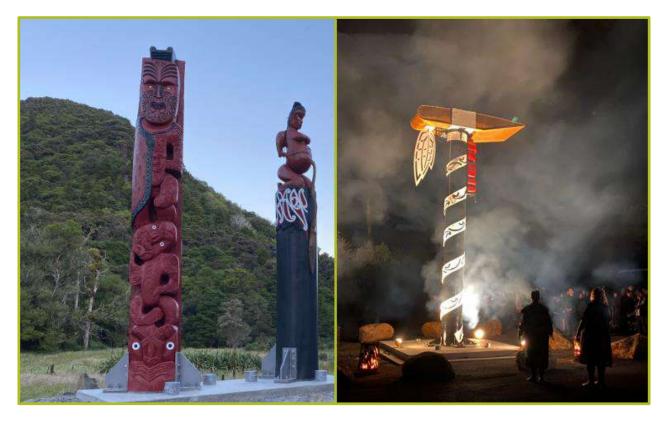
The Northern Pou (refer **Figure 10**) is carved from timber and is approximately 3.5m high with a 0.6m diameter.

The Southern Pou (refer **Figure 10**) is constructed out of steel is similarly approximately 3.5m high with a 0.6m diameter.

Figure 10: (Left) Northern Pouwhenua; (Right) Southern Pouwhenua

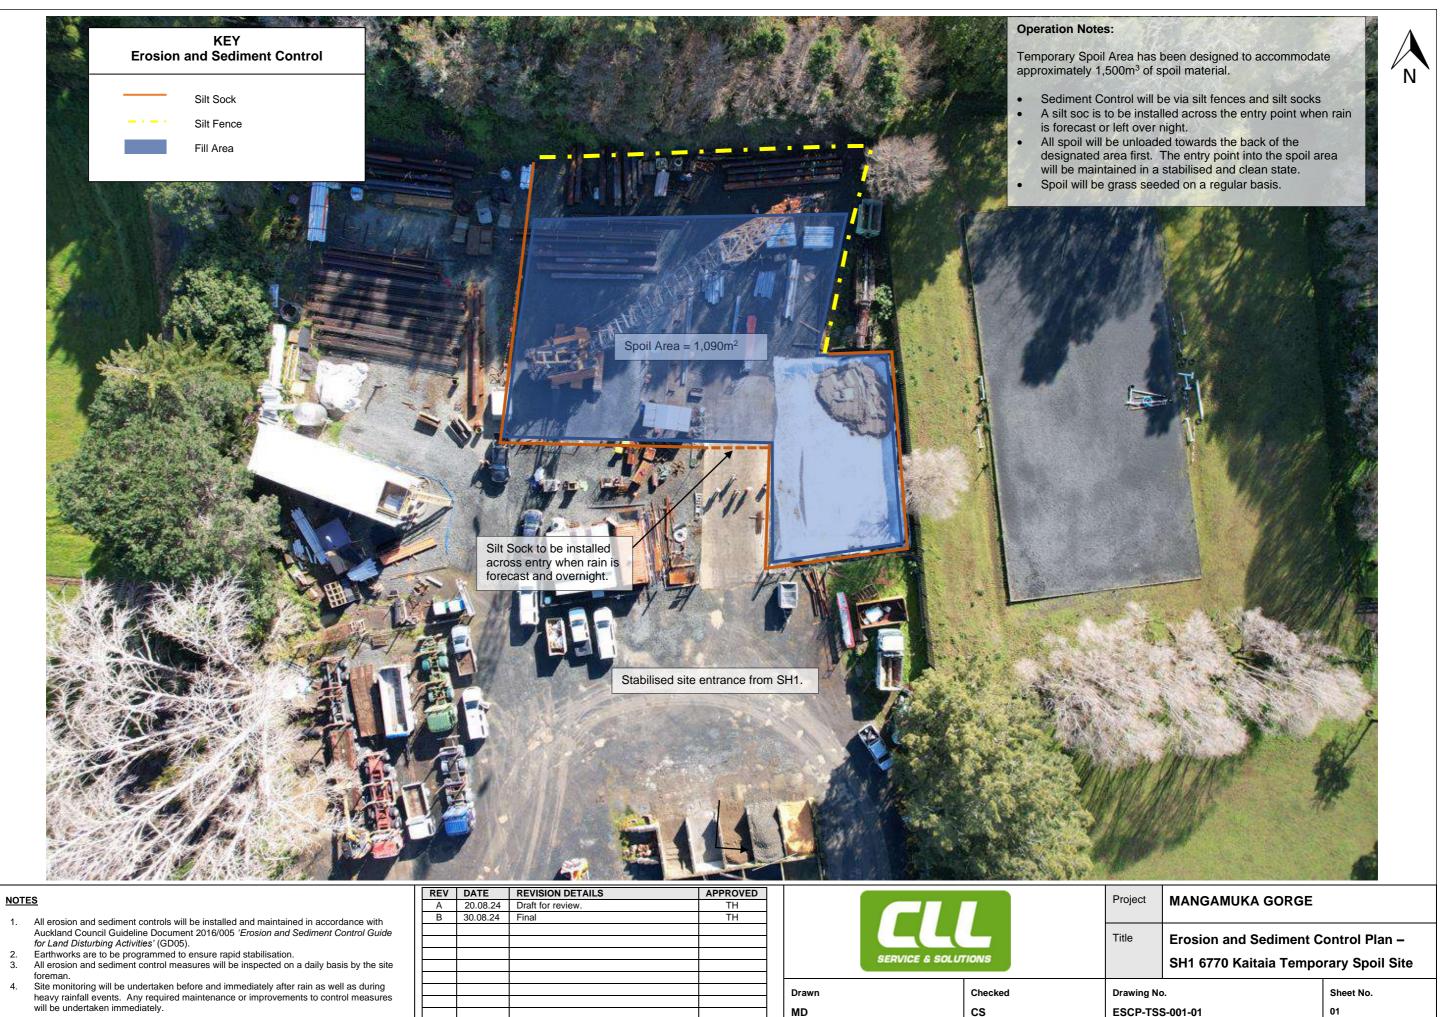
1940		
	N	
	Com >	the second second
Nr 1		
A.		
the state		and and
		8
		e la
1	e Car	and a start
		3
e l	1 Carry	
1	100.00	No.
S	H1	10-5
	Links	
9. A		
A H		Sak.
0		
		1 miles
Mal		and the second se
	KEY	
1	Erosion and Sedimer	nt Control
	Perimeter Bun	d
	Silt Fence	
	Decanting Ear	th Bund (DEB)
Project	MANGAMUKA GORGE	
Title	Erosion and Sediment C	ontrol Plan –
	Southern Gate Transfer 2024	Area – April
Drawing No		Sheet No.
ESCP-001	-01	01

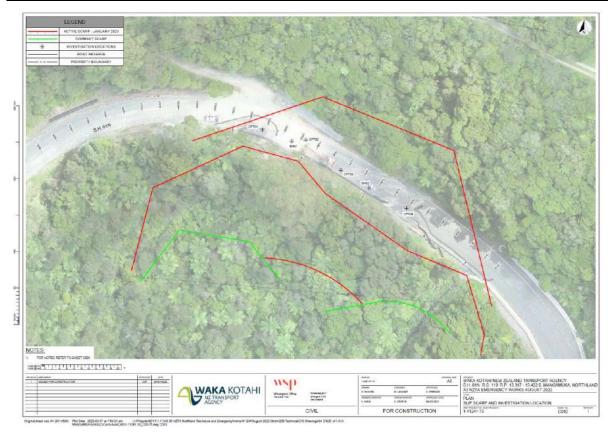
Figure 2: Slip A3.

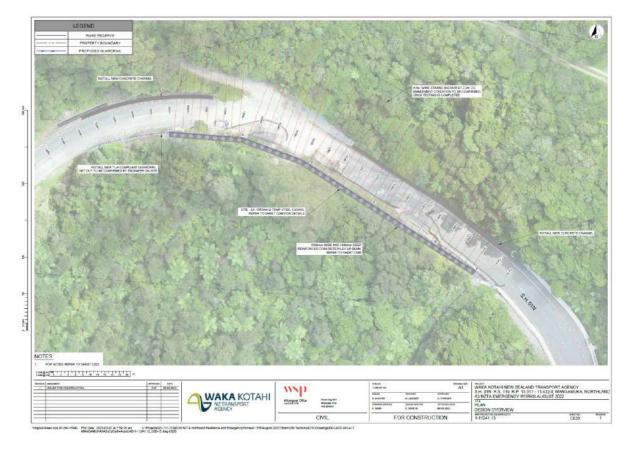
Figure 3: Slip A3, plan of concrete cap and pile retaining and new channelling.

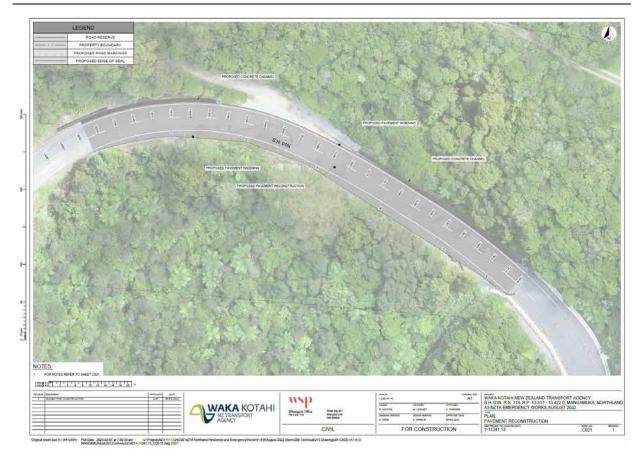
Figure 4: Slip A3, plan of pavement reconstruction.

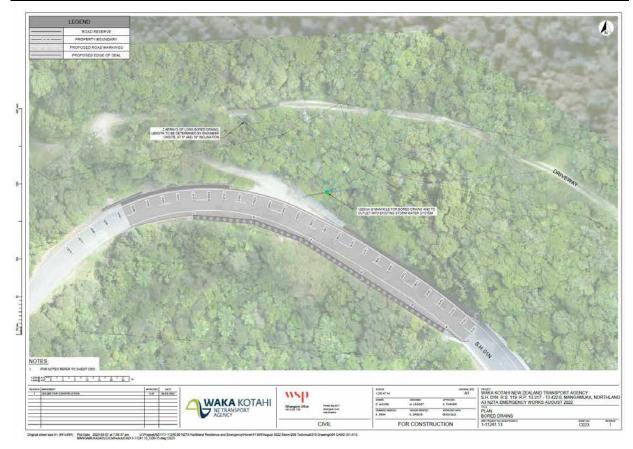
Figure 5: Slip A3, plan of bored drains.

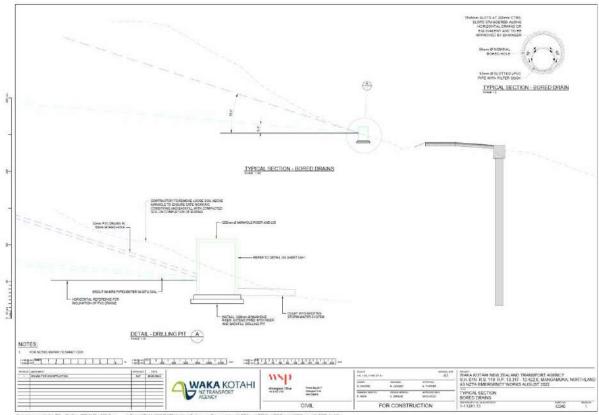
Figure 6: Typical cross section, bored drains.

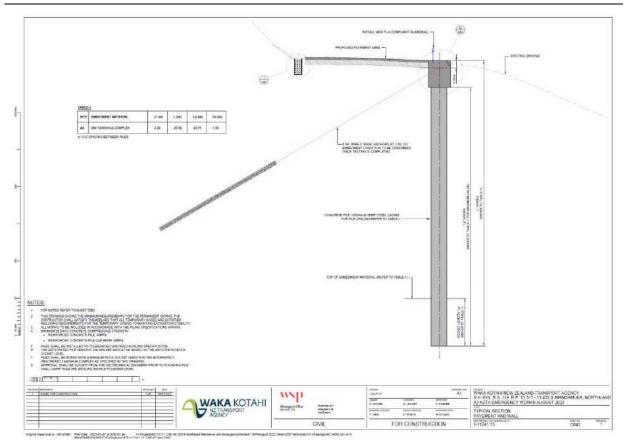
Figure 7: Typical cross section, concrete cap and pile retaining, channelling and pavement.

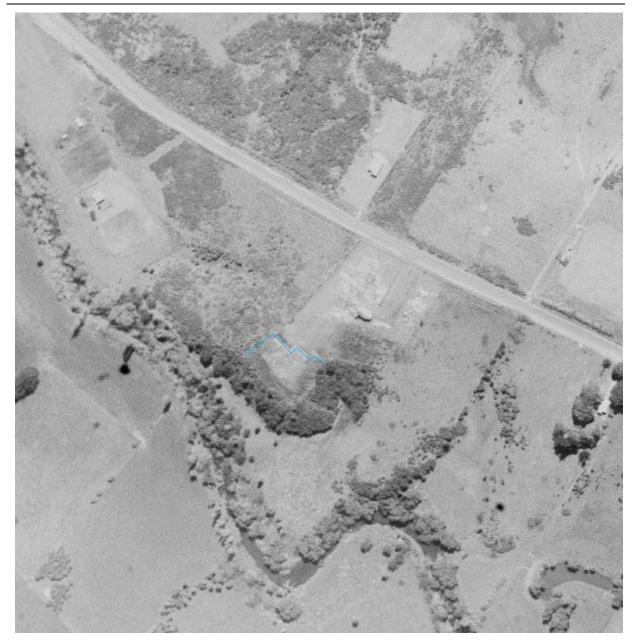
Figure 77: Detail from aerial image SN 350 1365/16 (1950) showing clearest image of possible defensive ditch with gun-fighting flanking angles at rear of urupa (in blue).

Both modern and historic aerial imagery (Figure 77 - Figure 80) show the remains of what appears to be a defensive earthwork with multiple flanking angles suggestive of gun-fighting adaptation on the northern face, most obvious in the 1950 aerial. A western return of the ditch back towards the river is most visible in the 1973 aerial.

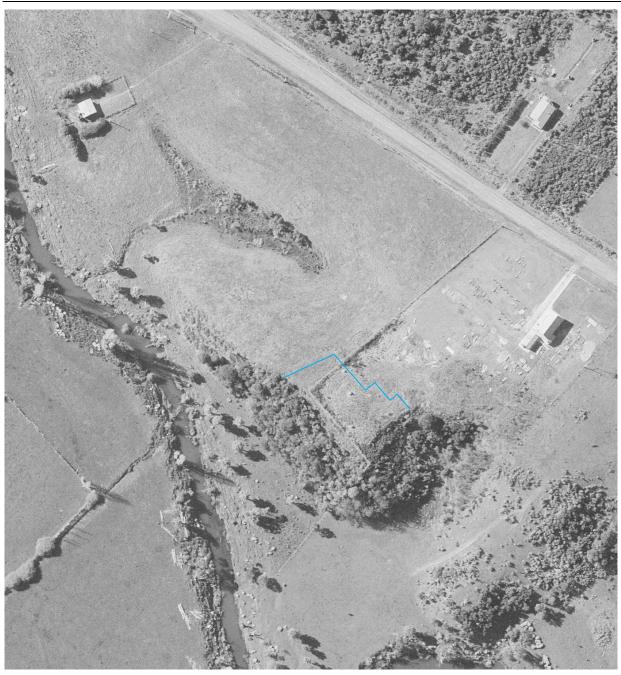
Figure 78: Detail from SN 1417 B/12 (1961) showing possible defensive ditch with gun-fighting features at rear of urupa.

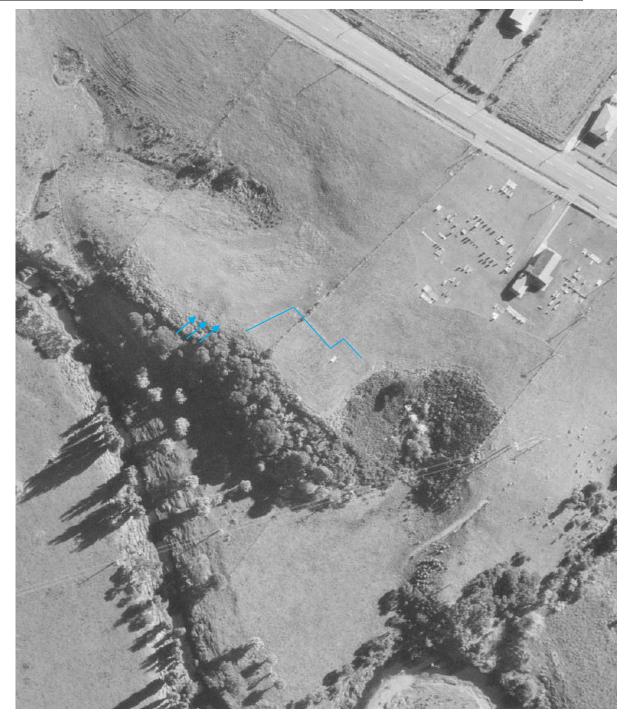
Figure 79: Detail from aerial image SN 3675 C/3 (1973) with defensive ditch and possible terraces.

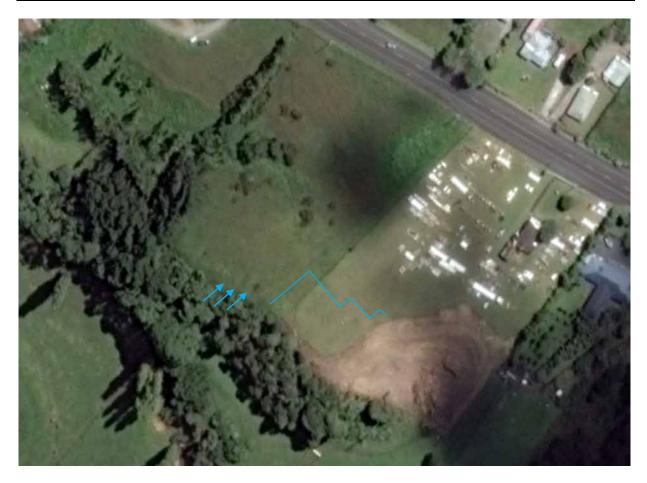
Figure 80: Detail from 2016 aerial showing possible terraces, and defensive ditch (Google Earth).

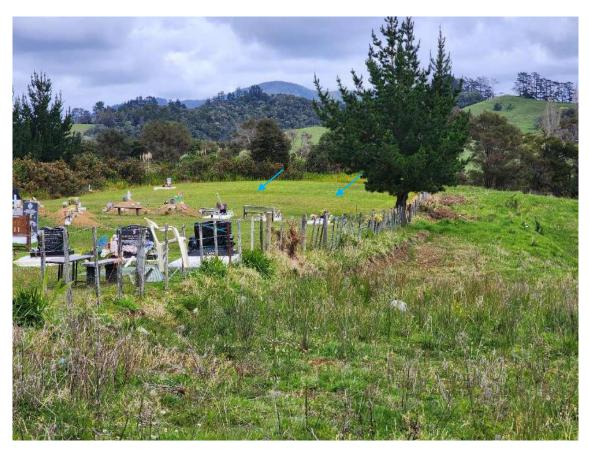
Figure 87: Looking south over rear of urupa with possible infilled ditch.

The proposed spoil dump site (Figure 86) was visited for an hour on 9 September 2023, in the company of T. Latimer, R. Gabel, and G. Latimer. The possible infilled defensive ditch in the urupa was visible as a slightly darker line of vegetation and shallow swale running across the rear of the urupa under closely mowed grass, but was not visible beneath the rank grass on the western side of the internal fence (Figure 87).

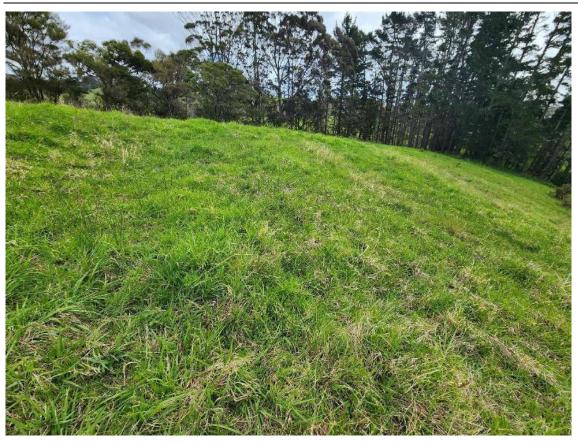
Figure 88: Possible terraces down western ridgeline.

A number of possible terraces were observed on the southern descending spur to the west of the fence. There were larger transverse terraces on the spur which were  $10-15 \times 10 \times 0.3$ m in size, and smaller lateral terraces around the head of the gully which are more likely to be erosional features. However they were all relatively indistinct and while they looked like they started as erosion features, have probably been modified by occupation and/or gardening (Figure 88).
